# Clark Boulevard Extension and Eastern Avenue Improvements Environmental Assessment Study

Rutherford Road to Kennedy Road

Safety Analysis Report City of Brampton

May 3, 2021

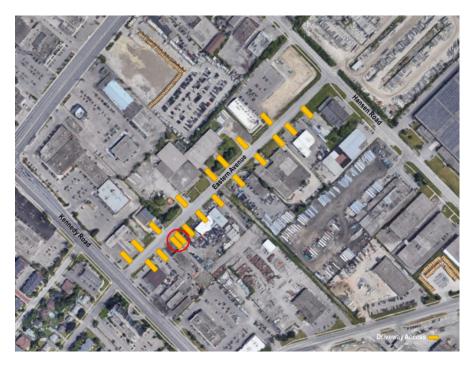
Figure 3-2 Existing Driveway Access - Eastern Avenue (Source: Google Maps)

The existing layout for driveway accesses are shown in **Figure 3-2**. The spacing between accesses were analyzed based on TAC 2017, Section 3.2.9.8, shown in **Appendix B**. The suggested minimum spacing requirement for driveway spacing for local and collector roads is 3 m for both commercial and industrial land uses. If, however, there is a need to provide parallel parking between driveways along the roadway, a spacing of 6.0 to 7.5 m is suitable.

The general spacing of accesses meet the minimum spacing requirements for the commercial / industrial land use, with the exception of the two accesses shown in red circle in **Figure 3-2**, which are located adjacently. Several accesses along Eastern Avenue present opportunities for consolidation. Consolidation of accesses would reduce conflict points (**Figure 3-3**) which will in turn enhance safety along the corridor.

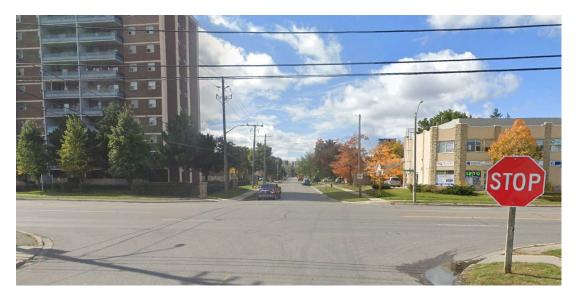
Figure 3-4: Kennedy Road and Eastern Avenue (Source: Google Earth, September 2020)

Existing pavement markings on Eastern Avenue are not visibly delineated. This includes lane lines, stop bars, and pedestrian crossings. Specifically to Eastern Avenue, lane lines should be used where the following conditions exist as per OTM Book 11 page 40:

Based on **Figure 3-4** through to **Figure 3-6**, lane lines are not shown under these two conditions.

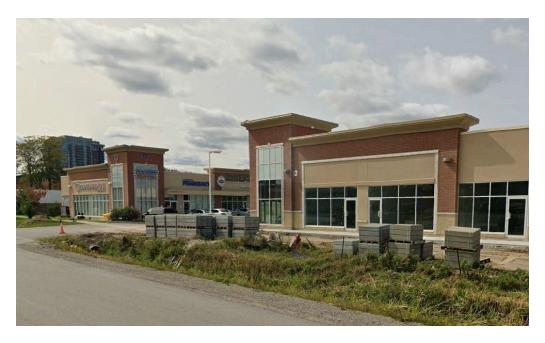
Figure 3-10: Discontinued Sidewalk at 80 Eastern Ave (Source: Google Streetview, September 2020)

As discussed in the Pedestrian Level of Service analysis documented in the Transportation Report, the Eastern Ave corridor currently provides no pedestrian crosswalks. There is currently an established commercial development at 80 Eastern Ave (shown in Figure 3-10) with urbanized roadside features (sidewalks of 1.47 m and curbs), however the sidewalks are discontinued beyond the commercial property. Although patrons to this plaza typically arrive by personal vehicle, the future continuity of the sidewalk along the corridor is required for the existing sidewalk to be utilized.

Elements	Existing Conditions	Dasian Standards	Meets or Exceeds Standards		
Sidewalk Width	1.48 m	1.8 m	No

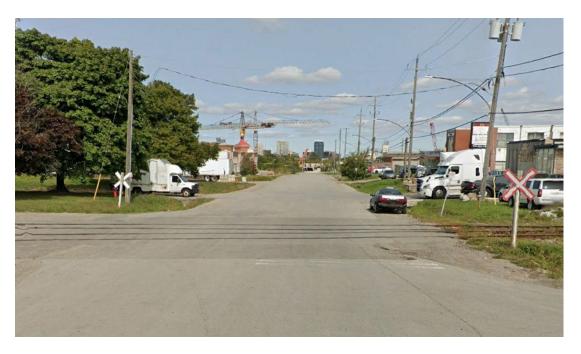
Figure 3-11 - Existing Uncontrolled Rail Crossing on Eastern Ave 200m East of Kennedy Rd (Source: Google Streetview, September 2020)

The crossing is without warning systems such as gates and signals. There are faded pavement markings east and west of the crossing along with small rail crossing signage, located immediately east and west of the crossing. There is no rail crossing ahead signage nor advanced pavement markings to denote a rail crossing. There are no sidewalks. Hydro poles and illumination are located on the south boulevard. No-passing markings are not visible to prohibit passing by vehicles approaching the railway crossing.

Thus, the existing at-grade rail crossing pavement marking and signage does not meet standard shown in OTM Book 11 Figure 46, Page 100 in and shown in Figure 3-12.

The frequency for rail vehicles at this crossing is unclear, however, the need for potential upgrade to traffic control devices should be considered for future alternatives where increased traffic and active road users are expected.

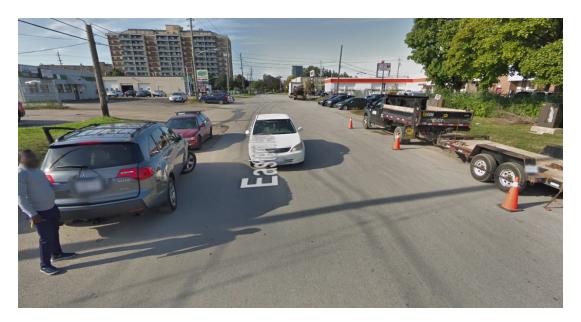
Based on existing industrial land use for the Eastern Avenue corridor, parking along the right of way is unrestricted on the south side but prohibited on the north side. Based on observations, there are many instances where large commercial vehicles occupy the north side of Eastern Avenue, shown in **Figure 3-14** and **Figure 3-15**.

Figure 3-14 Existing Parking and Roadside Obstructions (Source: Google Streetview, 2018)

Due to the generally low volume on Eastern Avenue, there is a lack of parking enforcement on Eastern Avenue. Although the illegal parking does not pose a substantial impact to traffic operation, they do significantly hinder sightlines for turning traffic from driveways. When the roadway expansion and potential connection to Clark Boulevard are provided for Eastern Avenue, vehicles are less likely to park along a higher volume corridor. However, enforcement measures to prevent vehicle blockages may be required in the future should this issue persist.

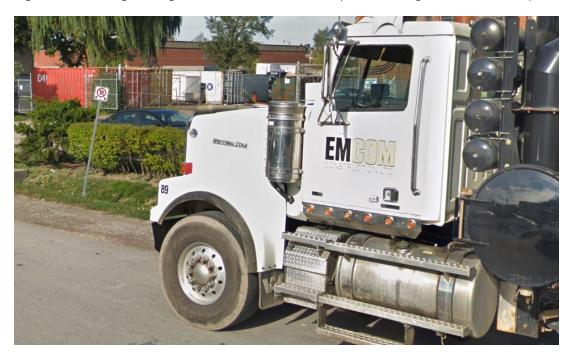
Figure 3-15 Illegal Parking on North Side of Eastern Avenue (Source: Google Streetview, 2018)
