Geotechnical Desktop Review and Road Conditions Assessment

**Extension of Intermodal Drive to Gorewood Drive
Brampton, ON, Canada**

22 December 2025

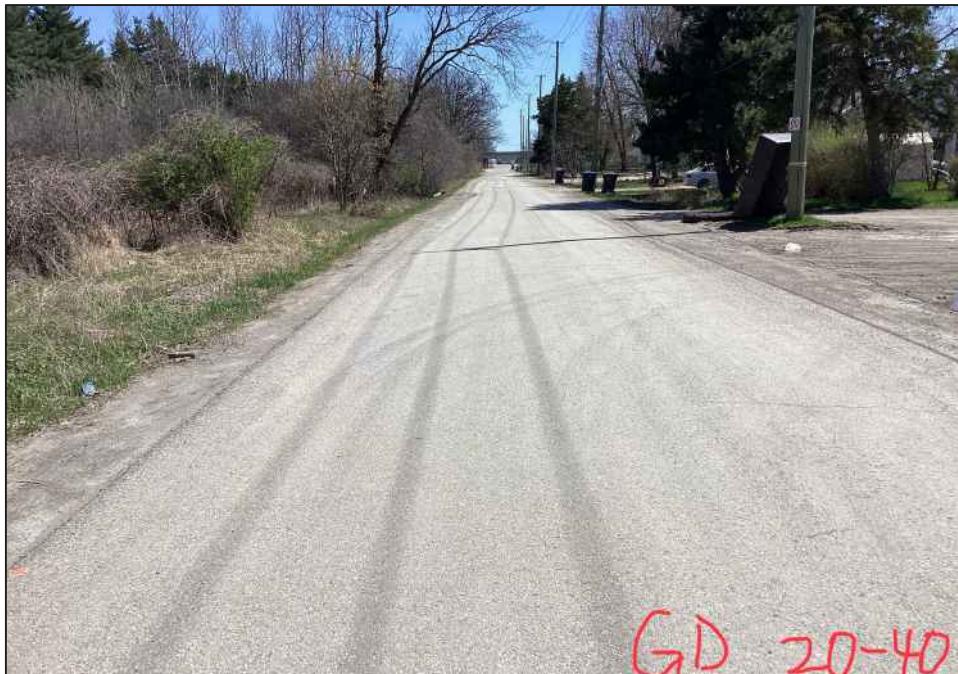
Photo: #1

Description: Part of Gorewood Dr with no visible distress.

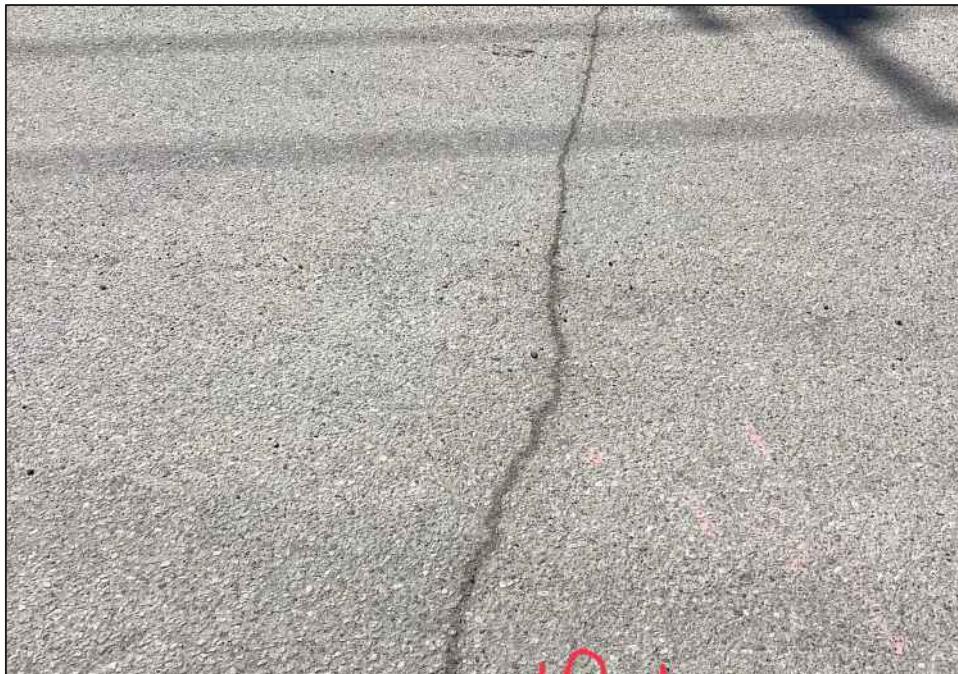
Photo: #3

Description: Part of Gorewood Dr showing Long & Trans Cracking .

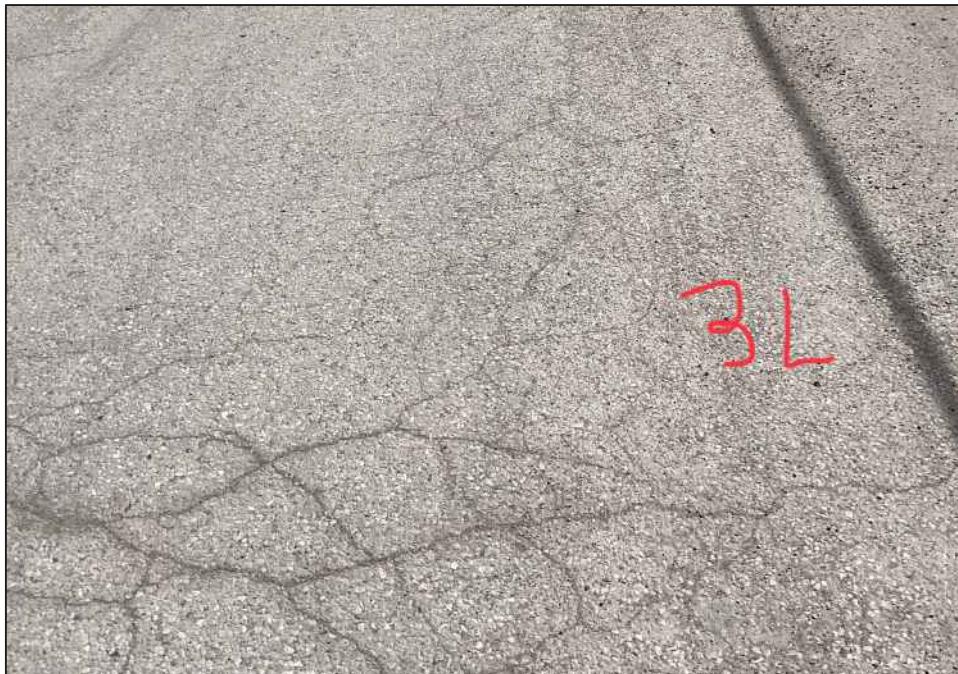
Photo: #5

Description: : Part of Gorewood Dr showing low severity Block Cracking.

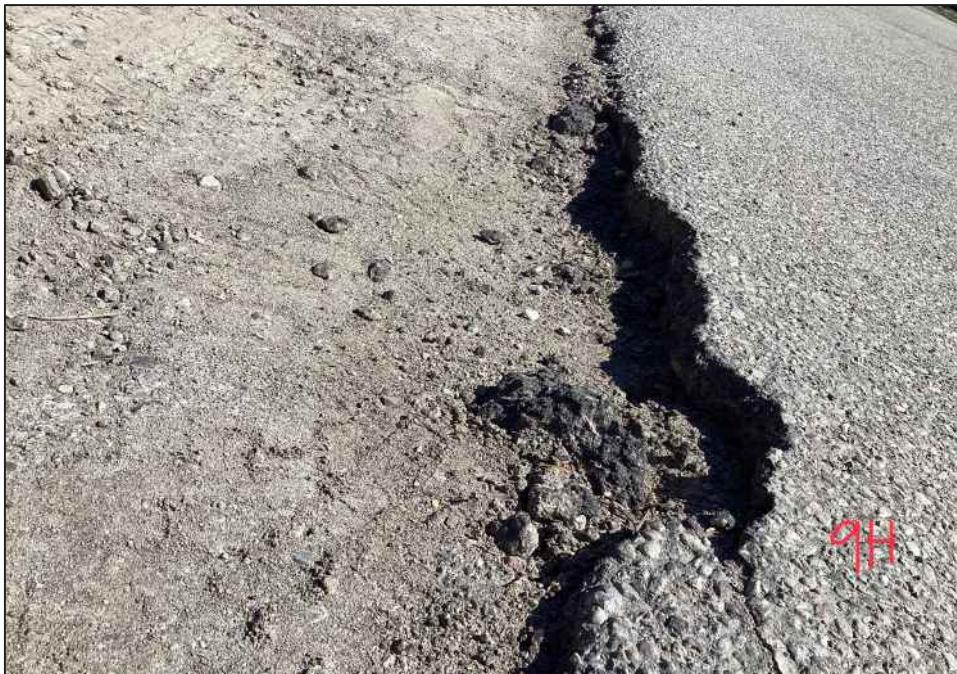
Photo: #7

Description: Part of Gorewood Dr showing high severity Lane/Shoulder Drop Off.

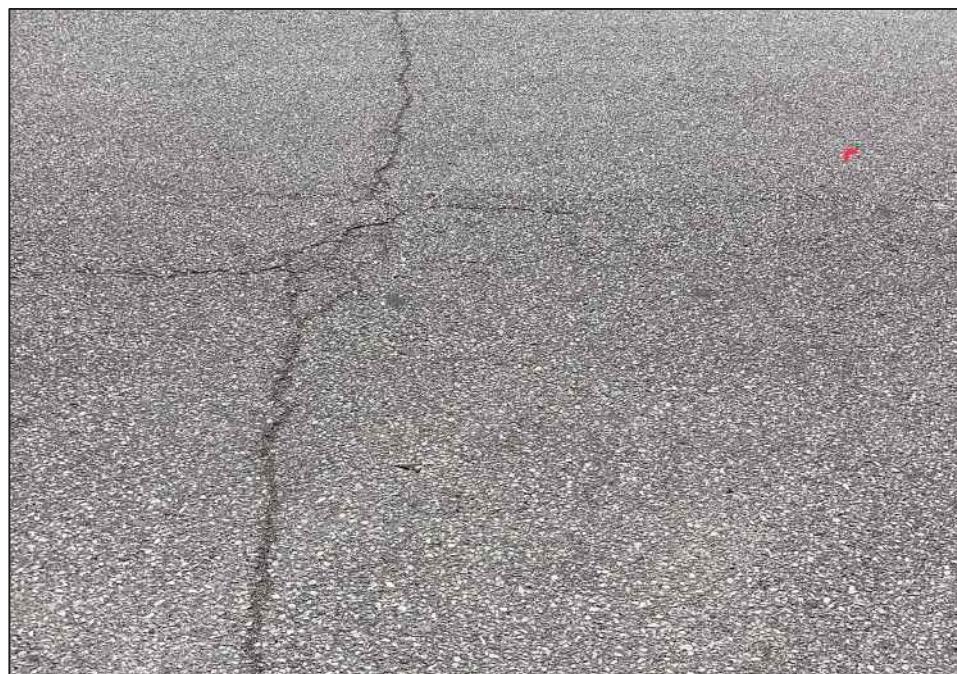
Photo: #8

Description: View of Long & Trans Cracking in GD.

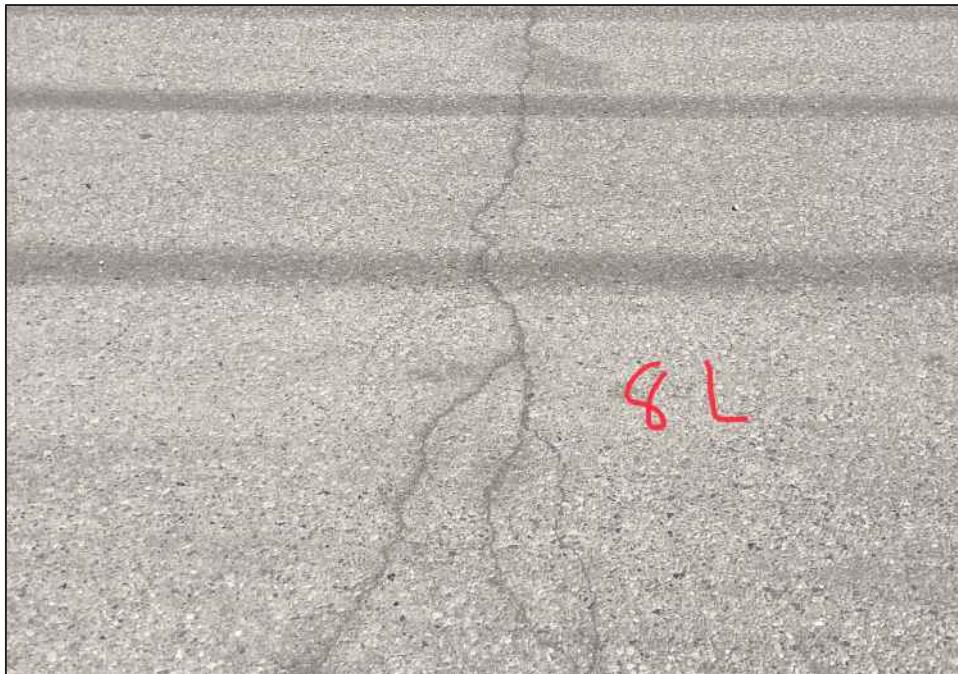
Photo: #9

Description: : Part of Gorewood Dr showing a low severity Jt. Reflection Cracking.

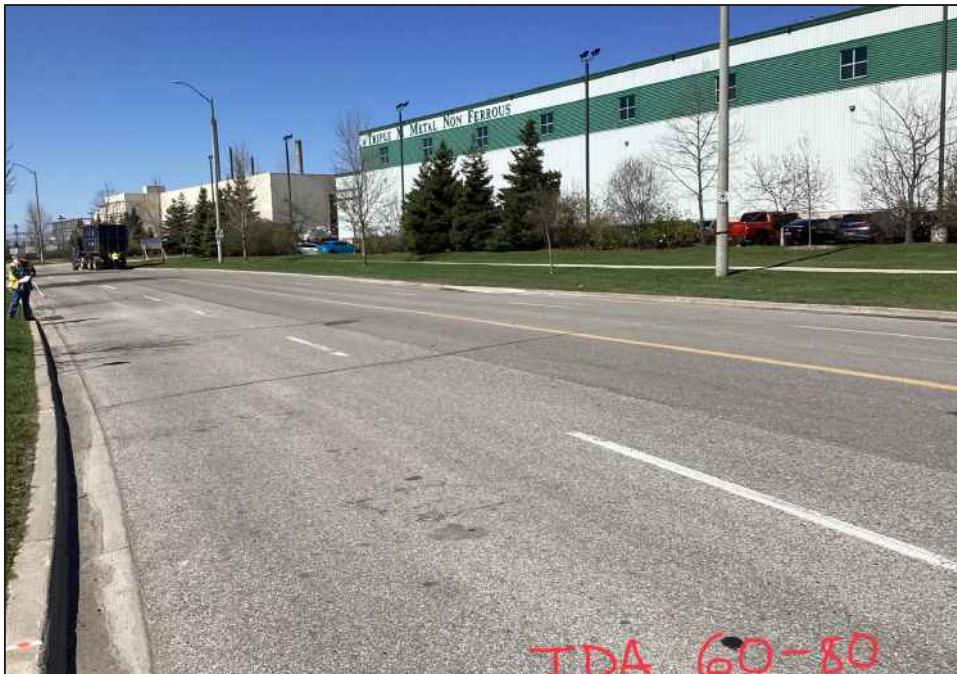
Photo: #1

Description: Part of Intermodial Dr with no visible distress.

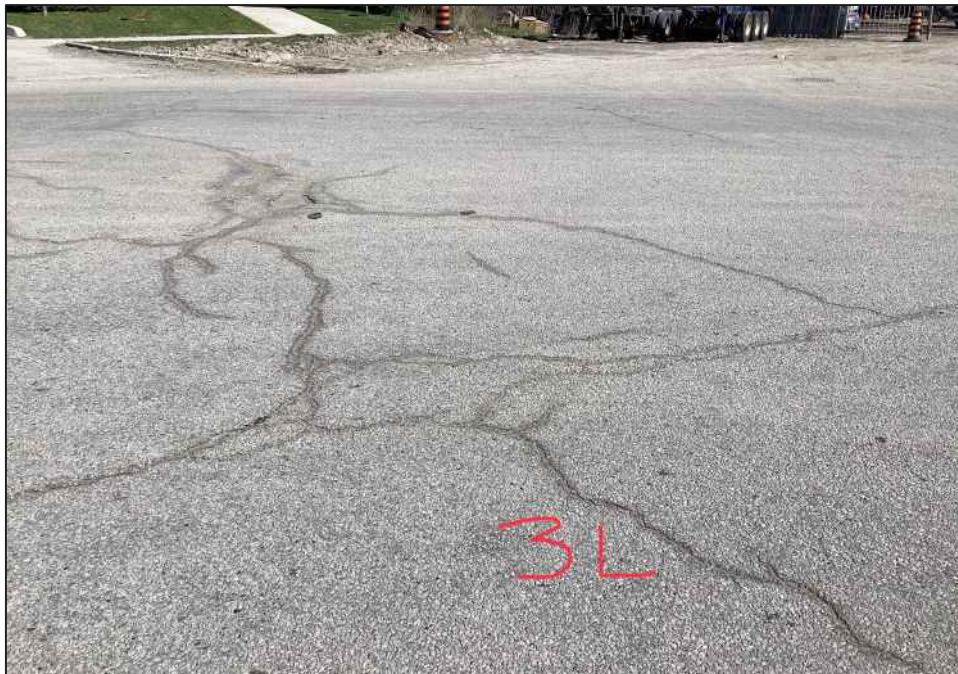
Photo: #3

Description: Part of Intermodal Dr showing low severity Block Cracking.

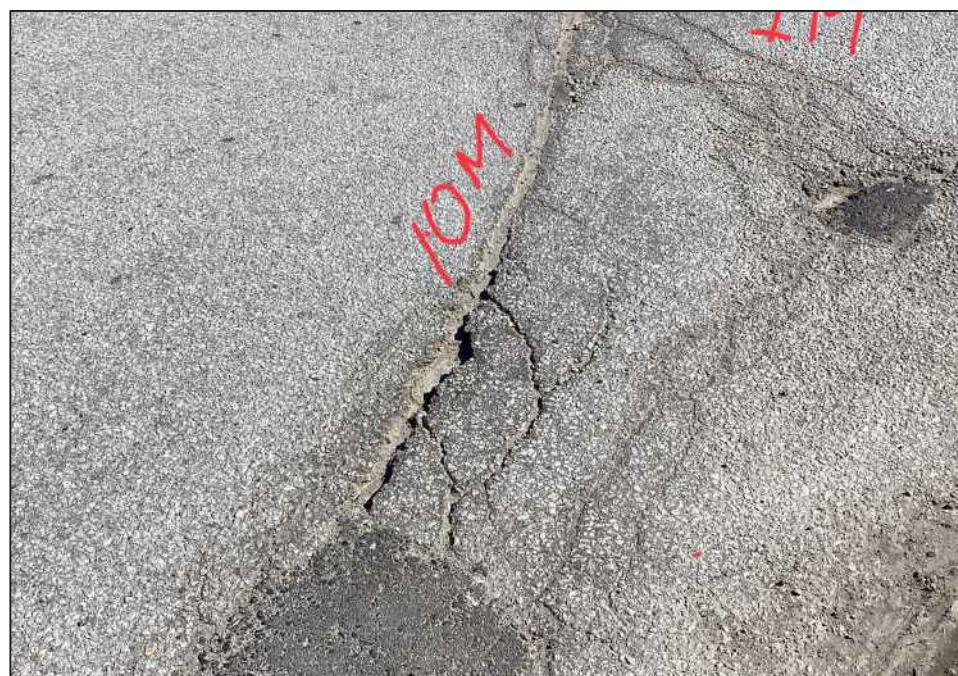
Photo: #4

Description: Part of Intermodal Dr showing medium severity Long & Trans Cracking, and Alligator Cracking.

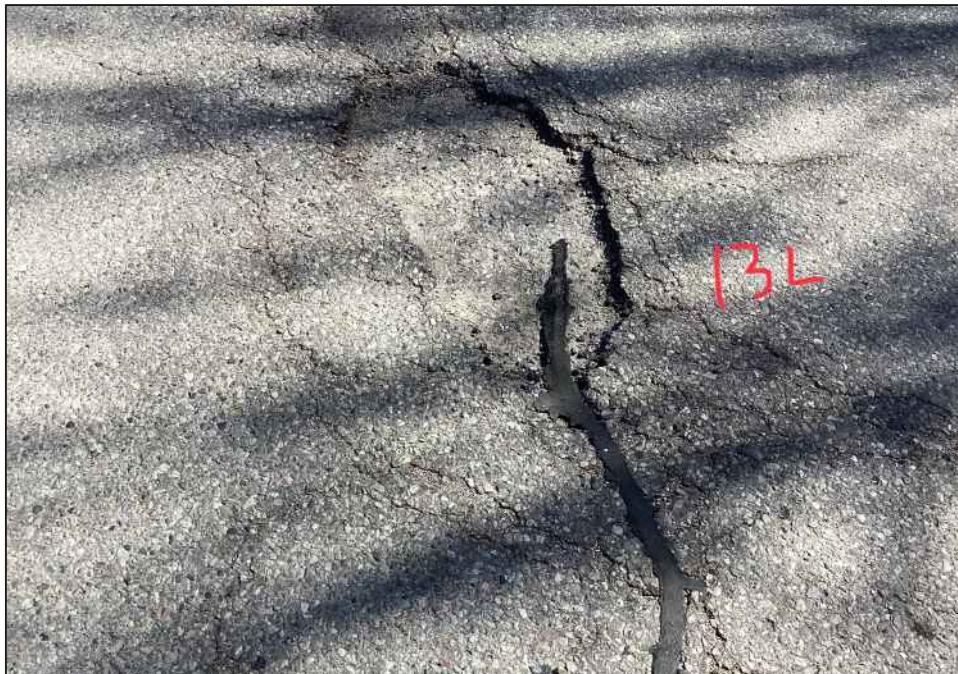
Photo: #5

Description: Part of Intermodal Dr showing low severity Potholes.

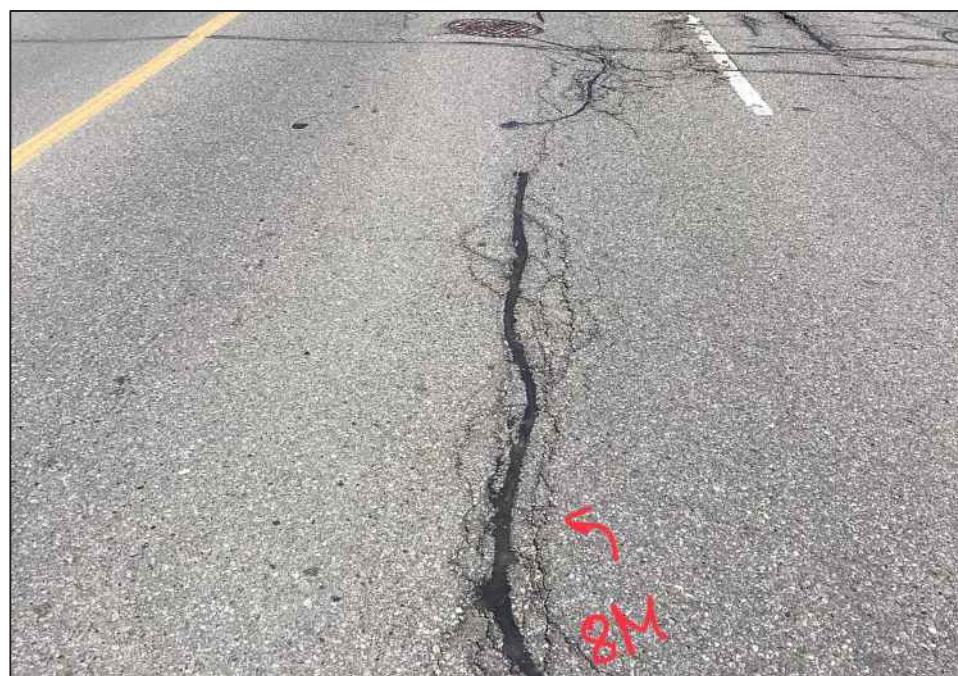
Photo: #6

Description: Part of Intermodal Dr showing medium severity Jt. Reflection Cracking.

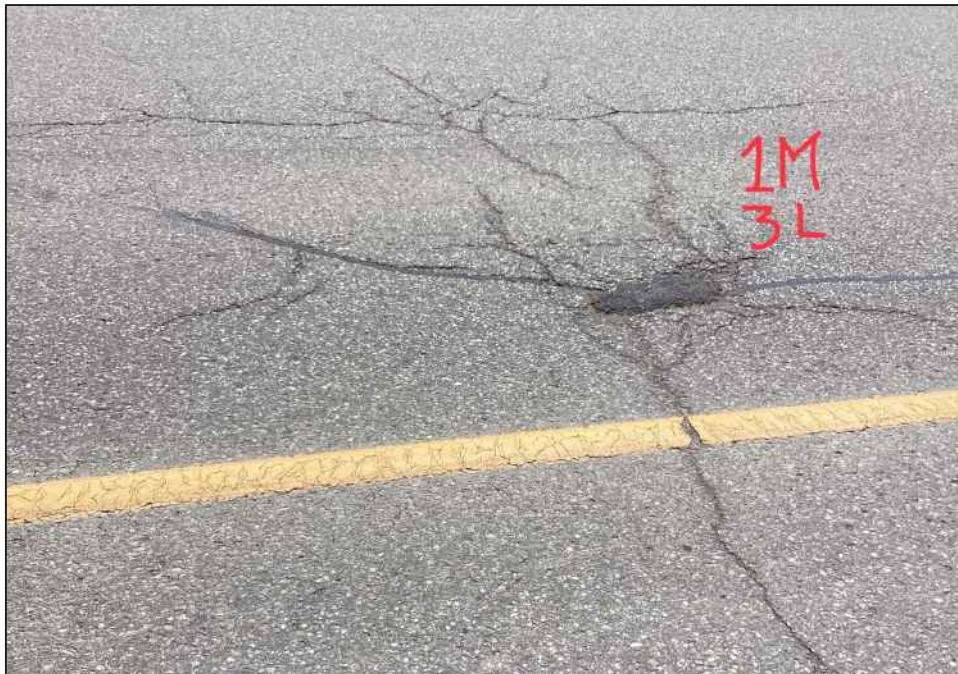
Photo: #7

Description: Part of Intermodal Dr showing medium severity Alligator Cracking and low severity Block Cracking.

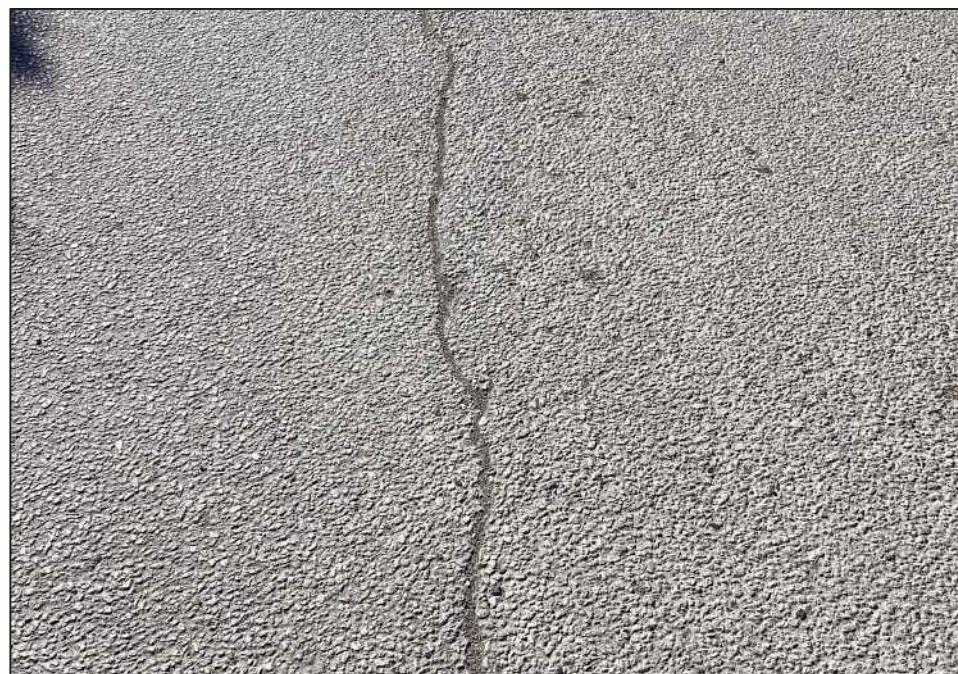
Photo: #8

Description: Part of Intermodal Dr showing low severity Long & Trans Cracking.

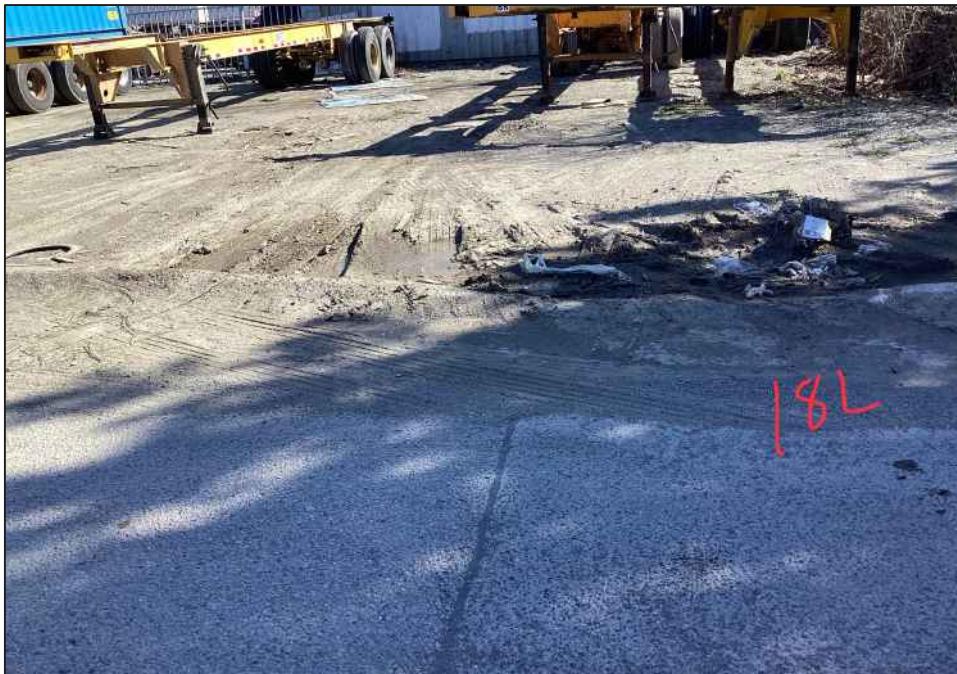
Photo: #9

Description: Part of Intermodal Dr showing low severity Swelling.

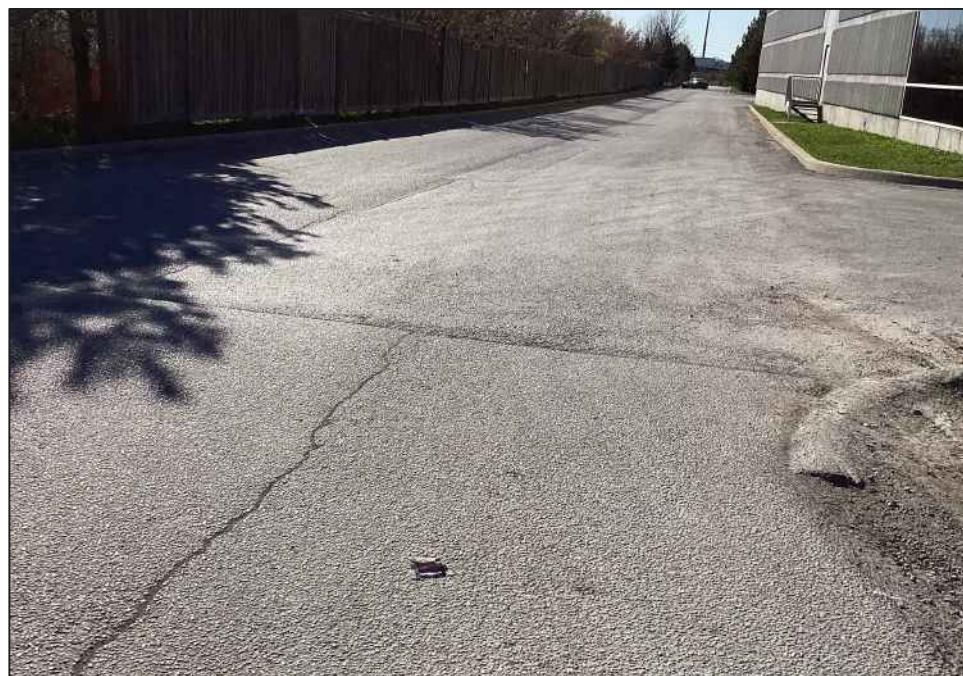
Photo: #10

Description: Part of Intermodal Dr showing low severity Long & Trans Cracking.
