D-2 SAFETY REVIEW OF EXISTING CONDITIONS

**Environmental
Assessment Study of
Arterial Roads Within
Highway 427 Industrial
Secondary Plan Area
(Area 47)
Safety Review of Existing
Conditions**

March 2016

CIMA
Partners in excellence

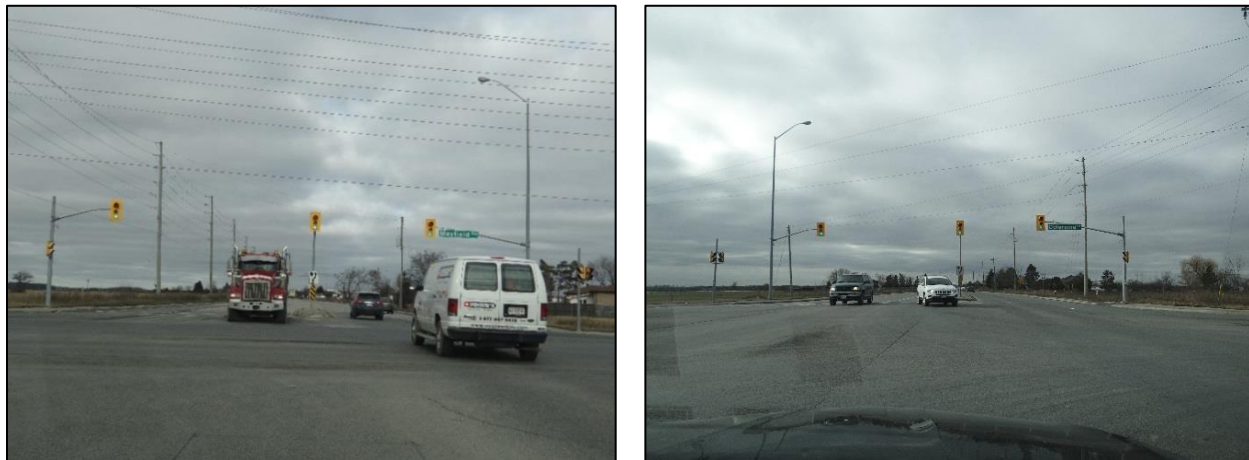
Figure 4: Offset Intersection Approaches (Colerain Drive and Region Road 50)

Existing left-turn lanes in all directions at the intersection of Coleraine Drive at Mayfield Road presents negative offsets. This configuration can create visibility restrictions to drivers attempting to turn left during the permissive phase when drivers in the opposite direction are attempting to perform the same manoeuver. This is aggravated when large vehicles, such as trucks, or in some cases large pick-up trucks, are in the opposing left-turn lanes as illustrated in Figure 4. This could be a contributing factor to turning movement collisions.

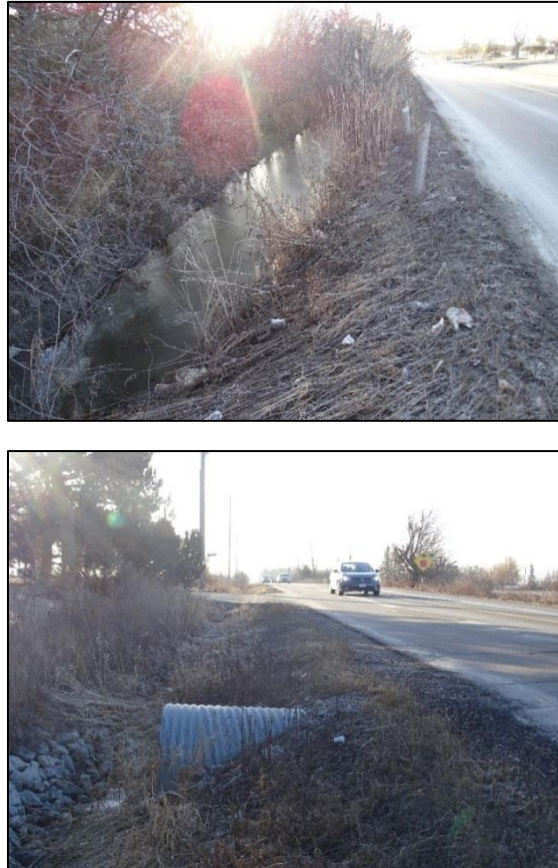
Figure 7: Side Slopes along the Coleraine Drive Corridor

slopes may not be able to recover and at some locations are likely to overturn. Recoverable slopes are generally the slopes flatter than 4:1 on which a driver can retain or regain the control of the vehicle in a run-off the road event. Non recoverable slopes are generally the slopes from 4:1 to 3:1. These slopes may be traversable, but the vehicle will continue to the bottom. Slopes steeper than 3:1 are known as critical slopes and are considered outside of the recovery zone. Vehicles encroaching on these slopes are likely to overturn. TAC notes that if critical slopes begin within the clear zone distance, a traffic barrier may be warranted if the slope cannot be readily flattened². Figure 7 illustrates a typical roadside slope within the clear zone.

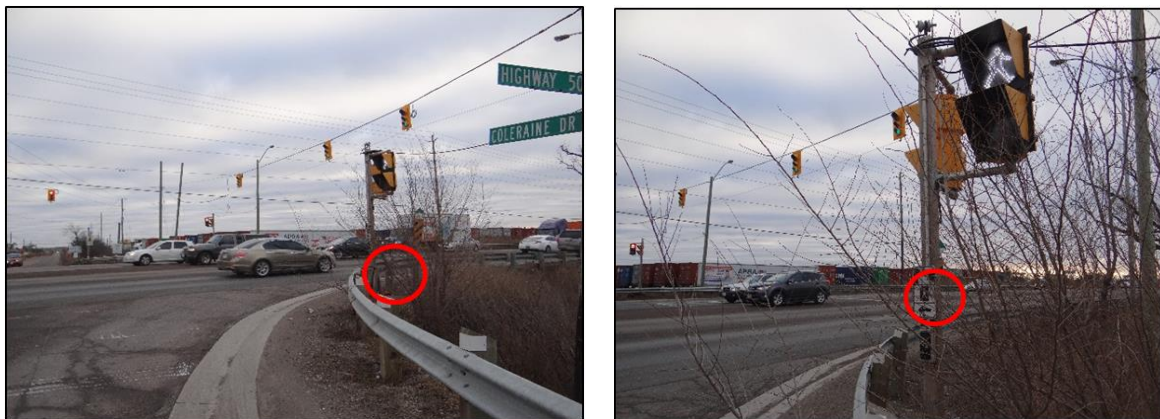
Figure 10: Obstructed Pedestrian Push Button (Coleraine Drive and Regional Road 50)

The pedestrian pushbutton located at the southwest corner of the intersection of Coleraine Drive and Regional Road 50 is obstructed by tree branches. During the spring and summer seasons once branches bloom, it may be difficult for pedestrians to locate the push button and safely operate the intersection as shown in Figure 10.

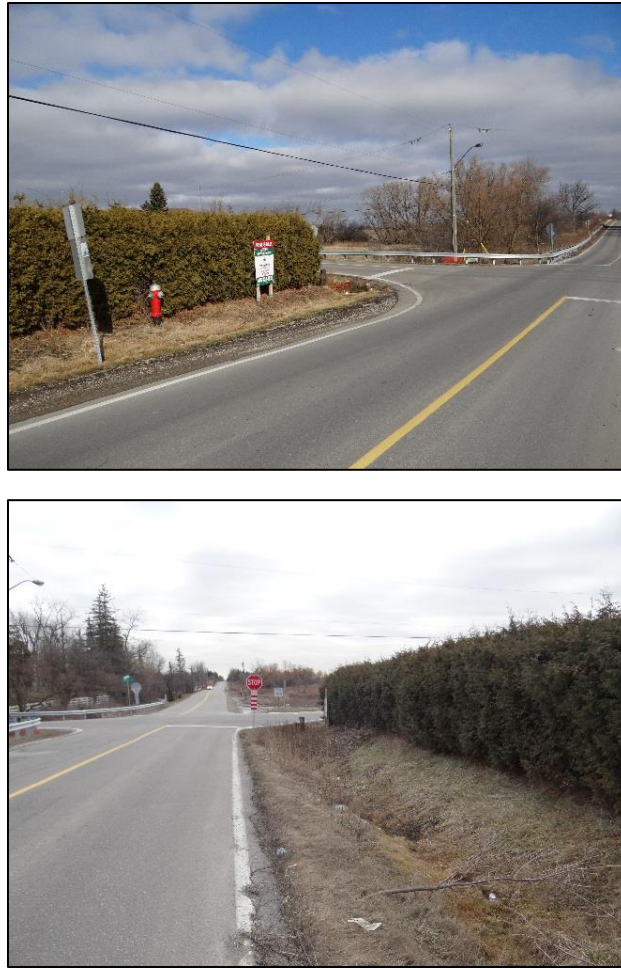
Figure 14: Limited Sight Triangles (Clarkway Drive and Countryside Drive)

Existing vegetation located on the northwest corner of Clarkway Drive and Countryside Drive reduces sight triangles for motorists travelling in the southbound and eastbound directions as shown in Figure 14. It should be noted that the subject intersection is all-way stop control and the requirement for clear sight triangles is not applicable for this type of intersection.

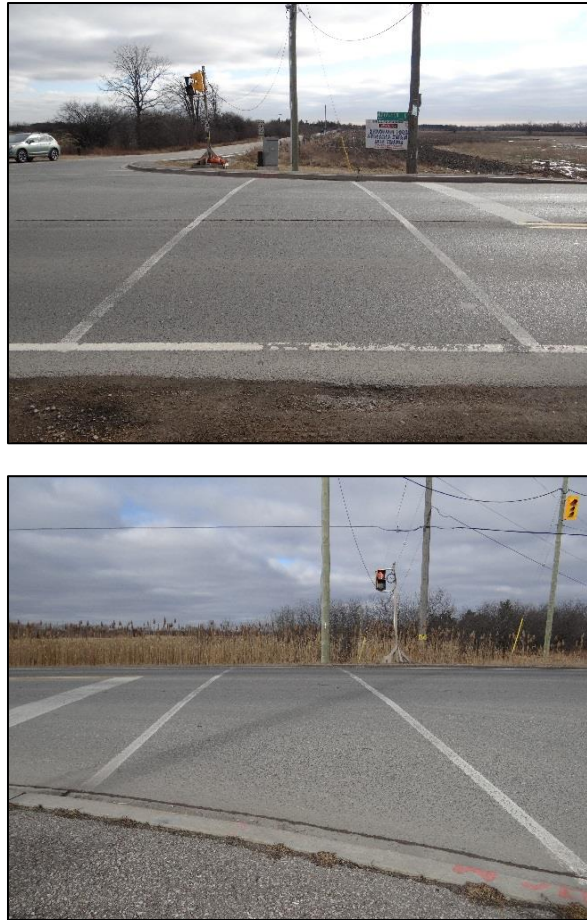
Figure 18: Offset Signal Heads (Clarkway Drive and Mayfield Road)

Existing pedestrian signal heads on all approaches located at Clarkway Drive and Mayfield Road are not properly aligned with the existing pedestrian crosswalks and sidewalks as demonstrated in Figure 18.

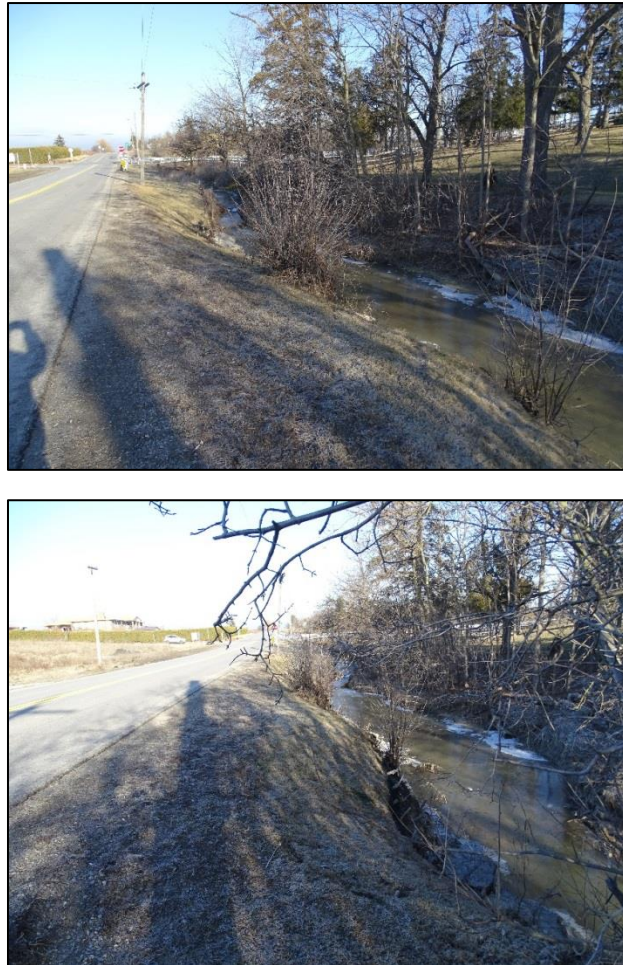
Figure 22: Inadequate Steel Beam Length along the Clarkway Drive

The steel beam guide rail is lacking in length of need (LON) as shown in Figure 22. According to the MTO standard⁵ for protection of water body hazards with barrier, the installation length of the barrier shall be the maximum encroachment distance.

The field review revealed that the length of need (LON) for existing steel beam guide rails are not adequate. The guide rail should be extended during the upcoming road widening to protect the vehicles from the water body hazards. It is noted that the need for guide rails in the long term should be evaluated during the design stages of the upcoming road widening. By widening the road, clear zones will be laterally shifted and may include new hazards requiring protection, or currently existing hazards may be eliminated, either by removal or by introducing proper cross section design.

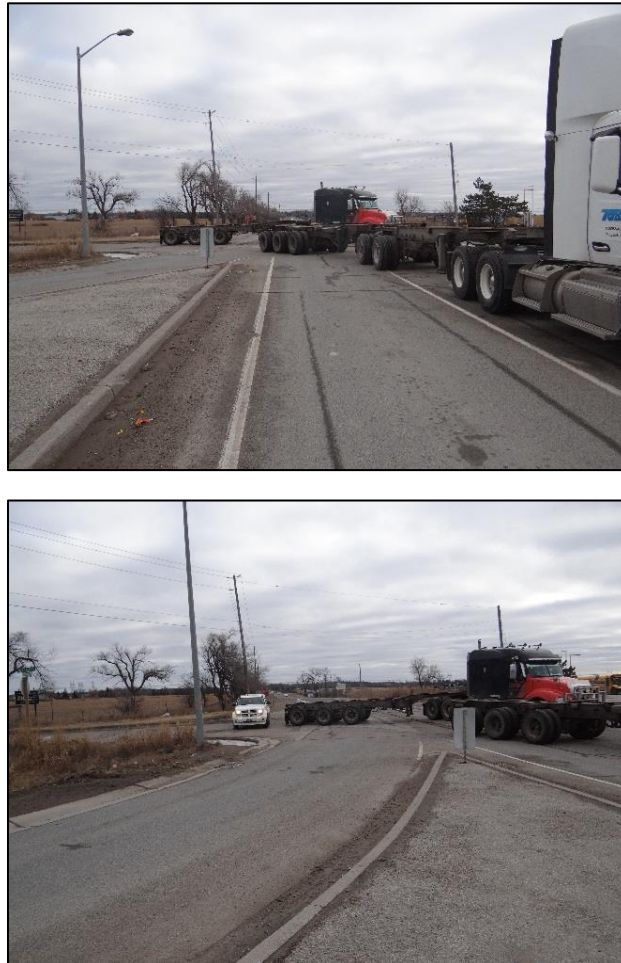
Figure 24: Proximity of the Two Intersections (Cold Creek Drive at Nashville Road and Countryside Drive at Regional Drive 50)

of Countryside Drive and Regional Road 50. The through and right turn vehicles will use the shoulder and/or the north leg of Cold Creek Drive intersection to make the maneuvers around the trucks. This may be a potential safety concern due to the reduced sightlines created by heavy vehicles blocking the through and right turn lanes and impatient motorists stuck behind the heavy vehicles as shown in Figure 24.

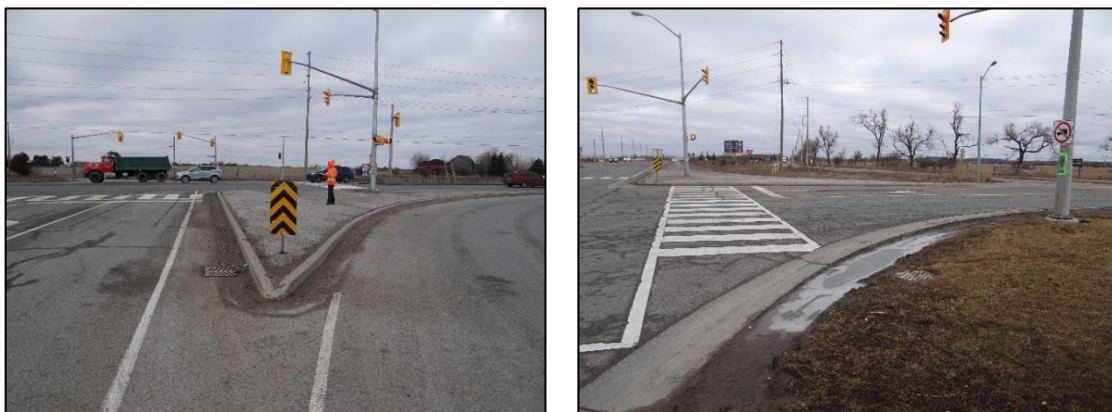
Figure 31: Lack of Pedestrian Infrastructure (Countryside Drive and Regional Road 50)

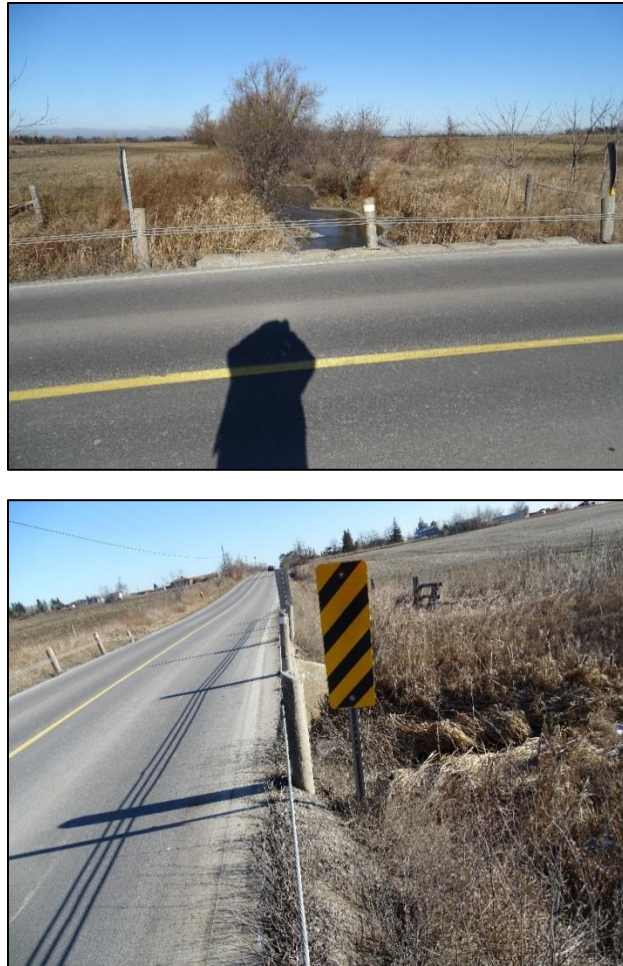
Figure 33: 3-Cable Guide Rail along Countryside Drive

The field investigation noted the presence of some 3-cable guide rail system. These systems are outdated and should be replaced, where possible, by steel beam guide rails.

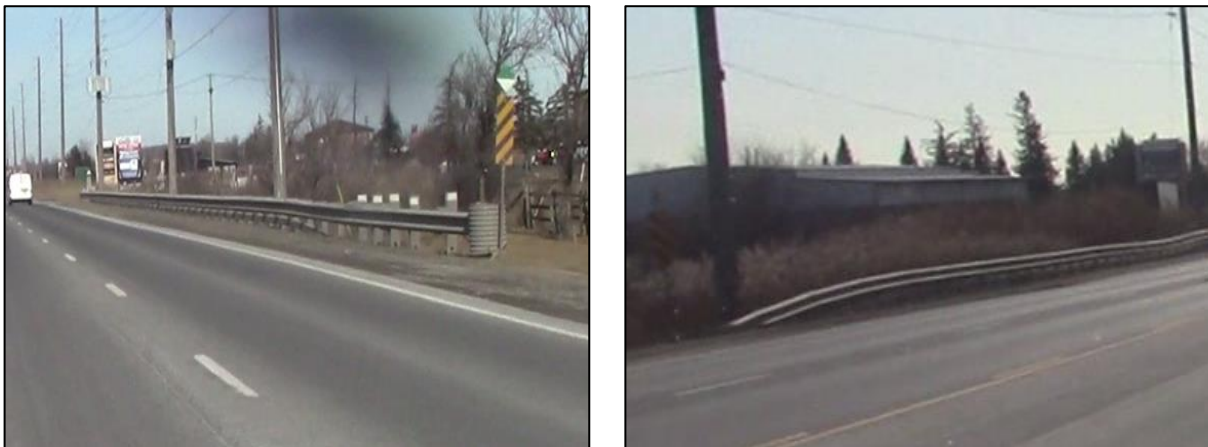
- Motorists were observed to be exceeding the posted speed limit of 80 km/h; and
- The existing guide rails located along Regional Road 50 from Castlemore Road to Mayfield Road contain outdated guide rail end treatments, including an eccentric loader and a turned down steel beam. Energy attenuators are preferable.

Figure 35: Missing Crash Cushion along Regional Road 50
