William Parkway Improvements Municipal Class EA

Bridge Over Spring Creek Structural Assessment Report

Submitted to: City of Brampton, Ontario

January 2024

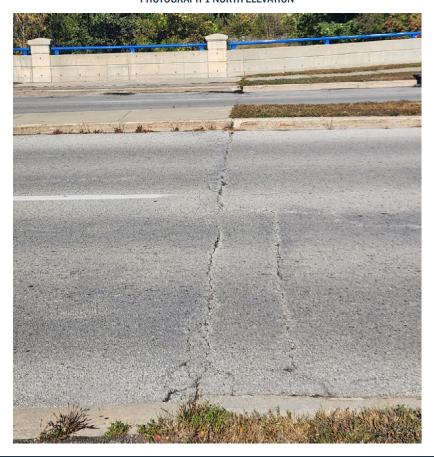
- The abutments are generally in good condition. Medium longitudinal cracks are found at west abutment close to stream elevation.
- The bridge deck is generally in good condition. Alligator cracks and pothole are noted on top of road close to the edge of north and south sidewalks. Wide transverse asphalt cracks are found on the top of road at both lanes.

PHOTOGRAPH 2 DECK TOP LOOKING NORTH, TRANSVERSE CRACK

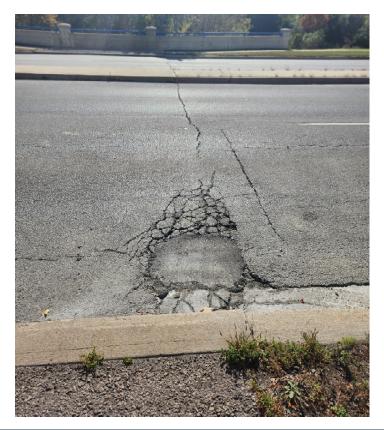
PHOTOGRAPH 3 DECK TOP LOOKING SOUTH, ALLIGATOR CRACKS

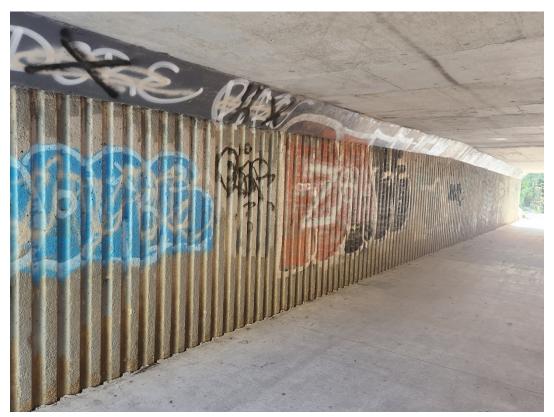
PHOTOGRAPH 6 WEST ABUTMENT

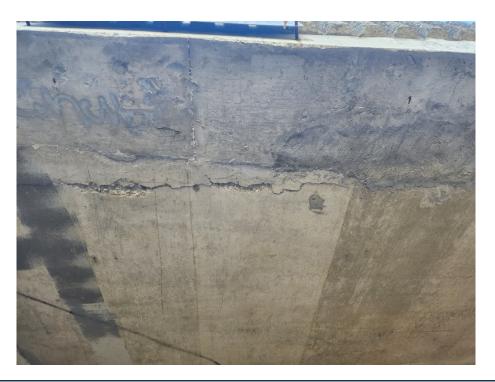
PHOTOGRAPH 9 UNDERSIDE OF NORTH SOFFIT

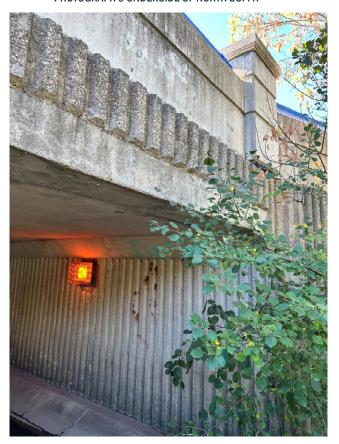
- The bridge soffit at north part of deck is generally in fair condition with spalls and stained small cracks. Patch repair is noted at north outlet soffit.

PHOTOGRAPH 10 NORTH SOFFIT

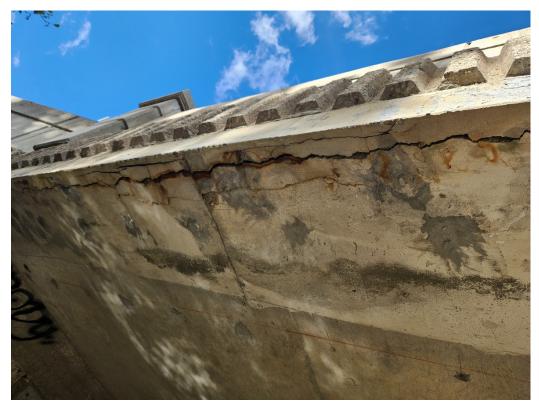
- The south soffit is generally in fair condition with medium to wide cracks at outlet with rebars exposed, medium transverse cracks with efflorescence and wet stain at middle of soffit. Delamination as spalls and small cracks are also noted.

PHOTOGRAPH 12 WIDE CRACKS AT SOUTH SOFFIT

Minor rehabilitation such as patch repairs and crack injection and the bridge inside barrel is also proposed. Detailed condition survey is recommended to evaluate the amount of cracks, patches and delamination on the bridge structure, especially on soffit and underside of deck.

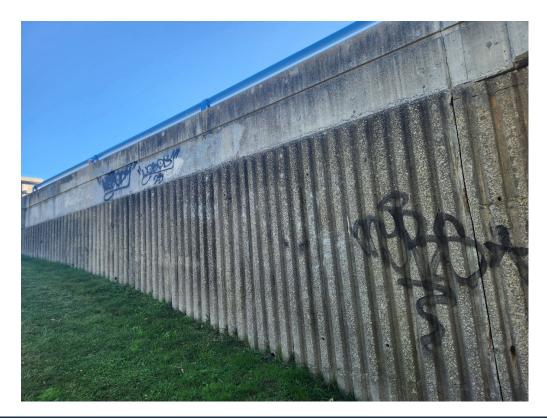
- NE wingwall is generally in good to fair condition. Small to medium cracks are noted near the east abutment.
- NW wingwall cannot be approached due to vegetation.

PHOTOGRAPH 13 NORTH EAST WINGWALL

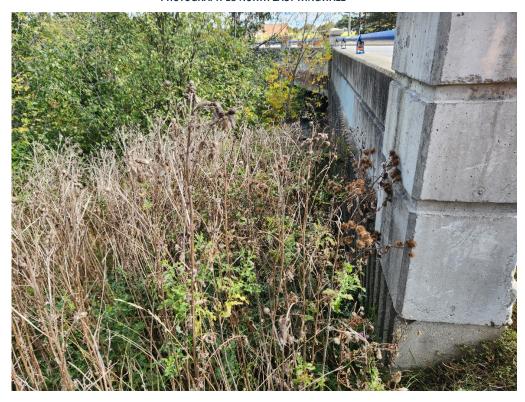
PHOTOGRAPH 14 NORTH WEST WINGWALL

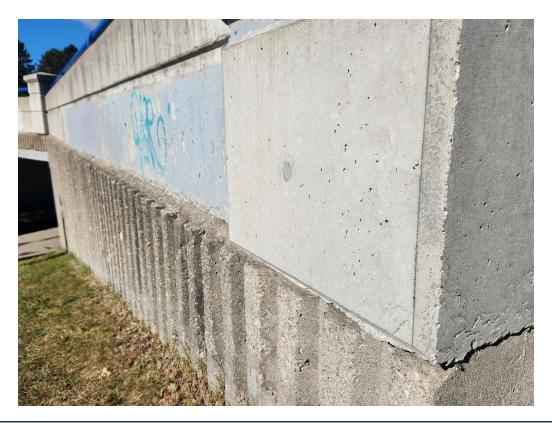
- SE wingwall is generally in good condition with spalls and small cracks.
- SW wingwall is generally in good condition with small to medium cracks and spalls.

PHOTOGRAPH 15 SOUTH EAST WINGWALL

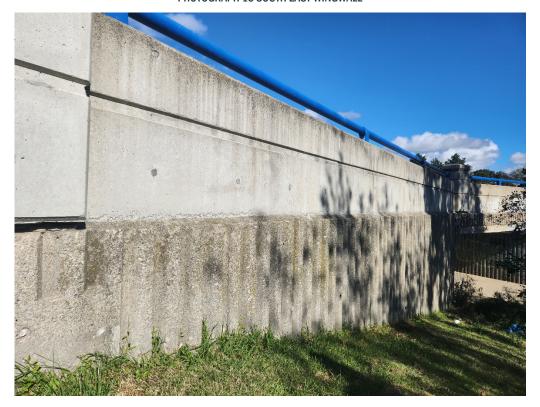
PHOTOGRAPH 16 SOUTH WEST WINGWALL

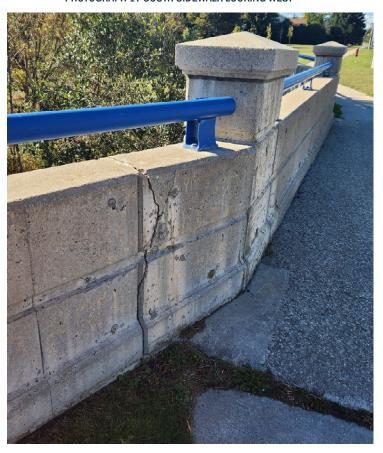
- North and south sidewalks are in good condition.
- Barrier walls at both sides of bridge are generally in fair condition. Wide vertical cracks are noted near joint
 locations at SE and NW barrier walls. Small vertical cracks are found at some of the railing supports at NW
 barrier wall. Delamination of rebars is noted at SW barrier wall. Some of the plugs for form ties are lost in north
 and south barrier walls.

PHOTOGRAPH 18 SOUTH BARRIER WALL WITH VERTICAL WIDE CRACKS

Considering serviceability and functionality, the existing barrier on deck is suggested to be replaced by combination traffic/bicycle barrier and railing, which can refer to Brampton Standard STD 417 and a modified Ministry of Transportation Ontario (MTO) Standard SSD 110-84. The proposed barrier wall has thickness of 250mm and height of 908 mm from the top of asphalt. The proposed railing is 462mm high from the top of barrier wall, and the total height of barrier will be 1370 mm. The sidewalk will be modified to accommodate MUP.

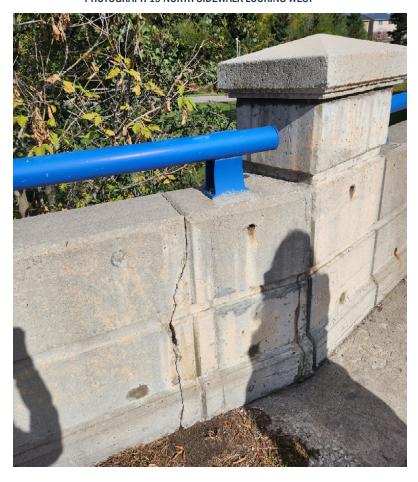
PHOTOGRAPH 20 NORTH BARRIER WALL WITH VERTICAL MEDIUM CRACKS

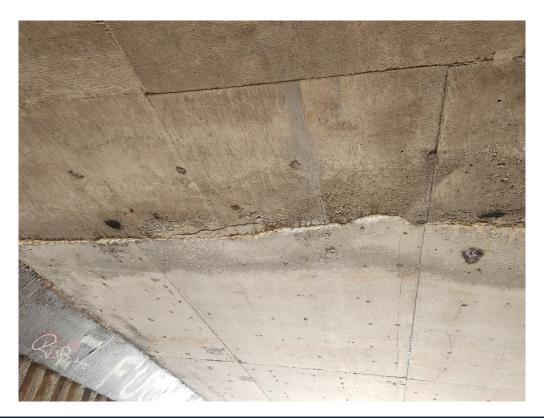
PHOTOGRAPH 21 TRANSVERSE NARROW TO MEDIUM CRACK WITH EFFLORESCENCE ON SOFFIT

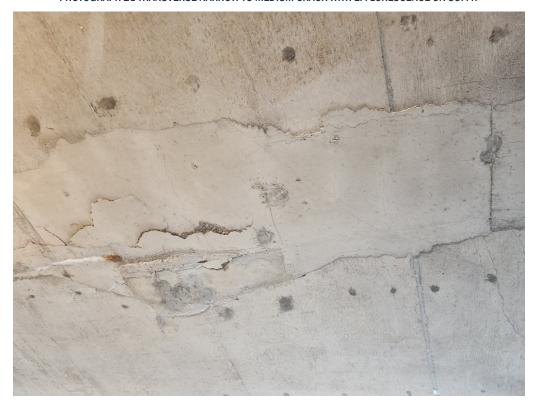
PHOTOGRAPH 22 DELAMINATION AND SPALL ON SOFFIT

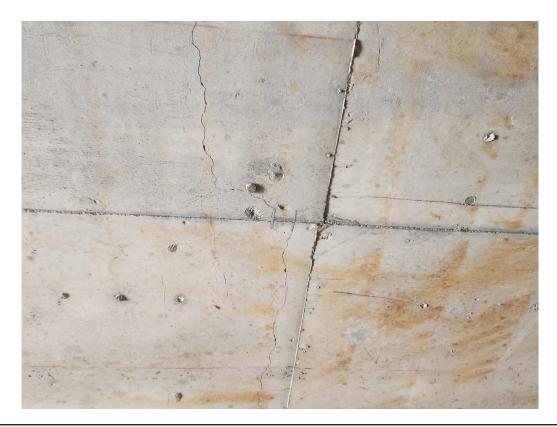
PHOTOGRAPH 23 SMALL CRACKS ON SOFFIT
