Heritage Heights Subwatershed Study Phase 1: Subwatershed Characterization and Integration Report

Brampton, Ontario
Project # TP111117

Wood Environment & Infrastructure Solutions

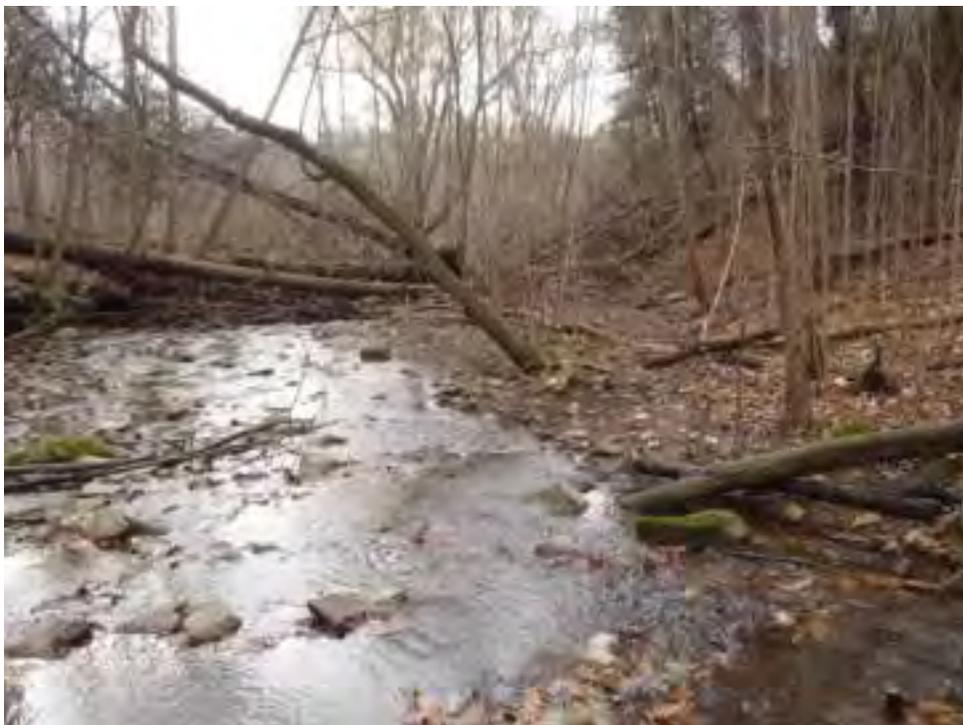
Photo 26.

Looking upstream along CRT2-2. Note the exposed shale and bank undercutting. A concrete weir structure was also noted.

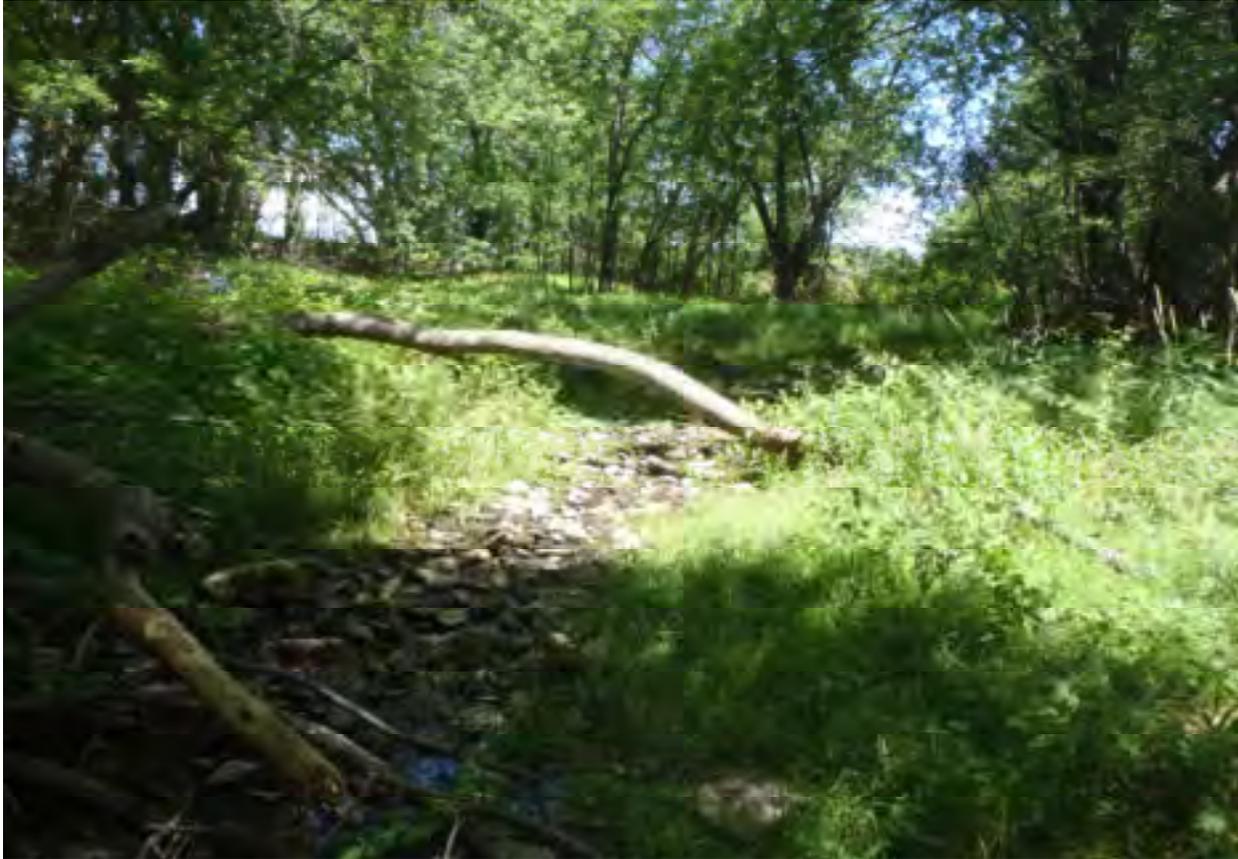
Channel flows through deciduous forest within a confined valley setting. Valley contacts and toe erosion were observed. Evidence of active adjustment included development of chutes and multiple flow paths.

Downstream view of cross section # 4

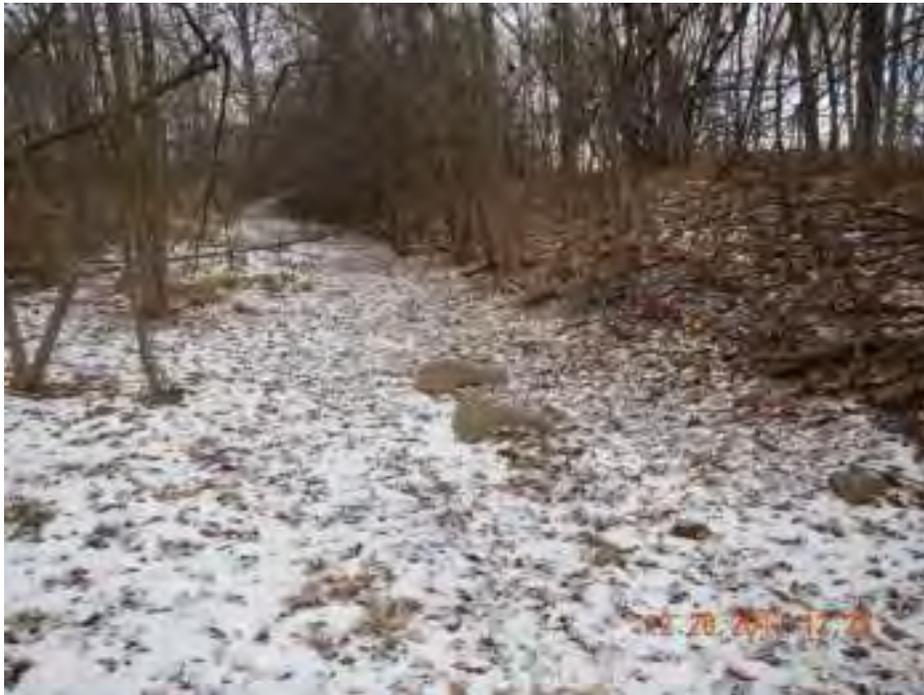
Photo 9 - View of typical conditions at confluence of CRT2 – 5 and CRT2 – 5a.

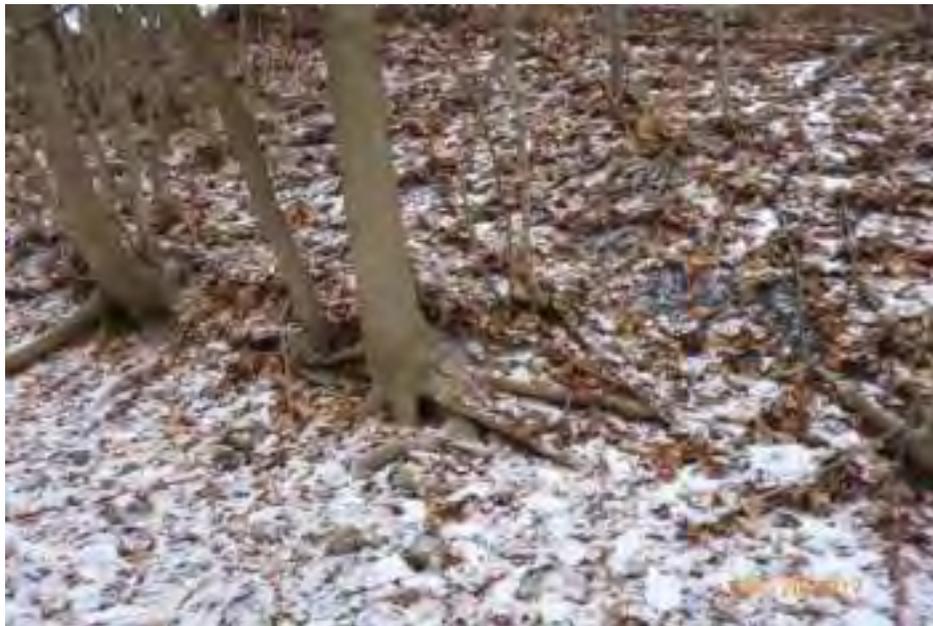
Photo 10 - Exposed tree roots near the confluence of CRT2 – 5 and CRT2 – 5a.

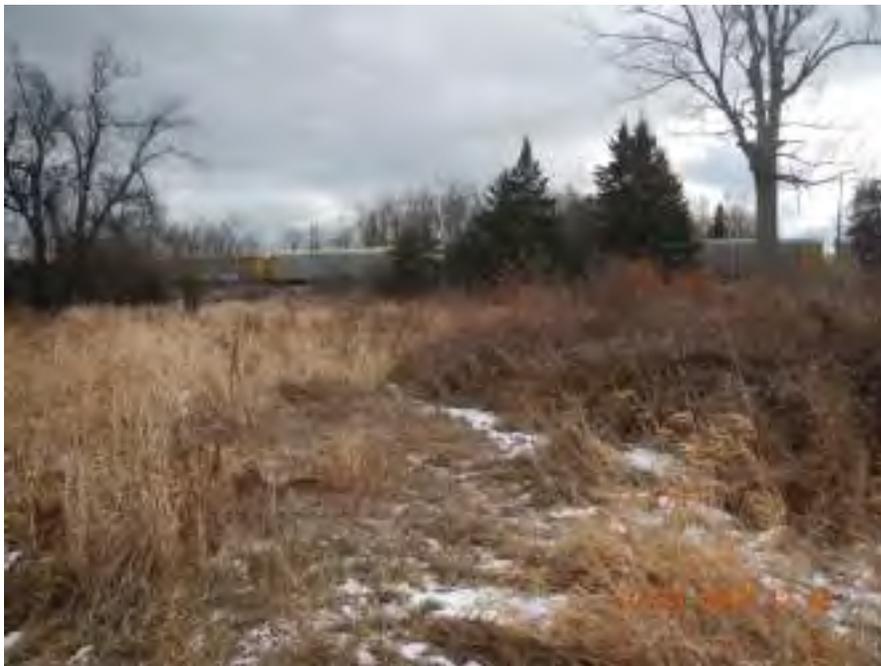
Photo 11 - Facing south towards CN Railway, typical conditions in riparian area.

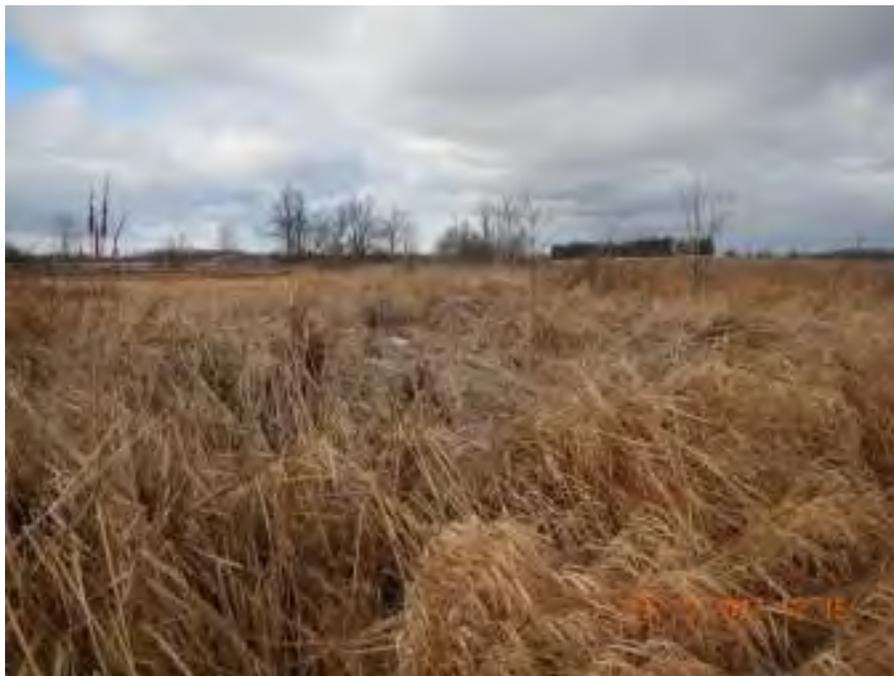
Photo 12 - Extensive vegetation makes watercourse indistinguishable from riparian area near the Heritage Road culvert. Increase in riparian vegetation since 2011 assessment.

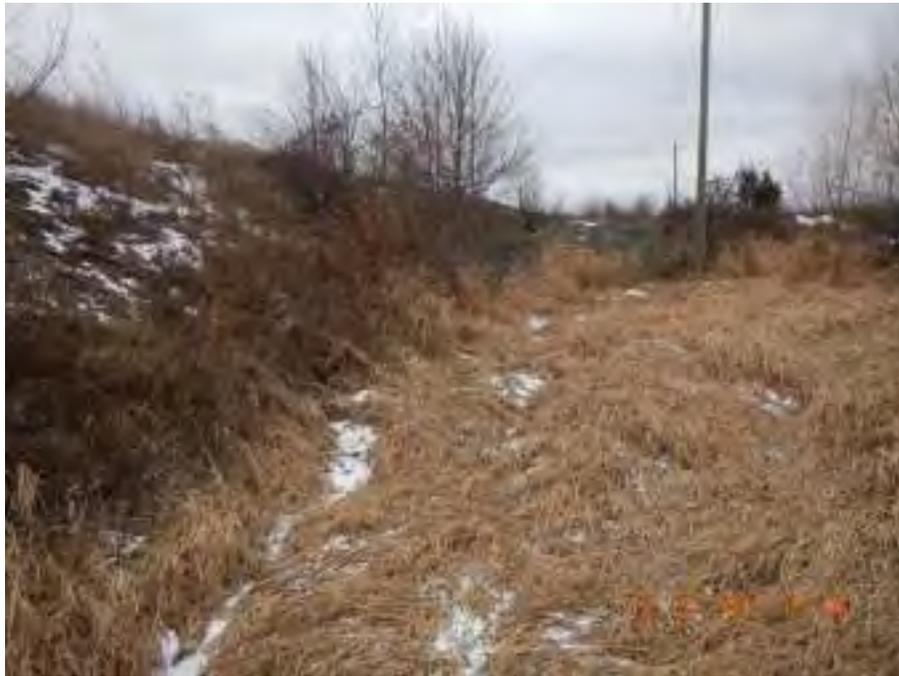
Photo 15 - Typical conditions west of culvert crossing under CN railway.

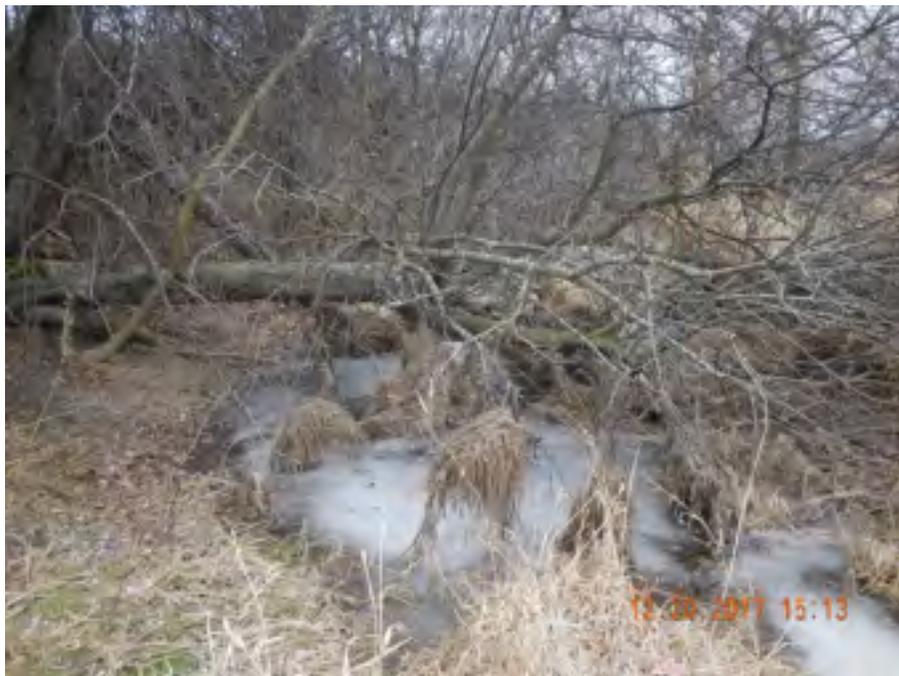
Photo 16 - Facing downstream, south towards CN Railway crossing. Debris stuck to tree branches at height above observed bankfull. Watercourse in contact with base of valley wall.

HV4	Railway embankment shows evidence of degradation, as exposed roots and undercuts were observed just west of the CN Railway culvert following a sharp change in flow direction from southeast to east. Debris comprised of thick grasses and dried silt/clay were observed stuck to tree bases and branches above visible bankfull level. Smaller amounts of debris comprised of just grasses stuck to hanging tree branches around bankfull level were observed in 2011. Watercourse was observed to be in contact with base of valley wall in multiple places within the reach; in the upstream half a defined section of the watercourse is in contact with a steep slope at the edge of an active farm field. It is not clear whether this was also observed in 2011. Submerged trees were observed in some parts of the reach.
