Final Report

Phase One Environmental Site Assessment

Extension of Intermodal Drive to Gorewood Drive, Brampton, Ontario

Prepared for City of Brampton
by Arcadis
September 2025

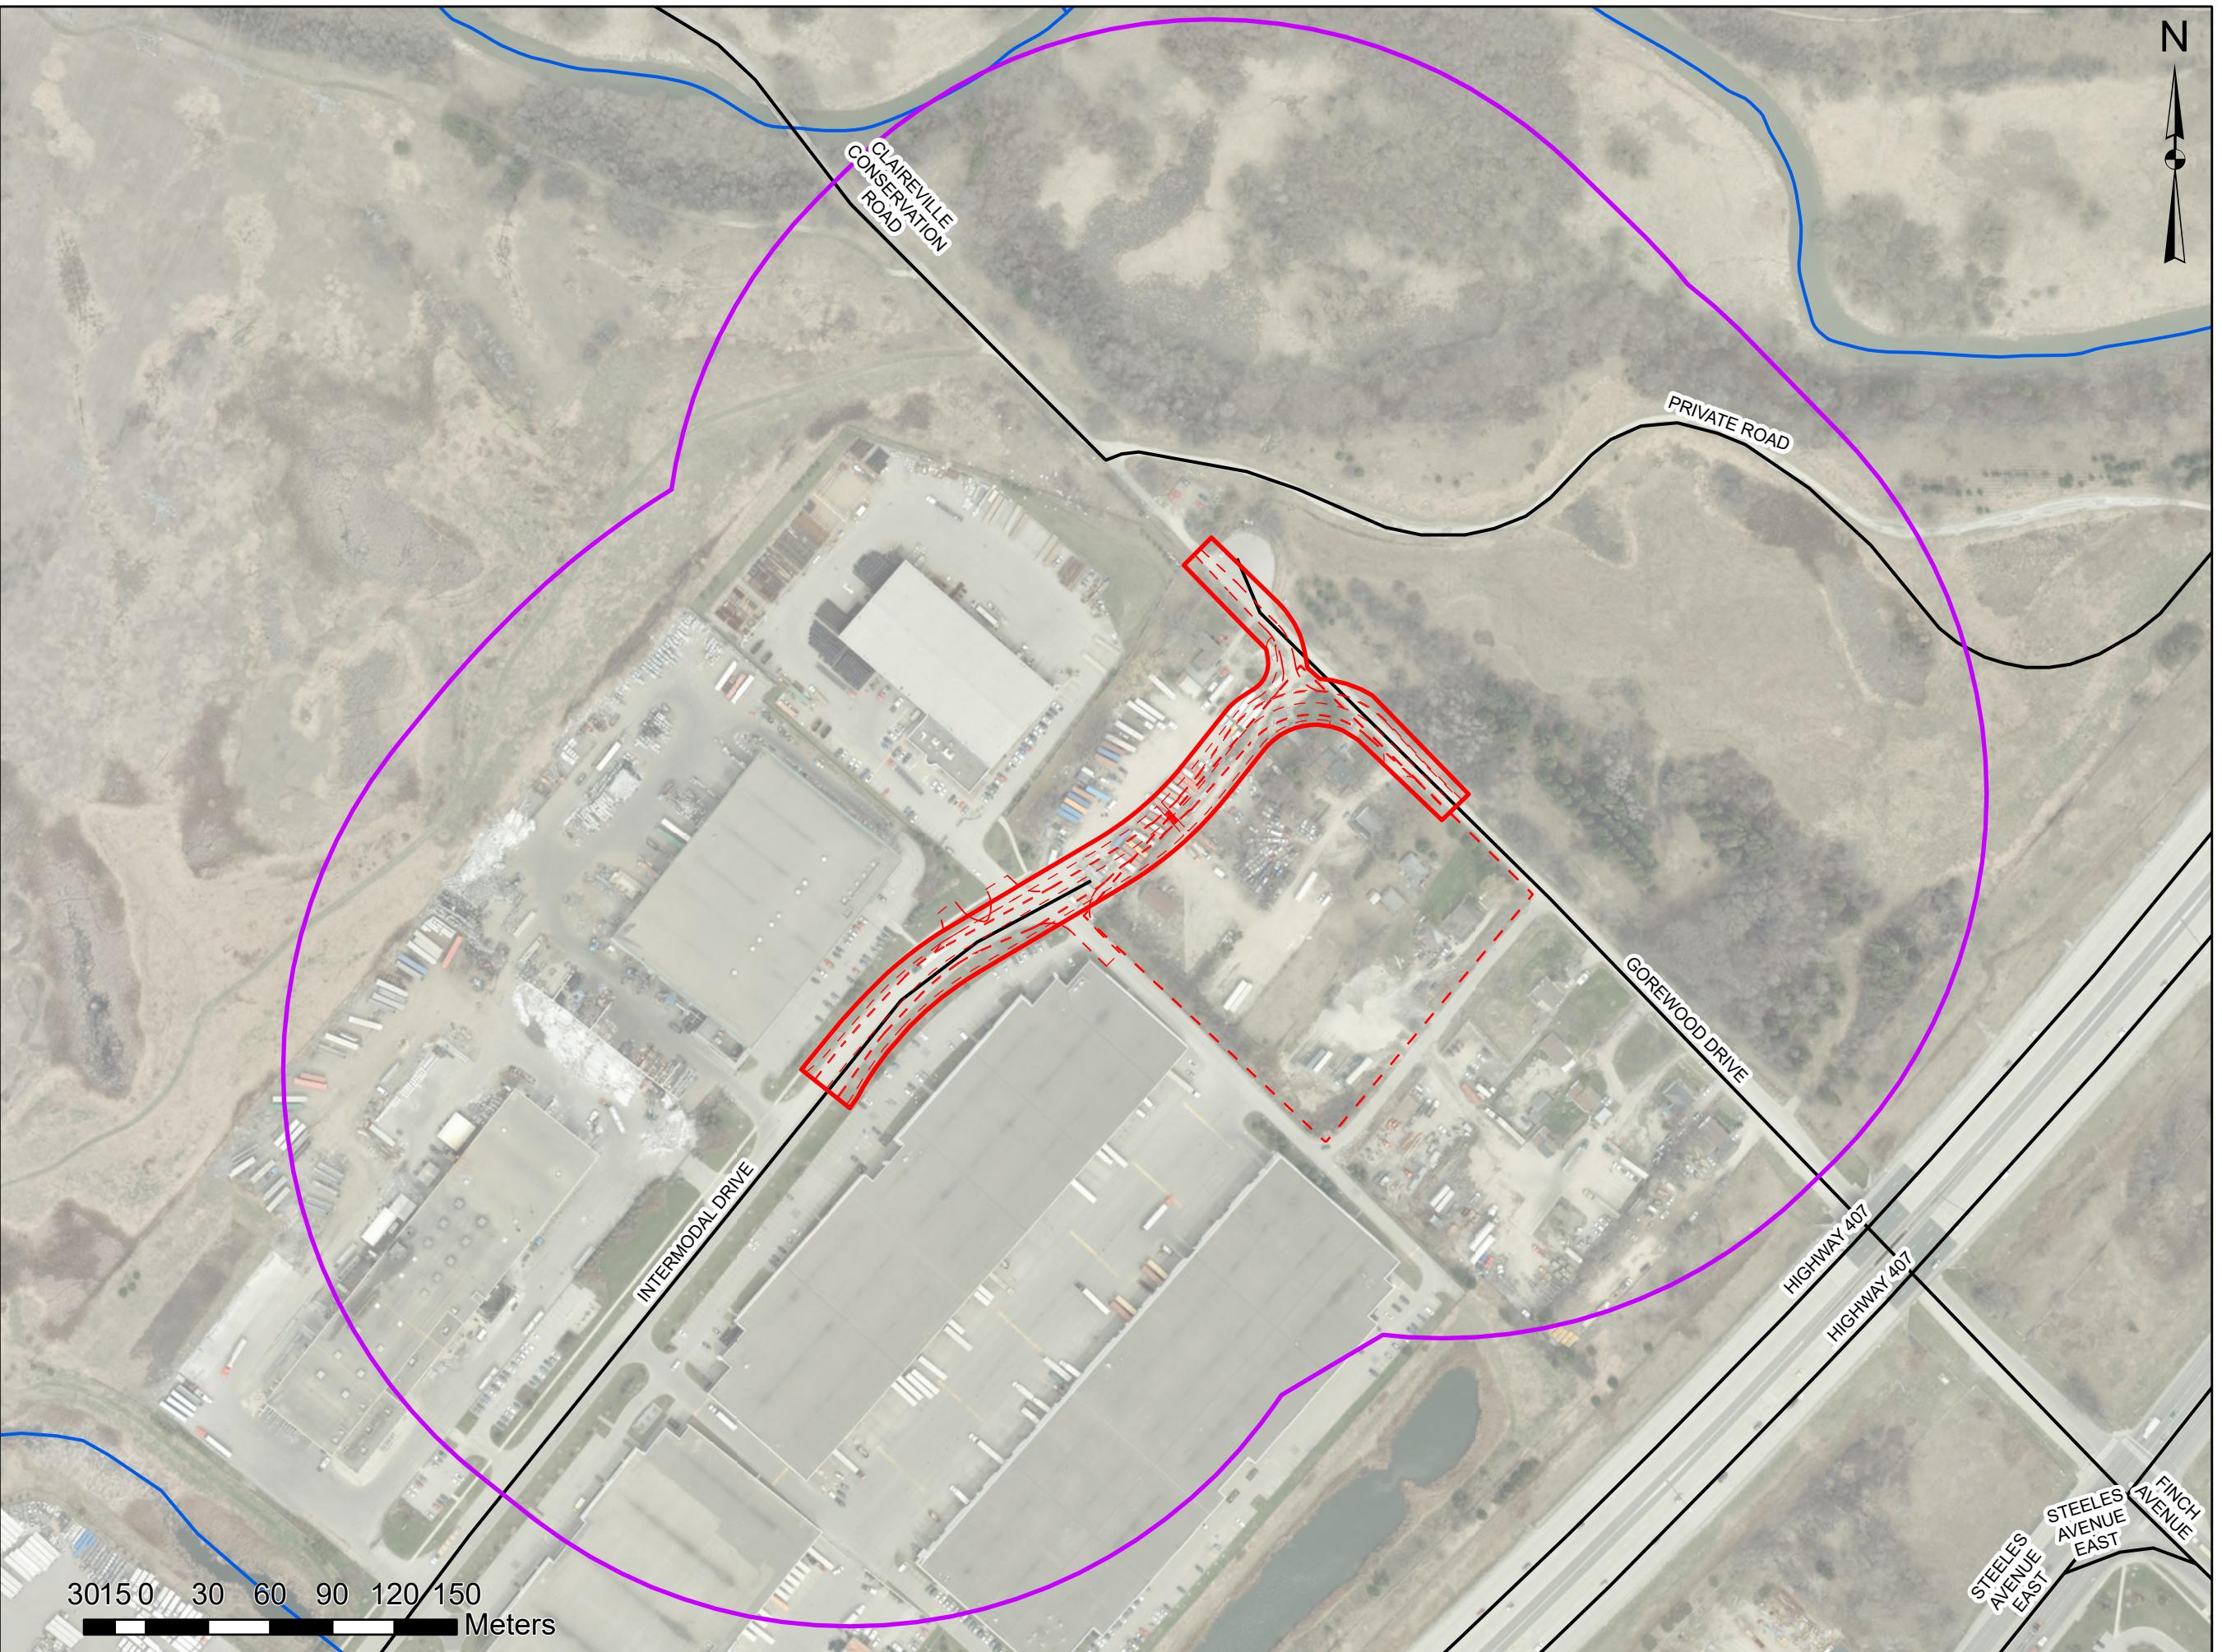
Project No.:	Scale:
145609	1:3,000
Figure No.:	Date:
1	March 2025

Site Location

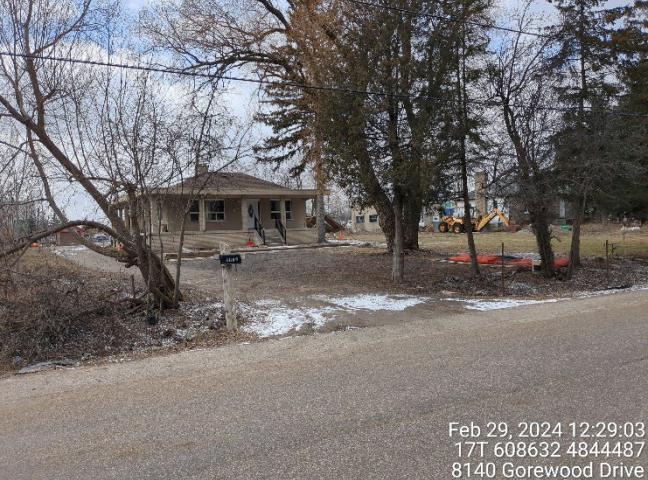
<p>Feb 29, 2024 12:29:03 17T 608632 4844487 8140 Gorewood Drive</p>

<p>Feb 29, 2024 12:38:01 17T 608609 4844498 8140 Gorewood Drive</p>
<p>Photo 1: A view of the residential property located at 8140 Gorewood Drive facing southwest.</p>	<p>Photo 2: A view of an above ground storage tank containing propane located to the west of the residential building at 8140 Gorewood Drive.</p>

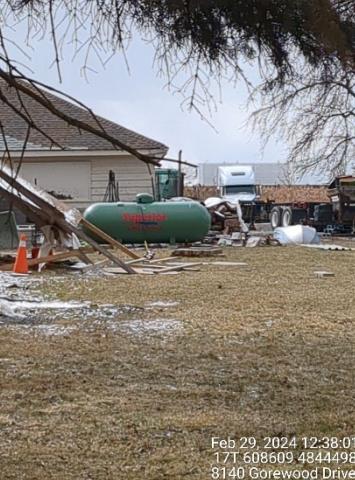
One (1) above ground storage tank containing propane was observed on the property at 8140 Gorewood Drive. No other further storage tanks could be identified.

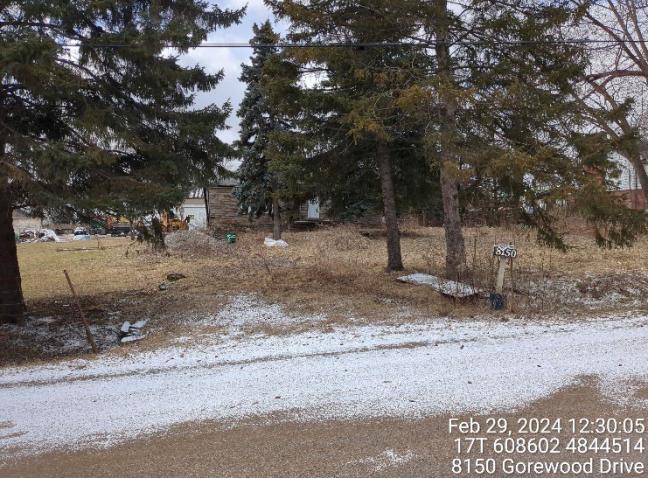
<p>Feb 29, 2024 12:30:05 17T 608602 4844514 8150 Gorewood Drive</p>

<p>Feb 29, 2024 12:30:13 17T 608597 4844513 8150 Gorewood Drive</p>
<p>Photo 3: A view of the residential property located at 8150 Gorewood Drive facing southwest.</p>	<p>Photo 4: A view of a mini bucket excavator and a small pile of unknown material observed.</p>

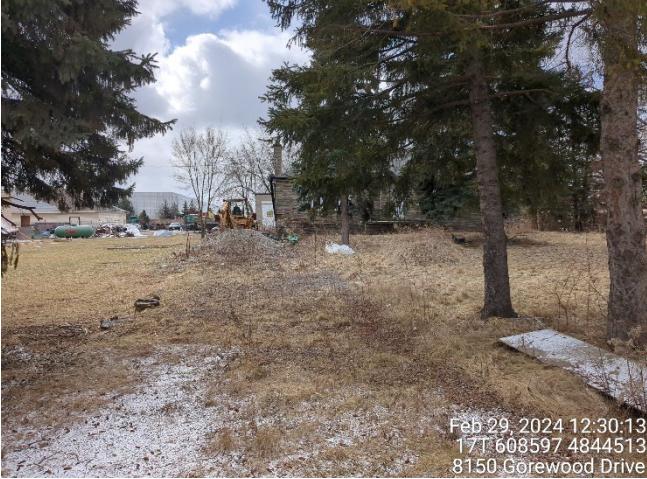
Potential activity related to fill material was observed on the property at 8150 Gorewood Drive. A mini bucket excavator and a small pile of unknown material was observed along the northern edge of the property.

As mentioned in **Section 3.3.3**, potential activity related to fill material was observed on the property at 8150 Gorewood Drive. A mini bucket excavator and a small pile of unknown material was observed along the northern edge of the property.

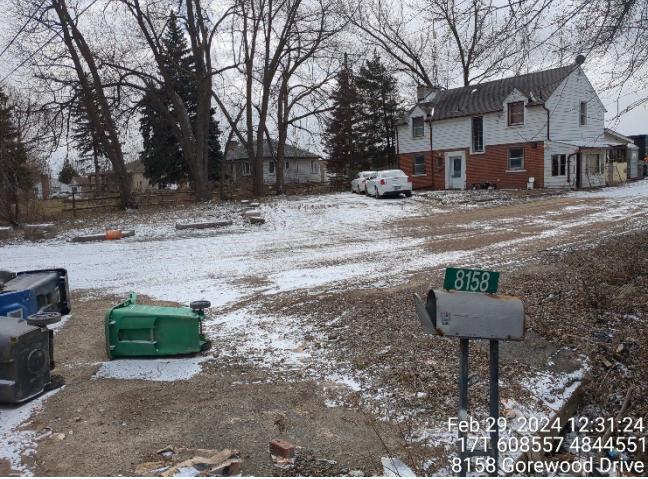
<p>Feb 29, 2024 12:31:24 17T 608557 4844551 8158 Gorewood Drive</p>

<p>Feb 29, 2024 12:31:47 17T 608557 4844551 8168 Gorewood Drive</p>
<p>Photo 5: A view of the residential property located at 8158 Gorewood Drive facing southwest.</p>	<p>Photo 6: A view of the residential property located at 8168 Gorewood Drive facing southwest.</p>

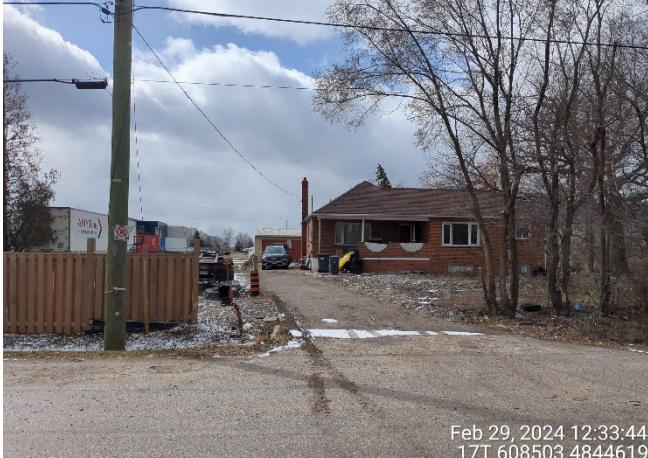
<p>Feb 29, 2024 12:33:44 17T 608503 4844619 8196 Gorewood Drive</p>

<p>Feb 29, 2024 13:03:45 17T 608652 4844461 Gorewood Drive</p>
<p>Photo 9: A view of the residential property located at 8196 Gorewood Drive facing southwest.</p>	<p>Photo 10: A view of Gorewood Drive facing northwest, abutting the north side of the properties. A forest is observed to the right.</p>

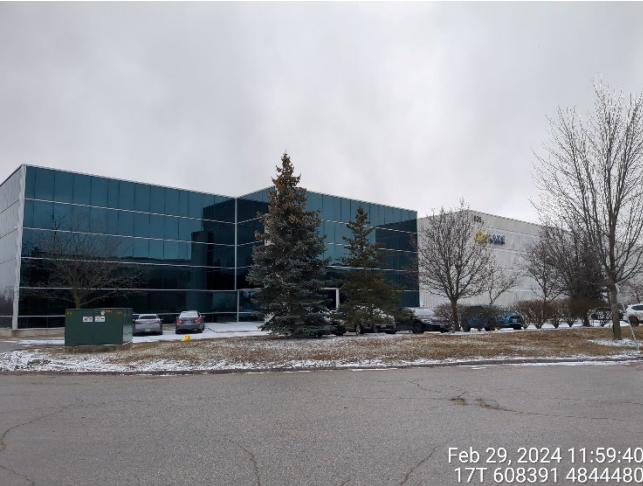
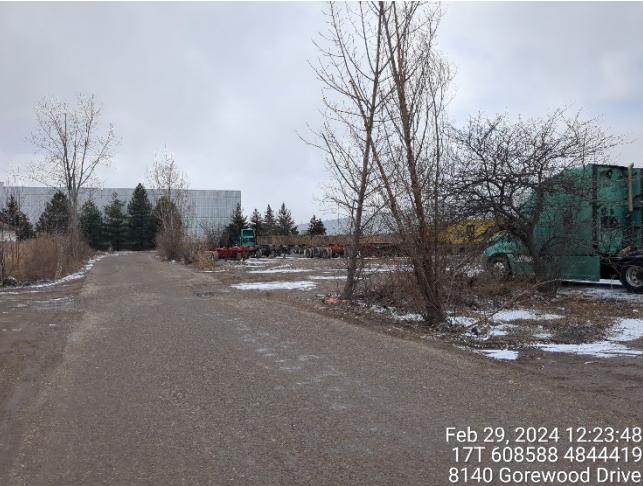
Feb 29, 2024 12:23:48 17T 608588 4844419 8140 Gorewood Drive
Photo 13: North adjacent property occupied by Nucor Rebar Fabrication on 980 Intermodal Drive.	Photo 14: A view of an unnamed road from Intermodal Drive to Gorewood Drive southeast of 8140 Gorewood Drive.

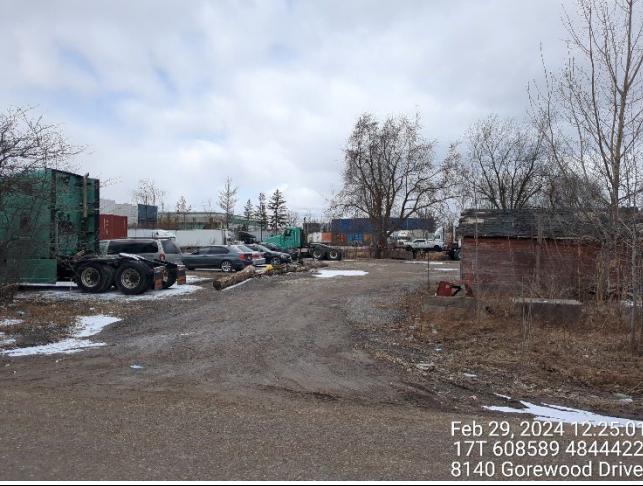
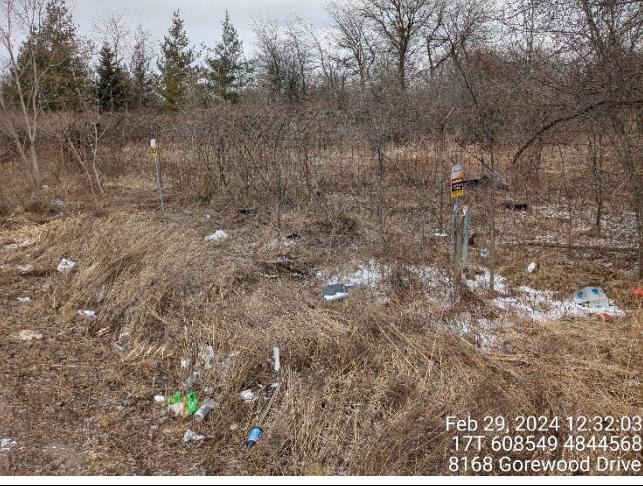
Feb 29, 2024 12:32:03 17T 608549 4844568 8168 Gorewood Drive
Photo 15: Another view facing northwest of the property of 8140 Gorewood Drive that is largely utilized as parking for vehicles.	Photo 16: Signage of Enbridge's natural gas lines marked out north of Gorewood Drive. The signs were observed from 8196 Gorewood Drive to 8140 Gorewood Drive.

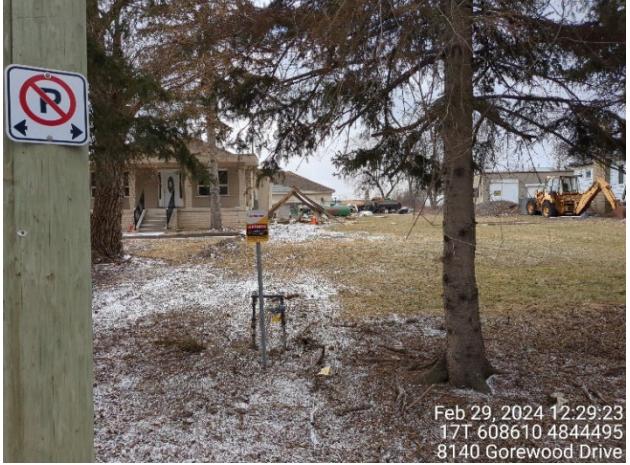
Feb 29, 2024 12:29:23 17T 608610 4844495 8140 Gorewood Drive	
Photo 17: A view of an Enbridge natural gas line marked on northeast side of the property at 8140 Gorewood Drive facing southwest. These were observed across the properties between 8140 and 8180 Gorewood Drive.
