Mount Pleasant GO Station

**Fluvial Geomorphological and
Meander Beltwidth
Assessment**

**October 2, 2017
(Revised November 28, 2019)**

**RE: East – West Connector Class EA (Mount Pleasant GO Station to West of Mississauga Road)
Fluvial Geomorphological Assessment
City of Brampton, Ontario**

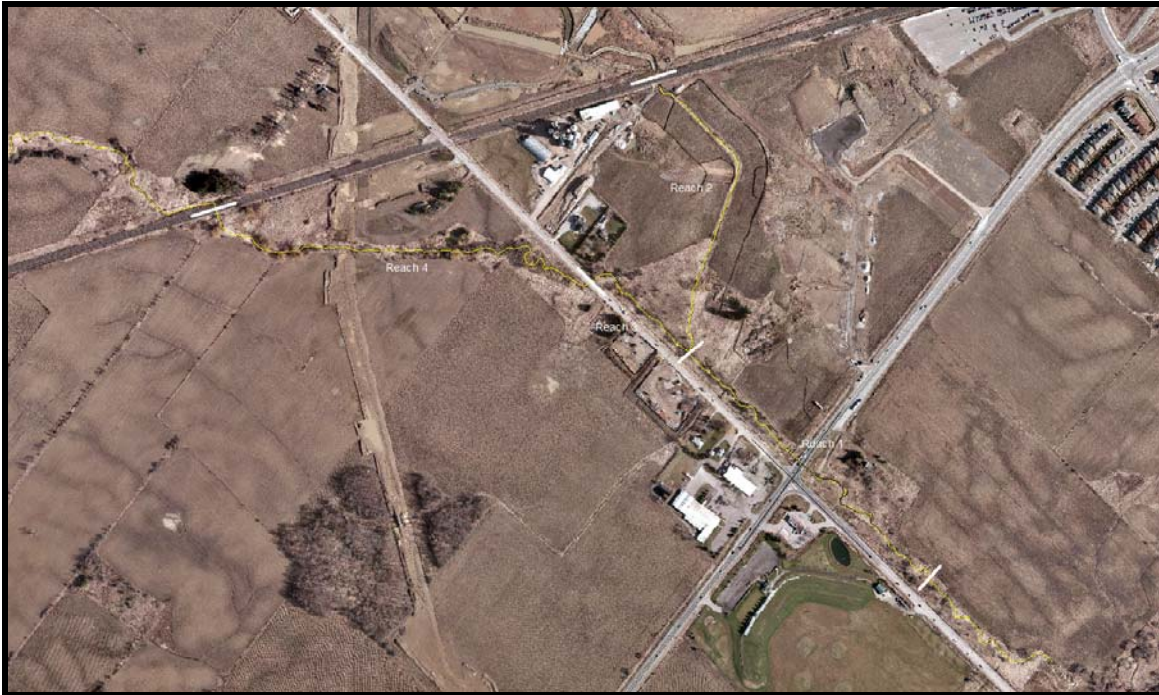
Figure 2: Location of Site with Reach Breaks (2013 Air Photo)

Figure 2 presents an aerial photograph of the site using a 2013 air photo. In addition to confirming our desktop assessment, field reconnaissance and a topographical survey included the determination of various geomorphic parameters. Details regarding these parameters can be seen in Table 1 which is separated into reaches. Multiple cross sections were surveyed at the site along with a longitudinal profile of the extending creek to gain reference data. The data was analyzed and the specific channel characteristics were determined. The site was also split into 4 separate reaches based on channel characteristics, vegetation and/or road separation. Reach delineation can be seen in Figure 2. Table 1 outlines the general characteristics of each of the four reaches.

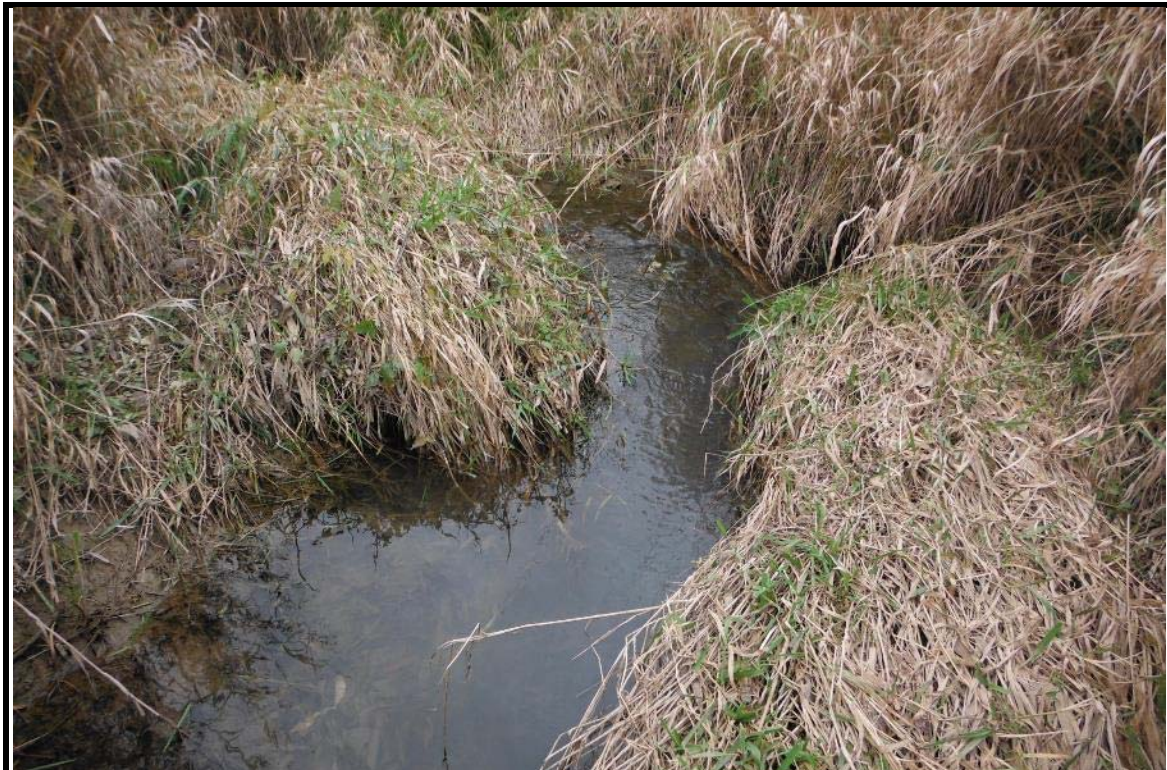
CREEK NAME: Huttonville Creek - Reach 1 (D/S of Bovaird)
FROM: Left Bank
LOOKING: Upstream
COMMENT: Typical Channel Conditions

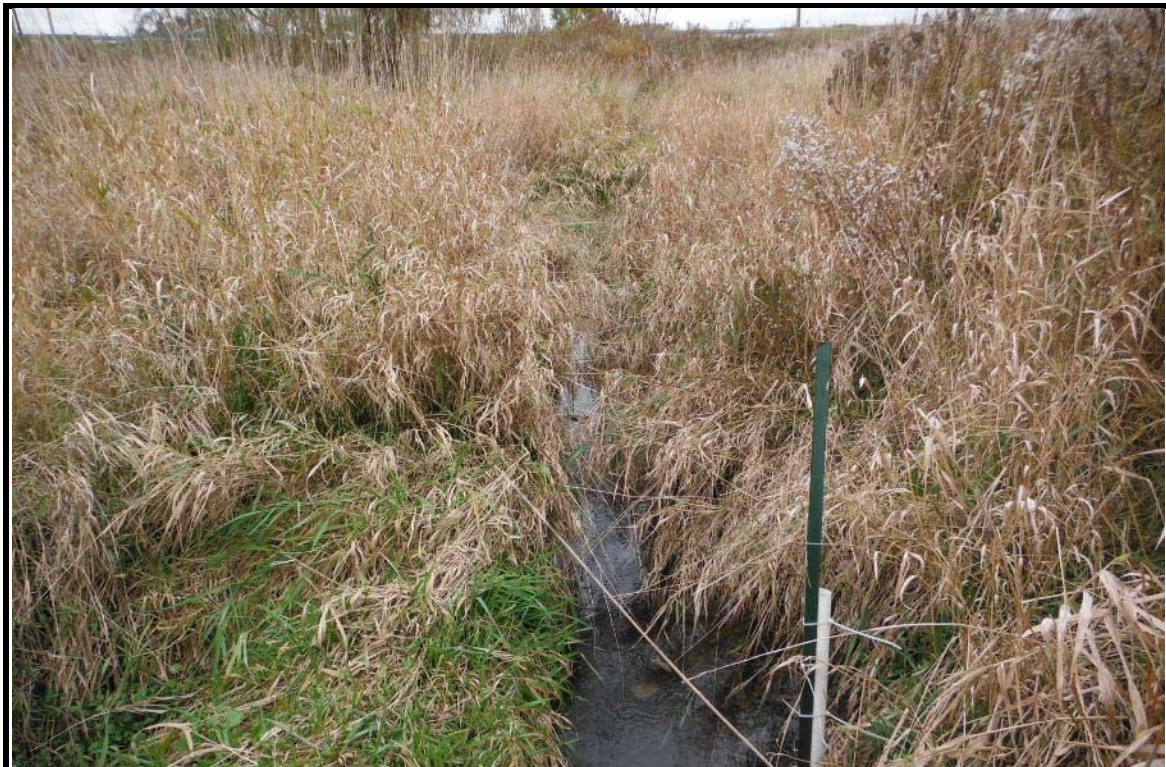
CREEK NAME: Huttonville Creek - Reach 1 (D/S of Bovaird)
FROM: Right Bank
LOOKING: Upstream
COMMENT: Typical Channel Conditions

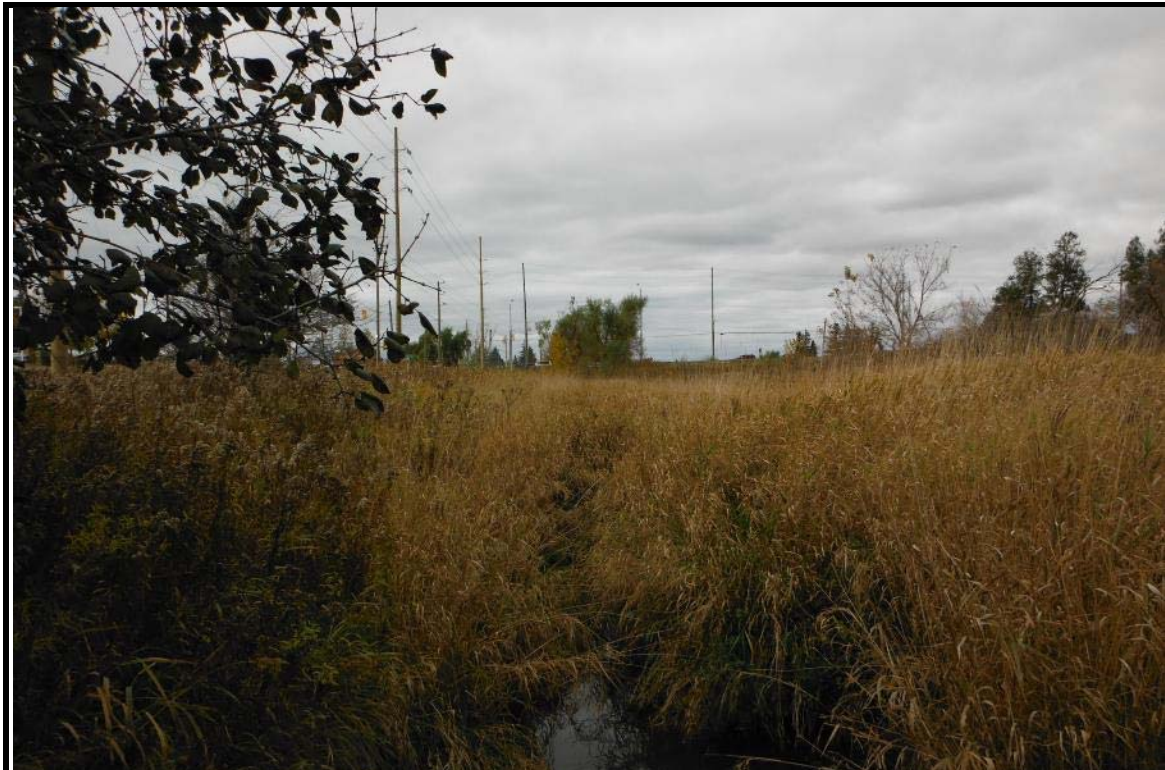
CREEK NAME: Huttonville Creek - Reach 1 (D/S of Bovaird)
FROM: Centre of Channel
LOOKING: Upstream
COMMENT: Typical Channel Conditions

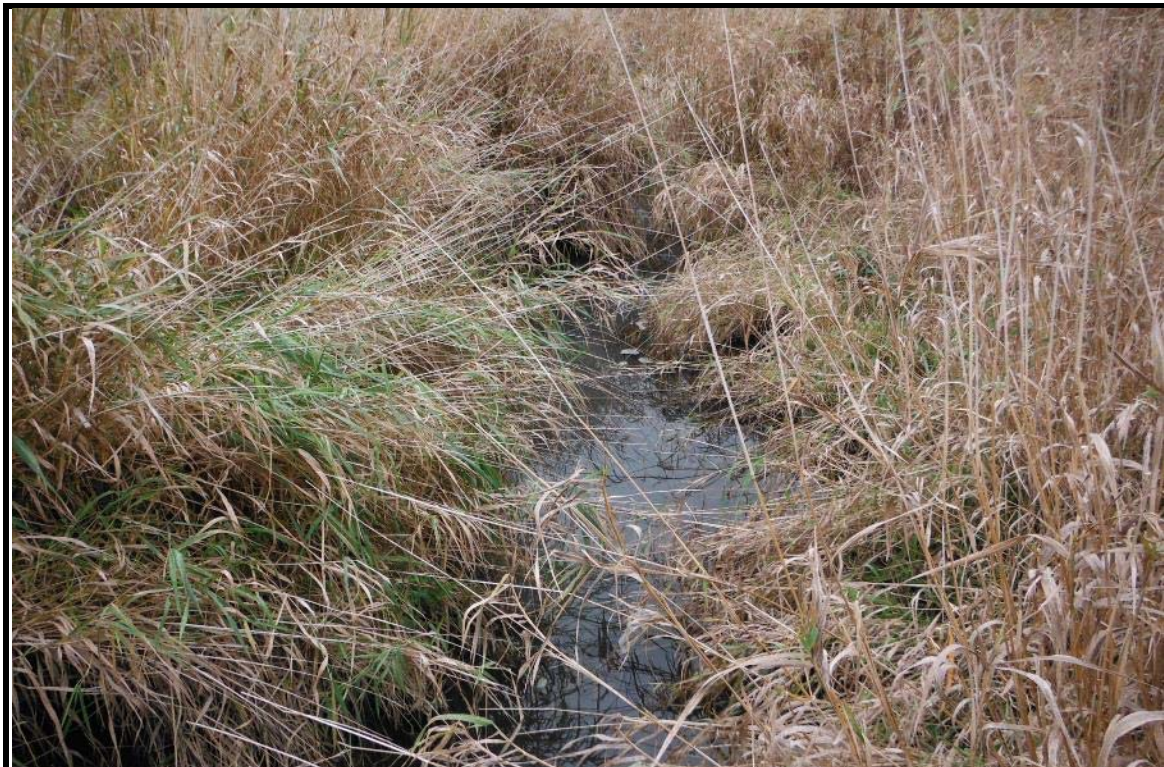
CREEK NAME: Huttonville Creek - Reach 1 (D/S of Bovaird)
FROM: Centre of Channel
LOOKING: Upstream
COMMENT: Typical Channel Conditions

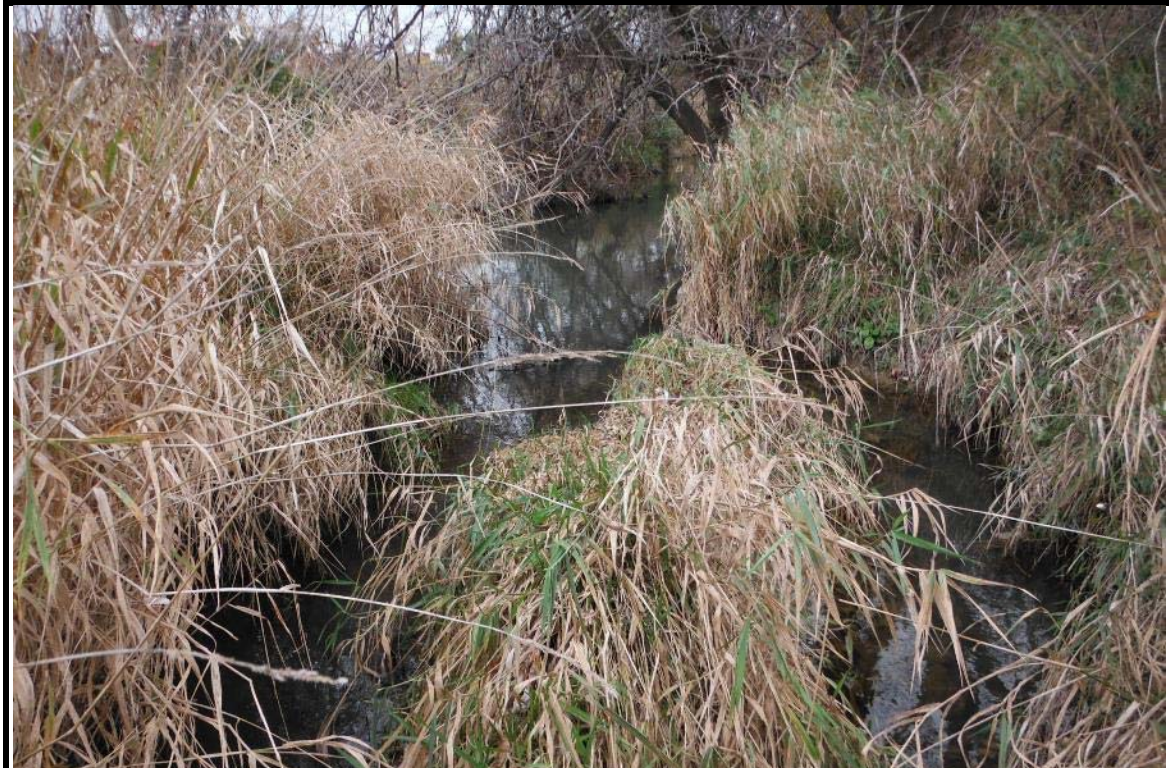
CREEK NAME: Huttonville Creek - Reach 1 (D/S of Bovaird)
FROM: Centre of Channel
LOOKING: Upstream
COMMENT: Typical Channel Conditions

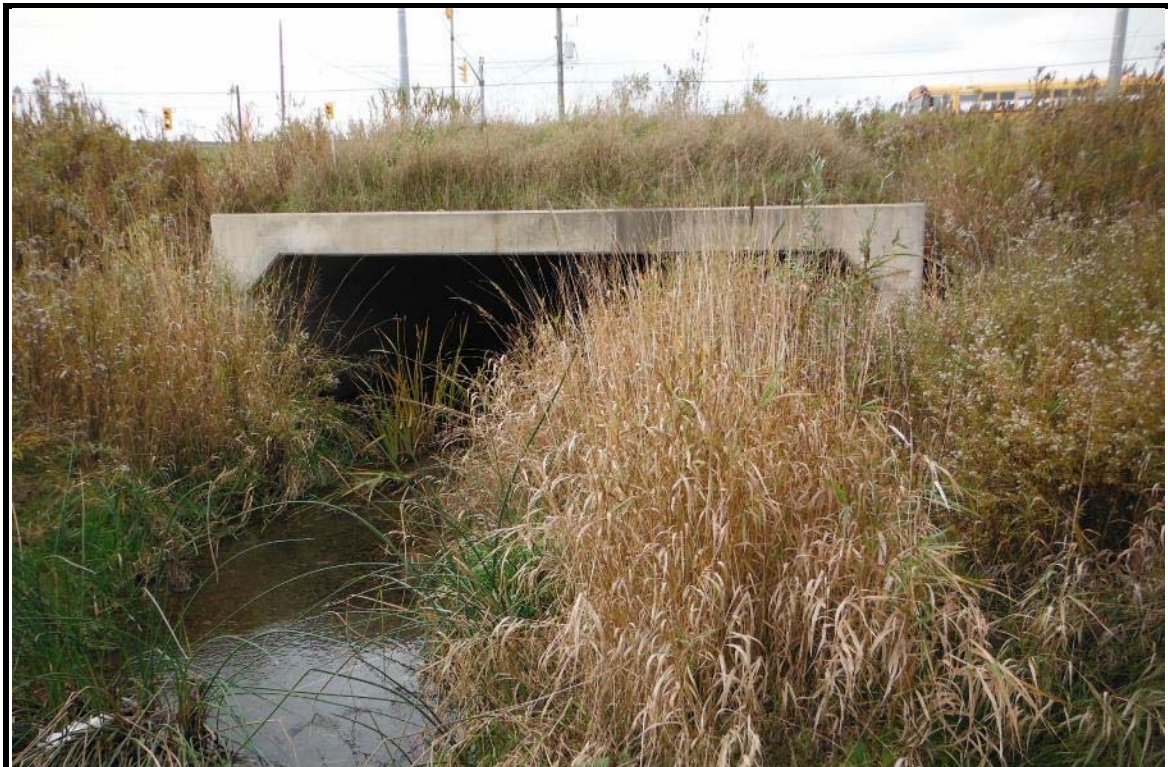
CREEK NAME: Huttonville Creek - Reach 1 (D/S of Bovaird)
FROM: Left Bank
LOOKING: Upstream
COMMENT: Typical Channel Conditions

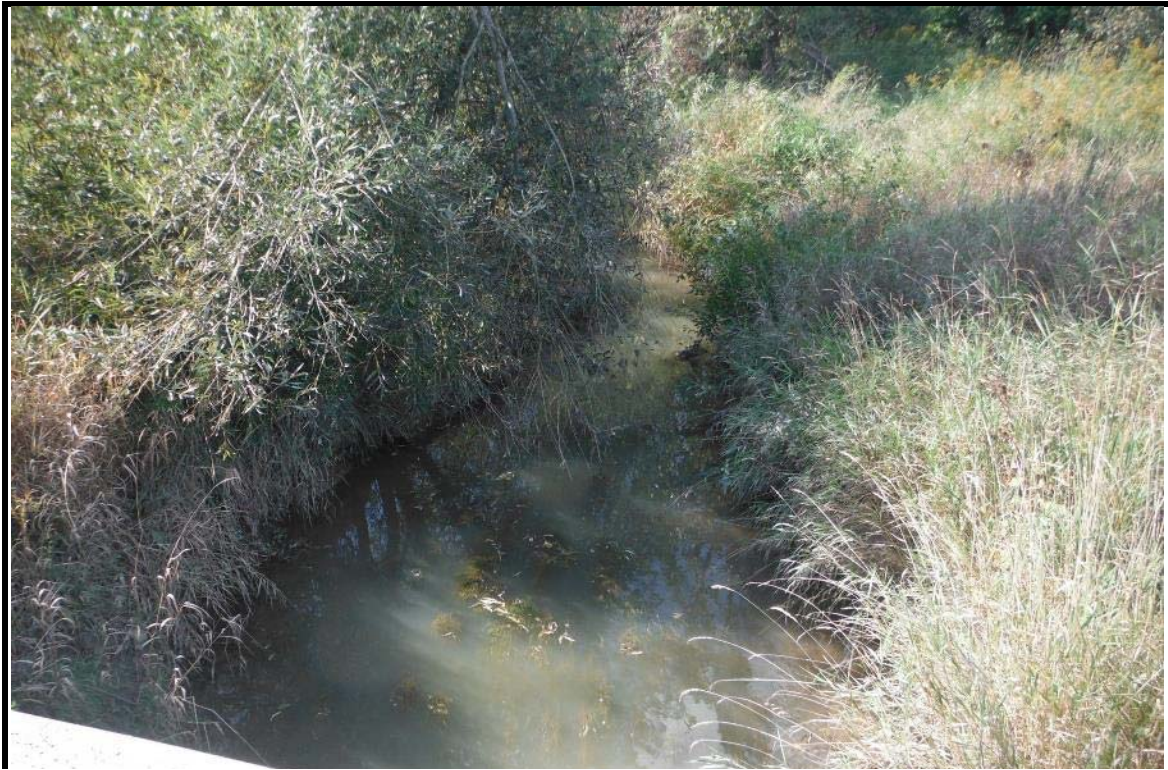
CREEK NAME: Huttonville Creek - Reach 1 (U/S of Bovaird)
FROM: Bovaird Dr. Culvert
LOOKING: Upstream
COMMENT: Typical Channel Conditions

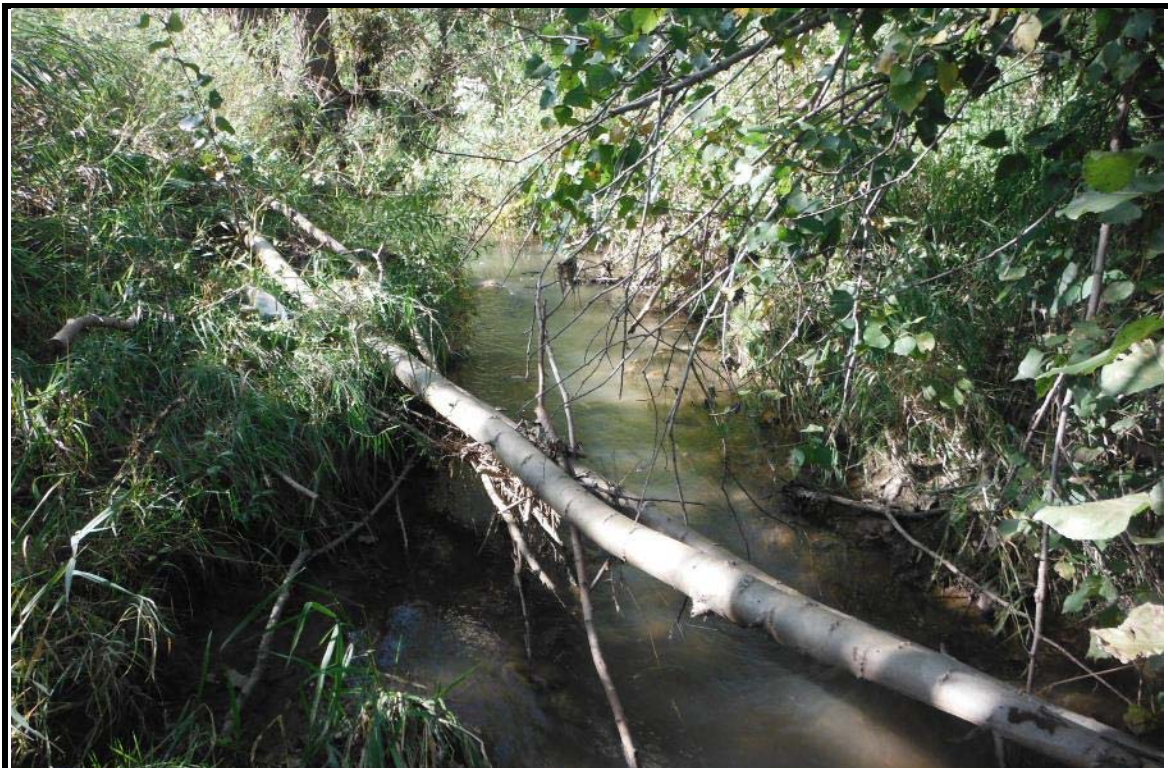
CREEK NAME: Huttonville Creek - Reach 1 (U/S of Bovaird)
FROM: Centre of Channel
LOOKING: Upstream
COMMENT: Typical Channel Conditions

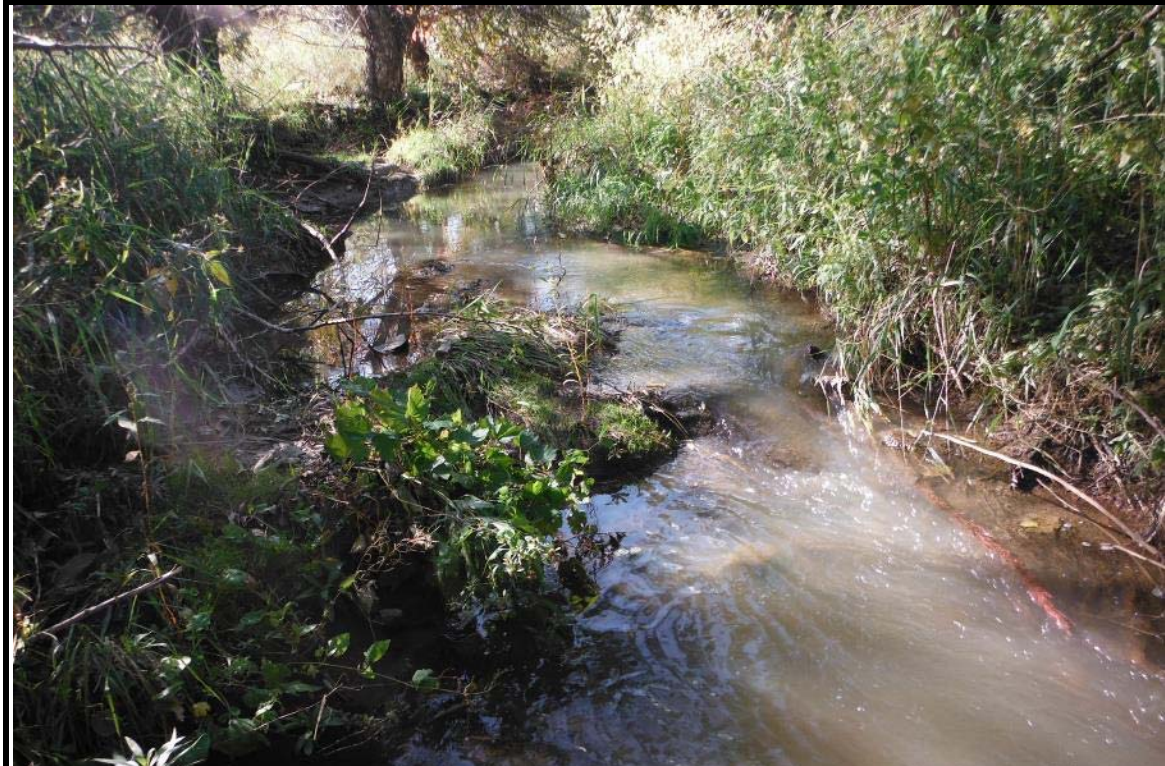
CREEK NAME: Huttonville Creek - Reach 1 (U/S of Bovaird)
FROM: Centre of Channel
LOOKING: Upstream
COMMENT: Typical Channel Conditions

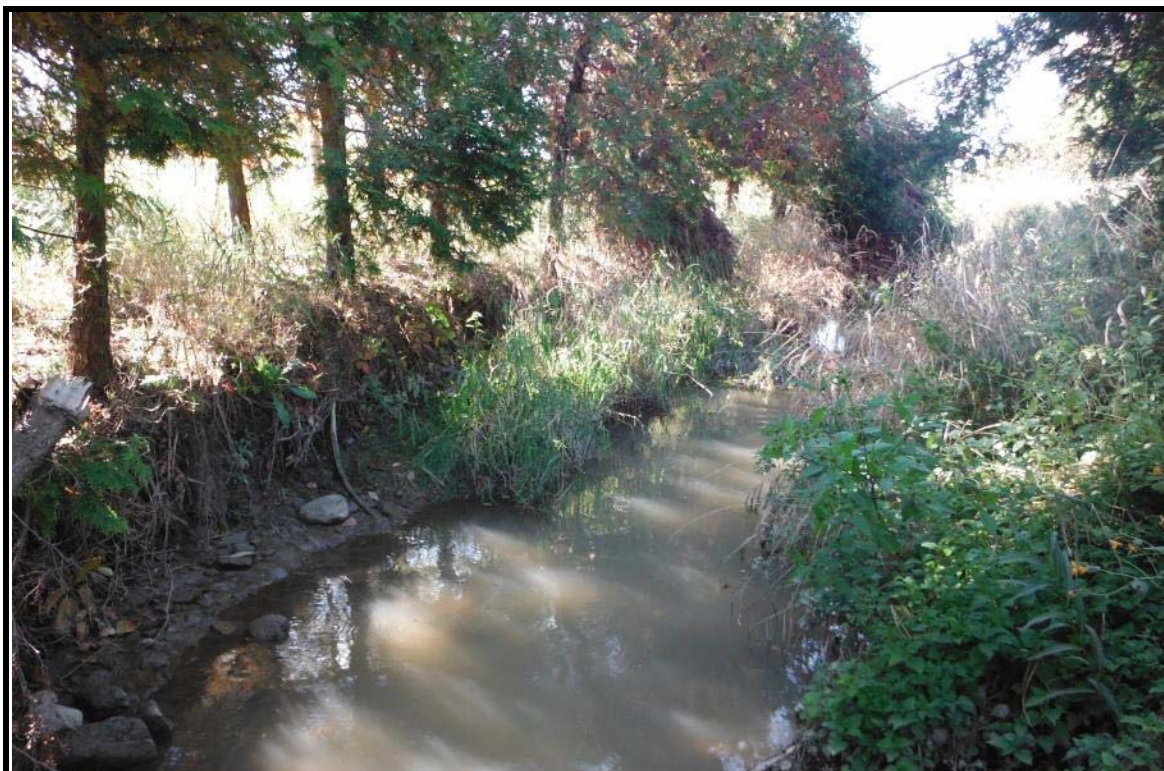
CREEK NAME: Huttonville Creek - Reach 1 (U/S of Bovaird)
FROM: Centre of Channel
LOOKING: Upstream
COMMENT: Eroding Bank

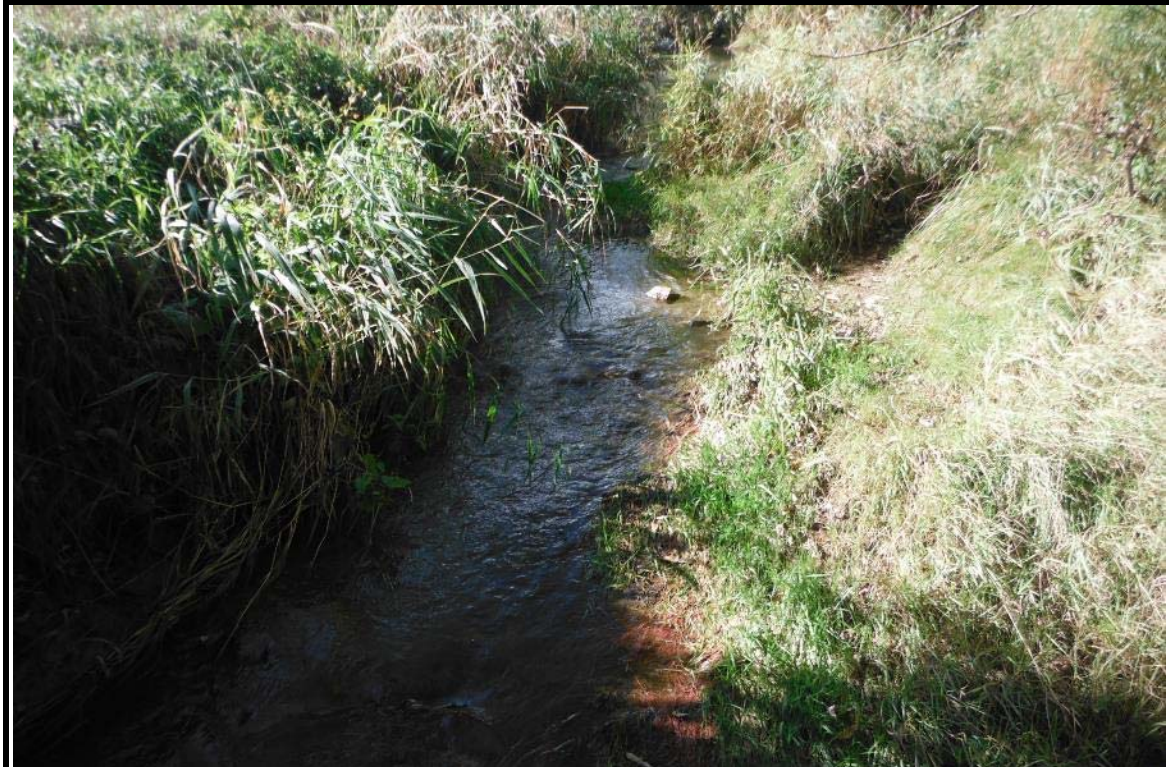
CREEK NAME: Huttonville Creek - Reach 1 (U/S of Bovaird)
FROM: Centre of Channel
LOOKING: Upstream
COMMENT: Typical Channel Conditions

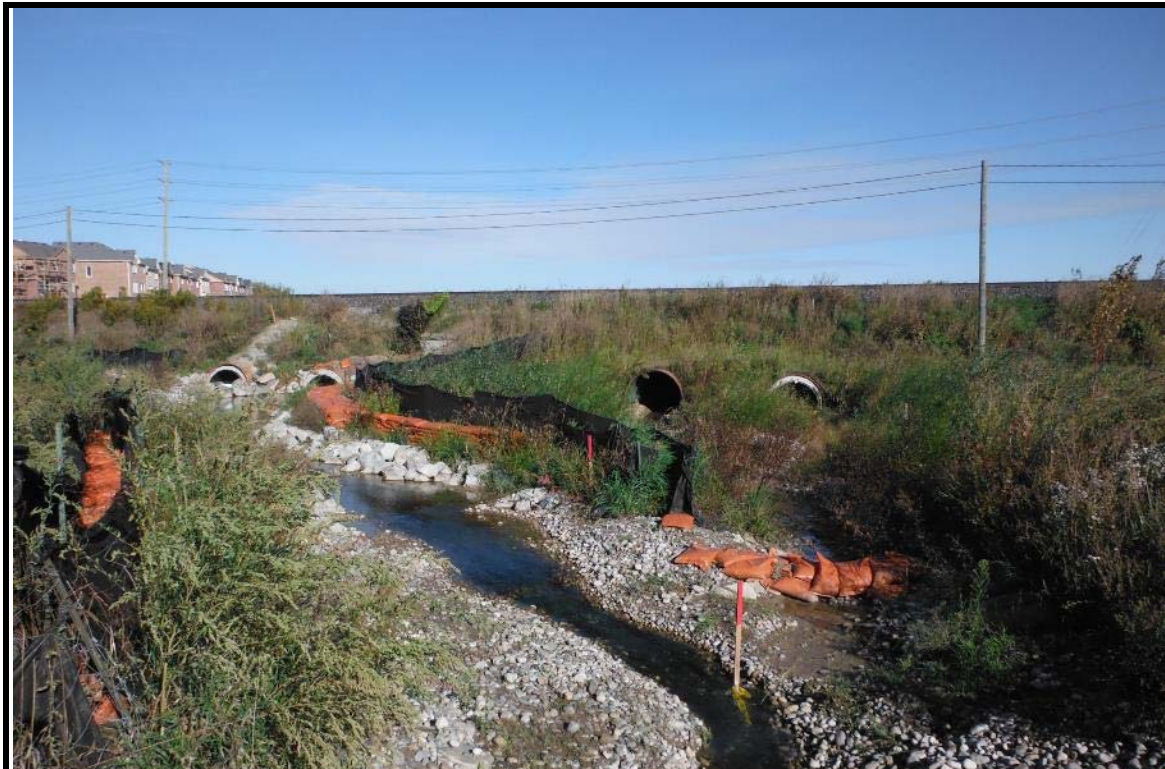
CREEK NAME: Huttonville Creek - Reach 2
FROM: Centre of Channel
LOOKING: Upstream
COMMENT: New channel alterations near rail line

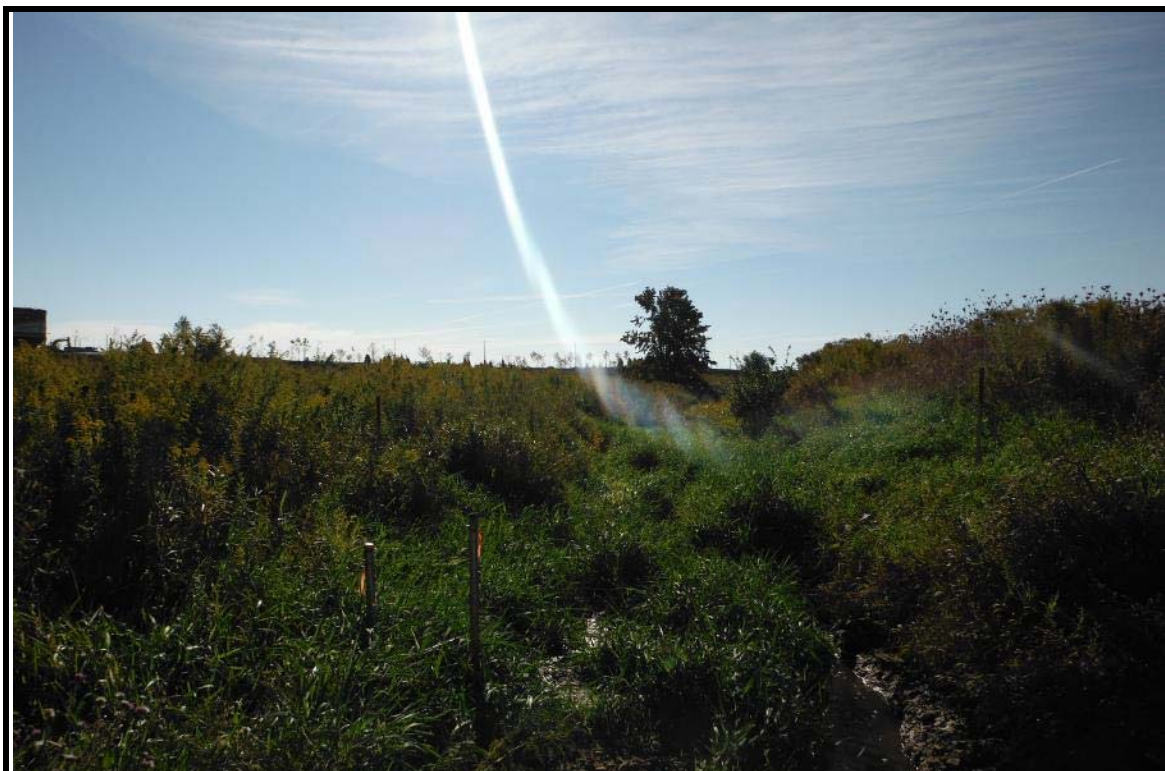
CREEK NAME: Huttonville Creek - Reach 2
FROM: Centre of Channel
LOOKING: Downstream
COMMENT: Typical Channel Conditions

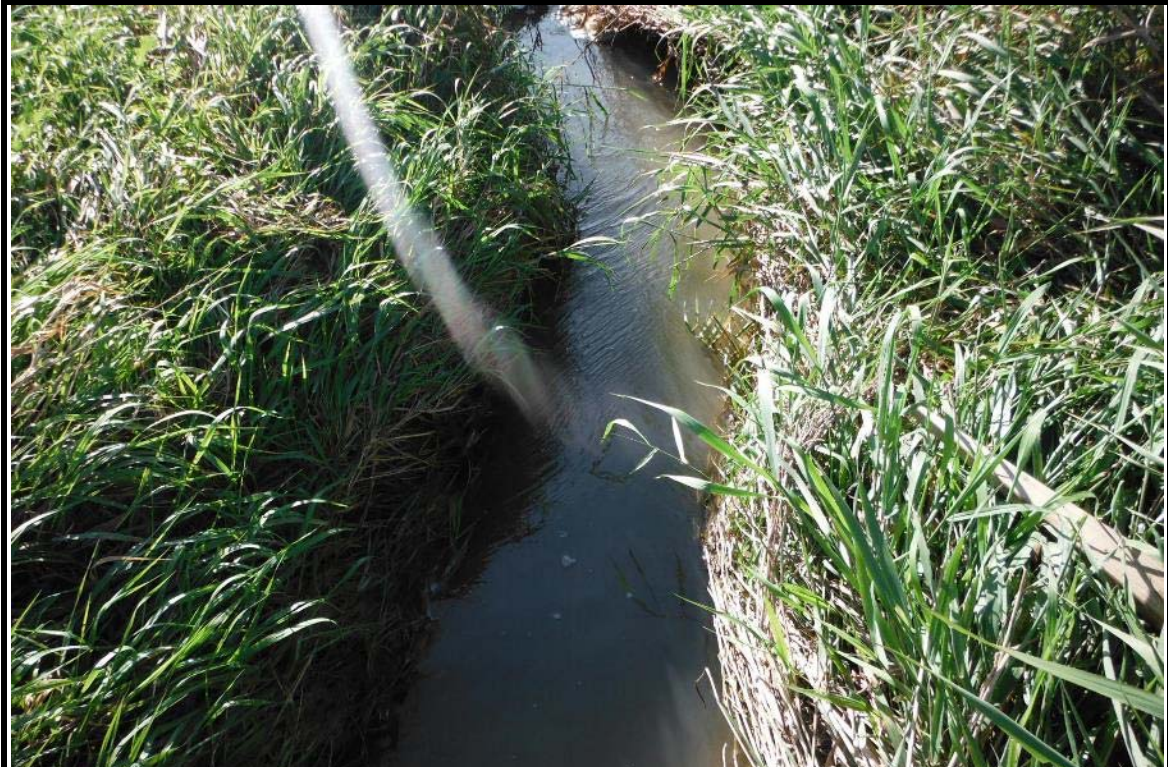
CREEK NAME: Huttonville Creek - Reach 2
FROM: Centre of Channel
LOOKING: Downstream
COMMENT: Typical Channel Conditions

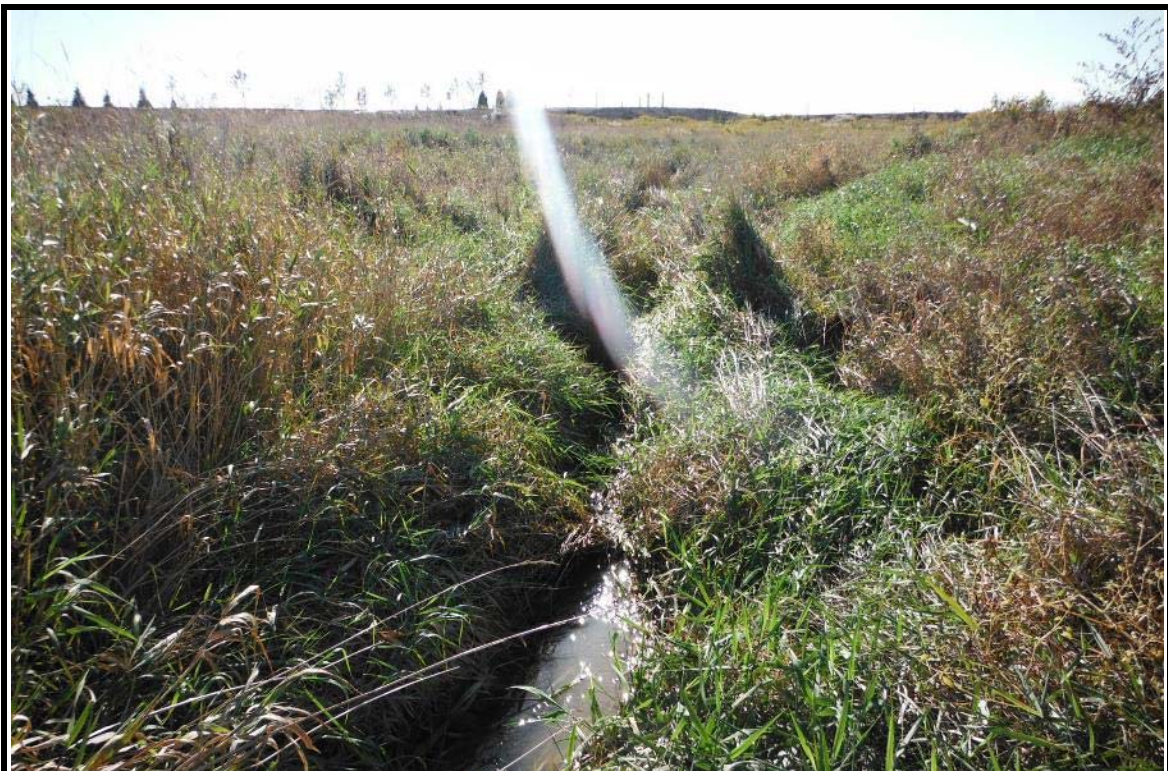
CREEK NAME: Huttonville Creek - Reach 2
FROM: Centre of Channel
LOOKING: Downstream
COMMENT: Typical Channel Conditions

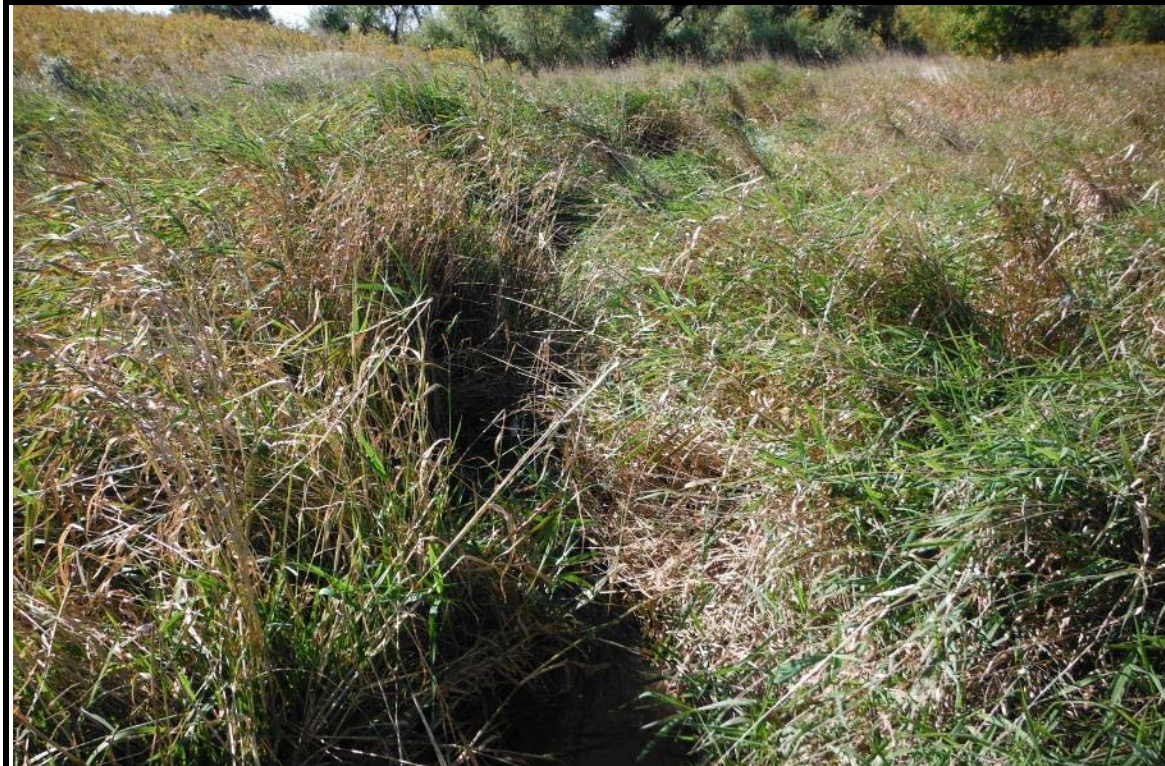
CREEK NAME: Huttonville Creek - Reach 2
FROM: Centre of Channel
LOOKING: Downstream
COMMENT: Typical Channel Conditions

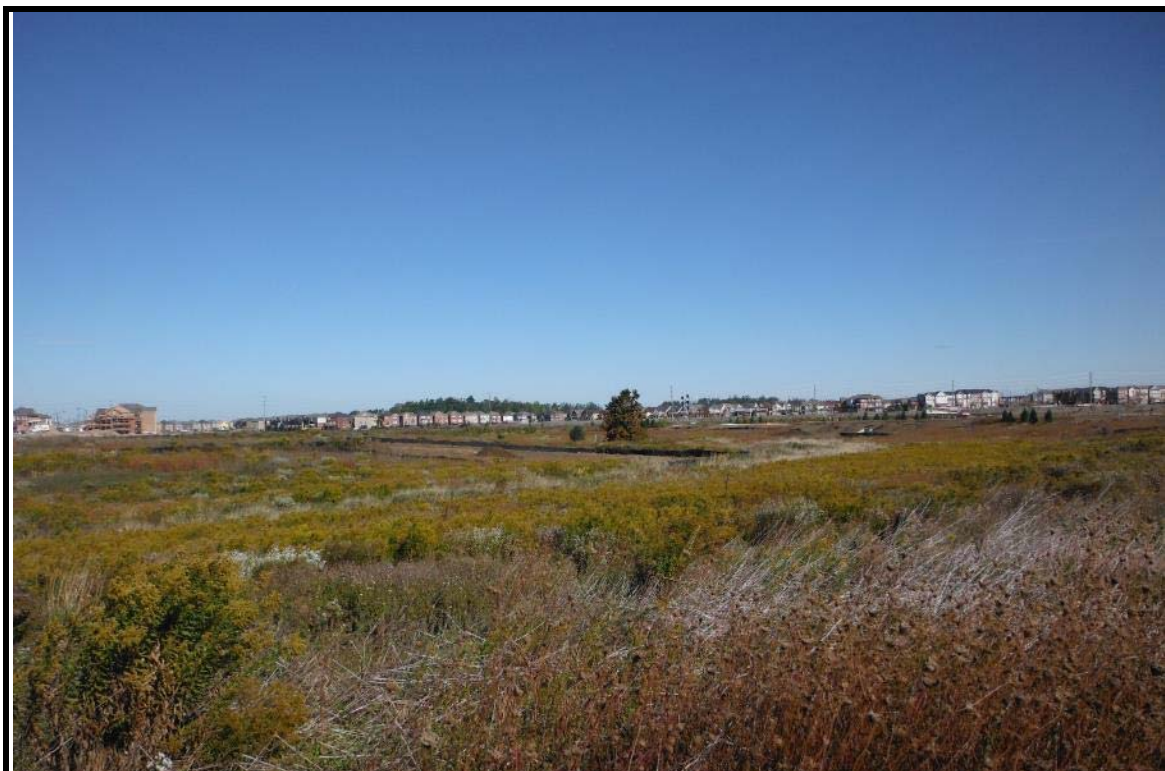
CREEK NAME: Huttonville Creek - Reach 2
FROM: Left Bank
LOOKING: Upstream
COMMENT: Valley Conditions

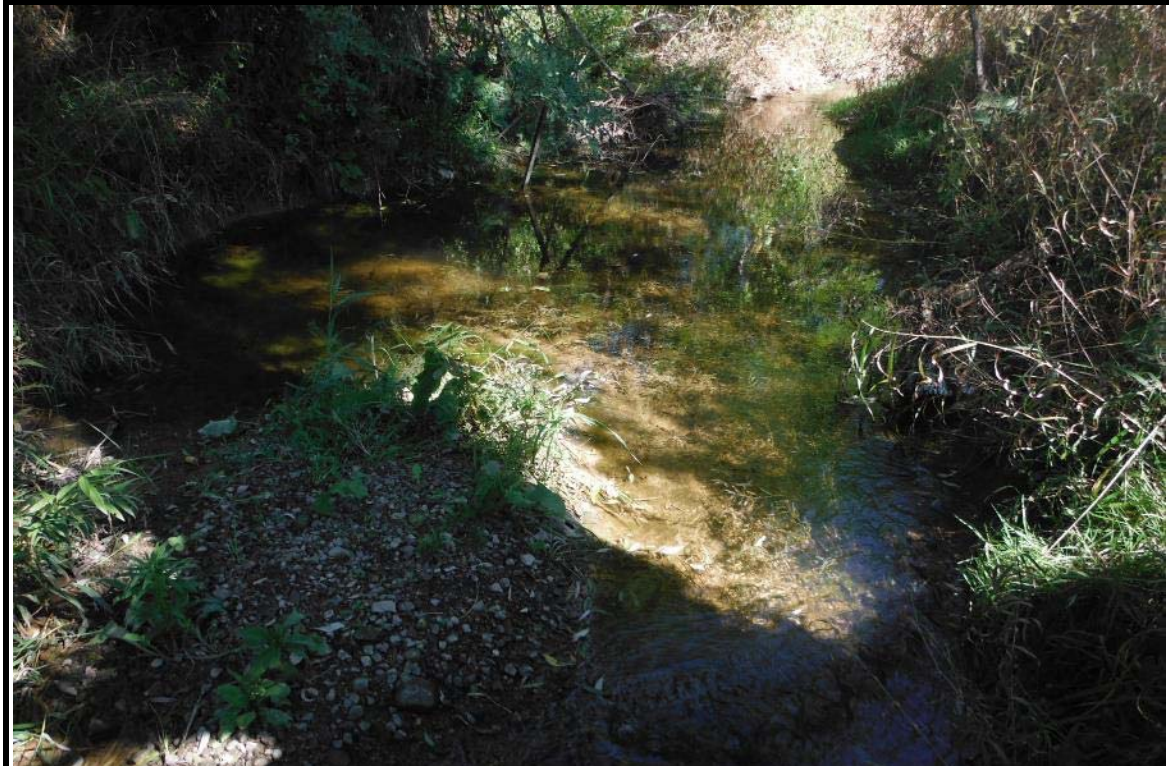
CREEK NAME: Huttonville Creek - Reach 3
FROM: Centre of Channel
LOOKING: Downstream
COMMENT: Typical Channel Conditions

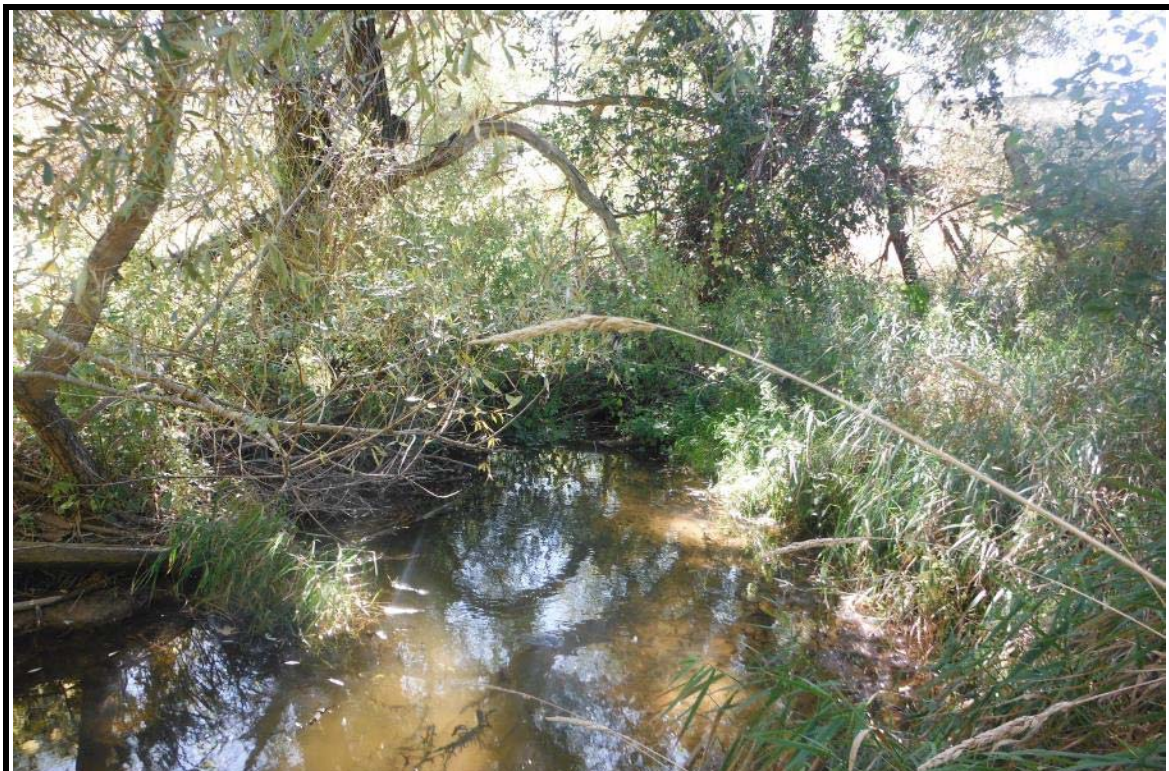
CREEK NAME: Huttonville Creek - Reach 3
FROM: Centre of Channel
LOOKING: Downstream
COMMENT: Typical Channel Conditions

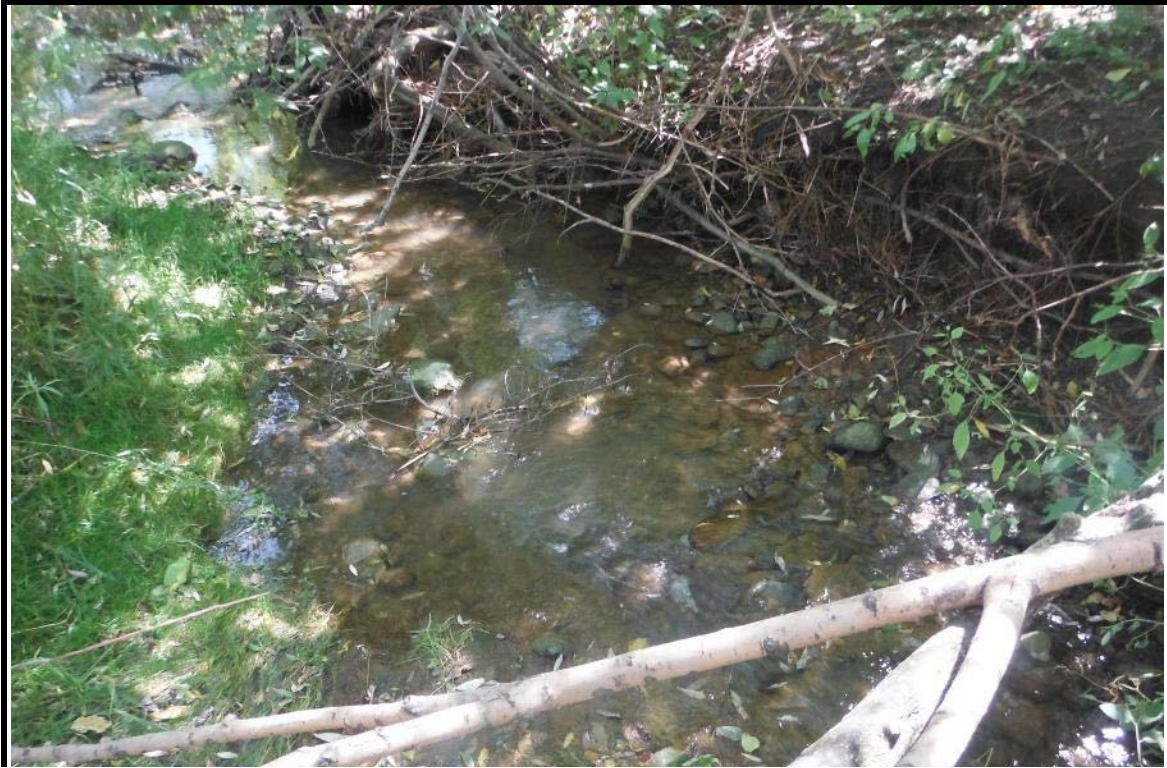
CREEK NAME: Huttonville Creek - Reach 3
FROM: Centre of Channel
LOOKING: Downstream
COMMENT: Typical Channel Conditions

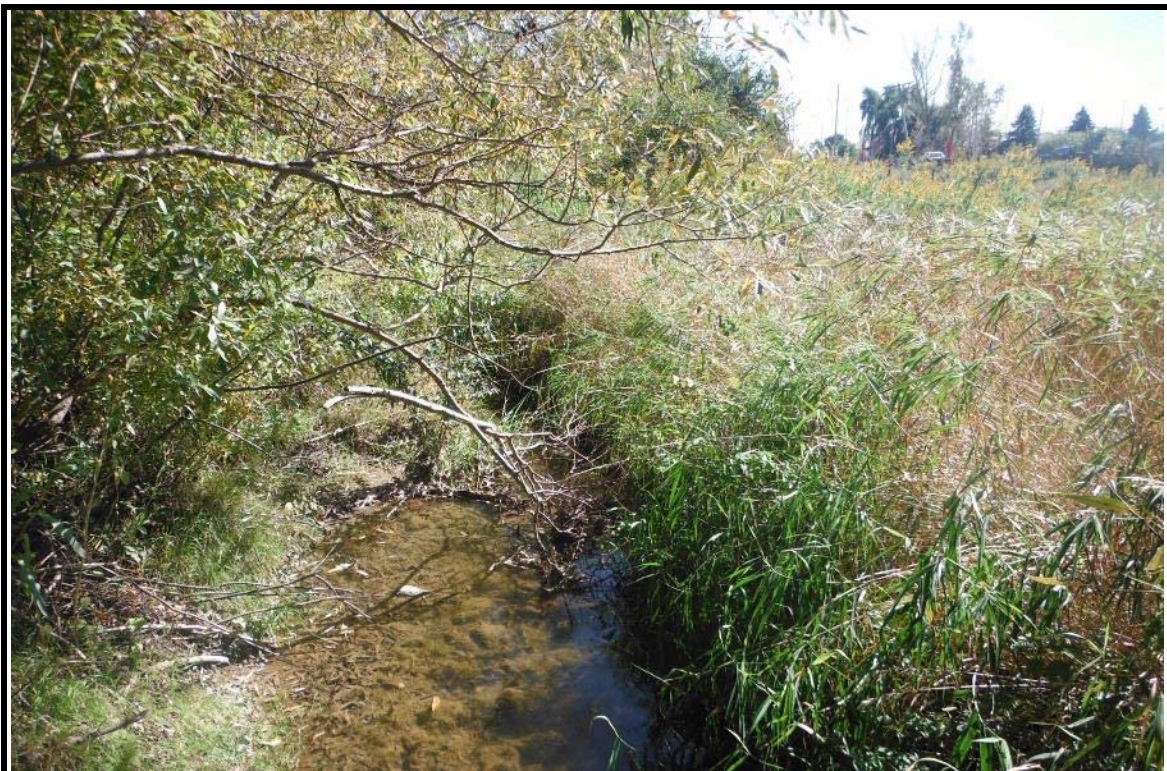
CREEK NAME: Huttonville Creek - Reach 3
FROM: Centre of Channel
LOOKING: Downstream
COMMENT: Typical Channel Conditions

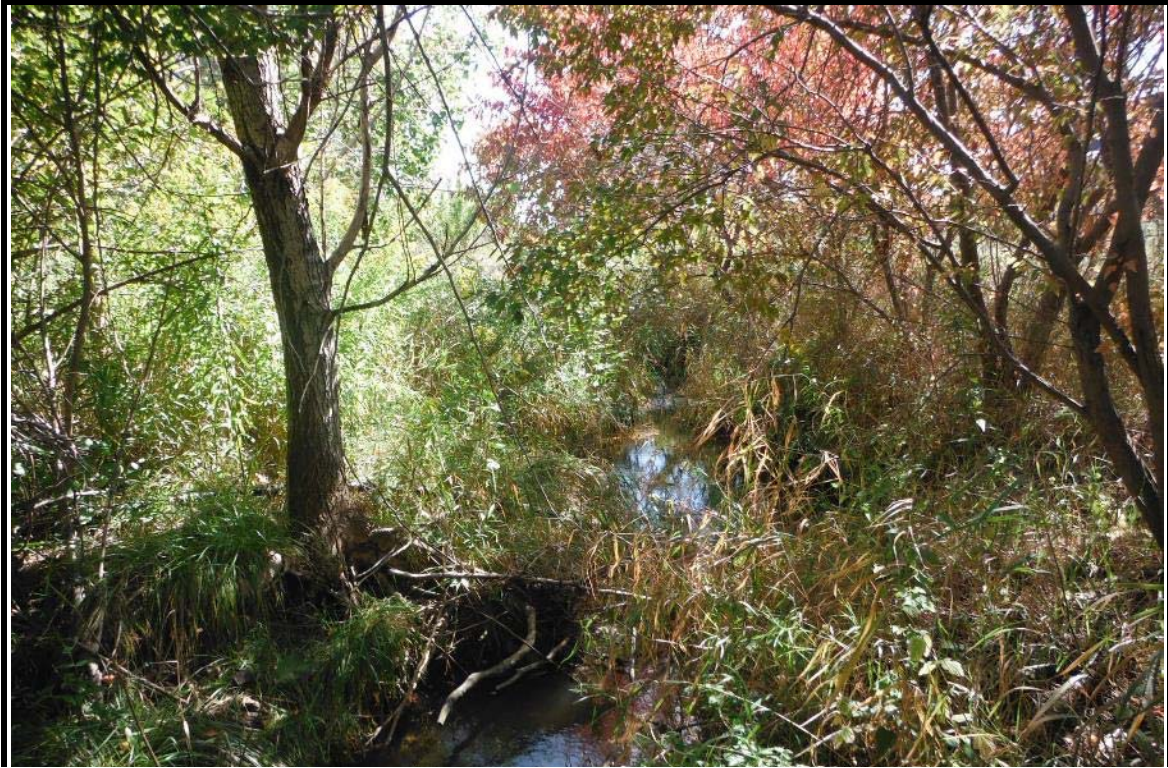
CREEK NAME: Huttonville Creek - Reach 3
FROM: Centre of Channel
LOOKING: Downstream
COMMENT: Typical Channel Conditions

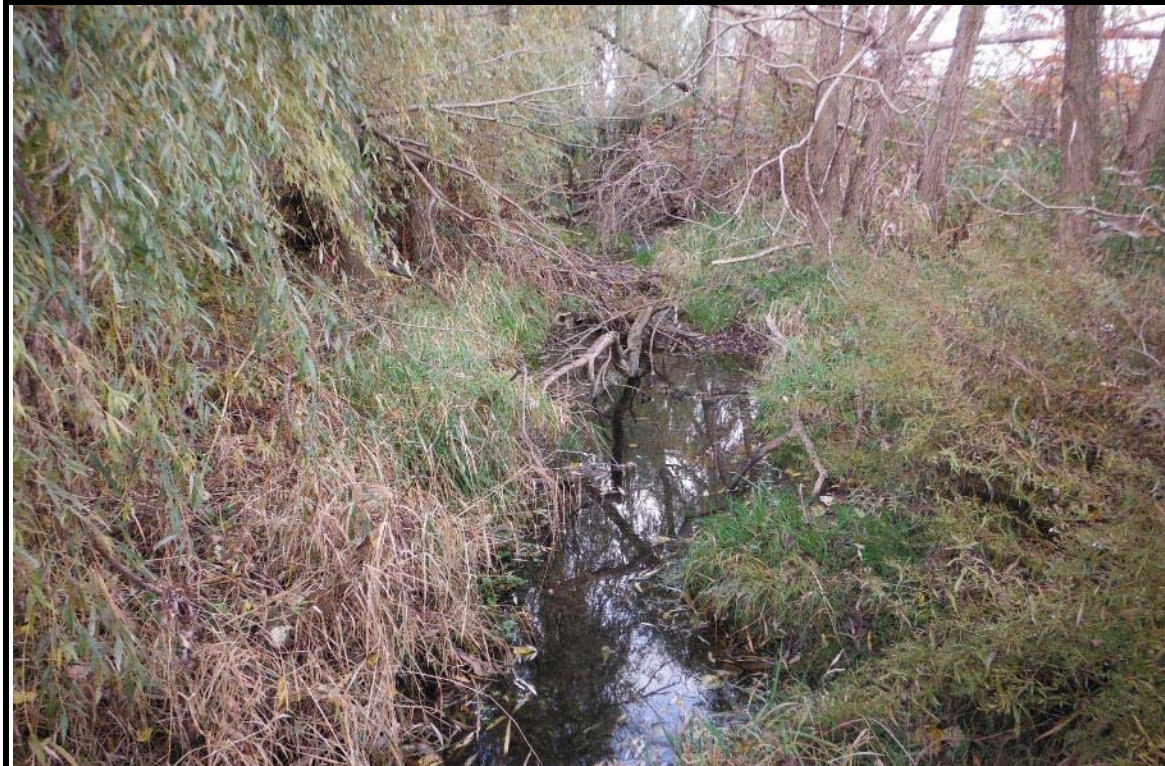
CREEK NAME: Huttonville Creek - Reach 4
FROM: Centre of Channel
LOOKING: Upstream
COMMENT: Typical Channel Conditions
