Mount Pleasant GO Station

**Fluvial Geomorphological and
Meander Beltwidth
Assessment**

**October 2, 2017
(Revised November 28, 2019)**

**RE: East – West Connector Class EA (Mount Pleasant GO Station to West of Mississauga Road)
Fluvial Geomorphological Assessment
City of Brampton, Ontario**

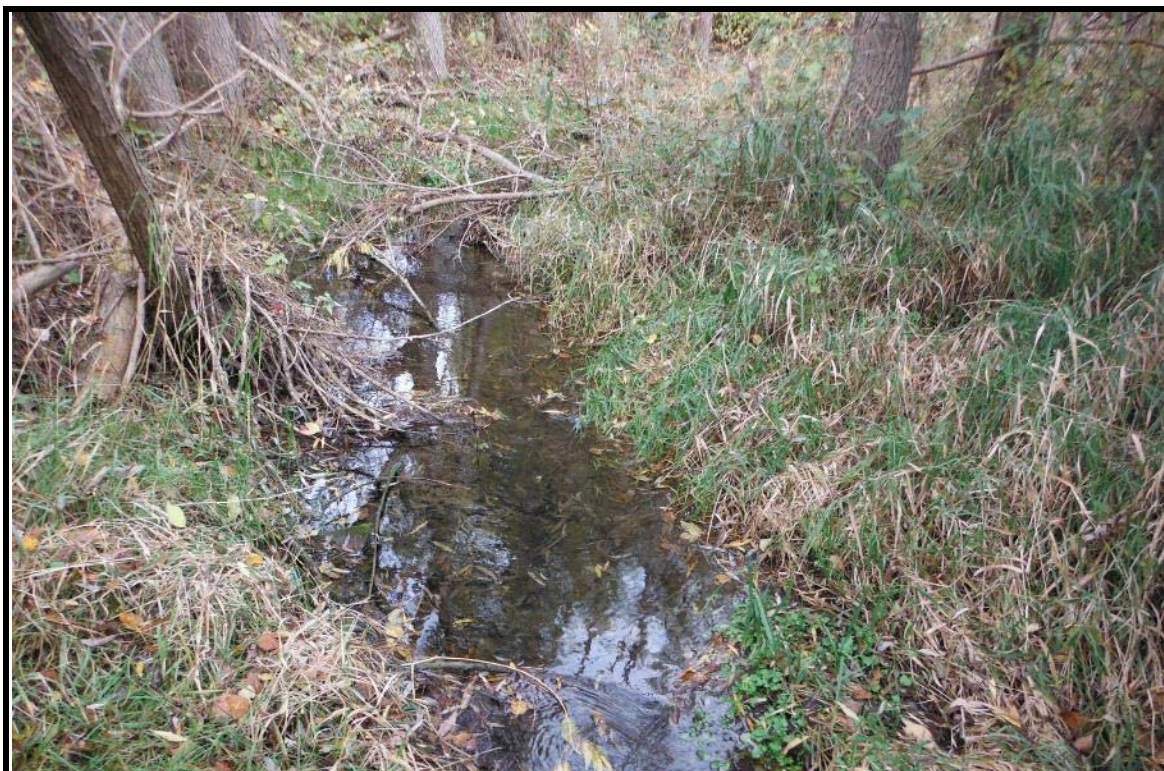
CREEK NAME: Huttonville Creek - Reach 4
FROM: Centre of Channel
LOOKING: Upstream
COMMENT: Typical Channel Conditions

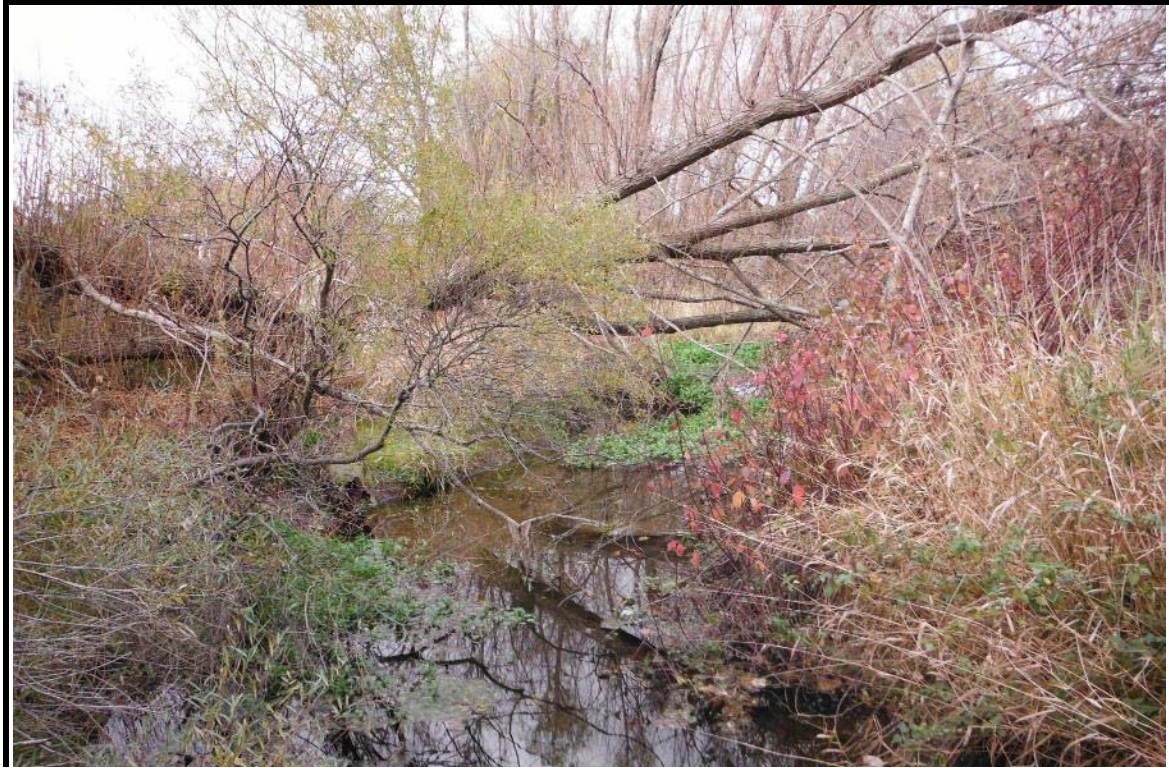
CREEK NAME: Huttonville Creek - Reach 4
FROM: Centre of Channel
LOOKING: Upstream
COMMENT: Typical Channel Conditions

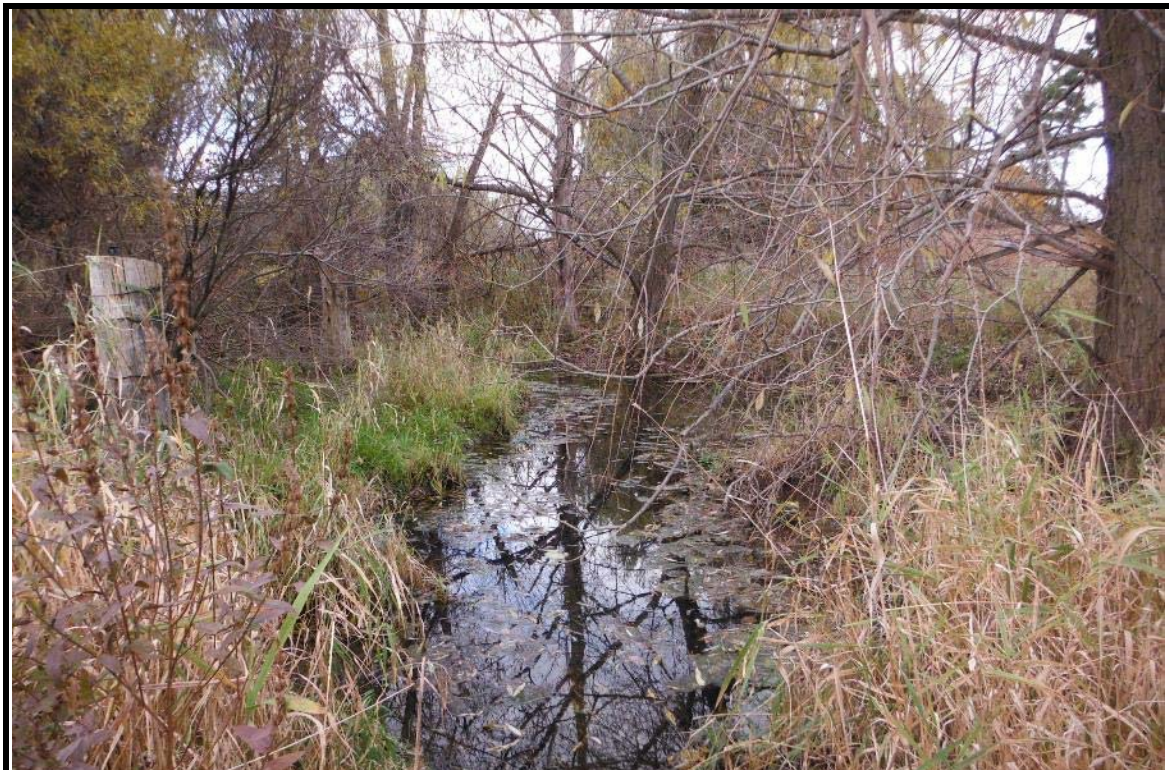
CREEK NAME: Huttonville Creek - Reach 4
FROM: Centre of Channel
LOOKING: Upstream
COMMENT: Typical Channel Conditions

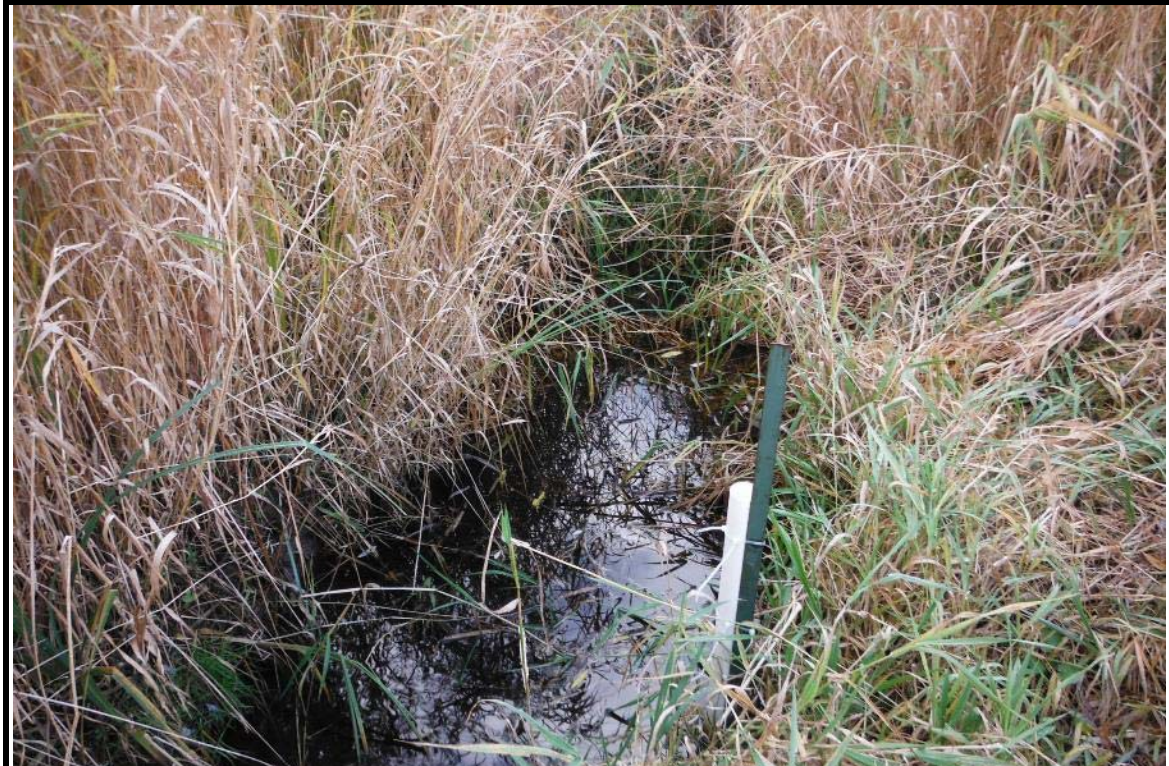
CREEK NAME: Huttonville Creek - Reach 4
FROM: Centre of Channel
LOOKING: Upstream
COMMENT: Typical Channel Conditions
