Environmental Assessment Study City of Brampton Transit Facility

Fluvial Geomorphological Assessment Rainbow Creek

Brampton, Ontario

Report Title: Environmental Assessment Study
City of Brampton Transit Facility
Fluvial Geomorphological Assessment, Rainbow Creek

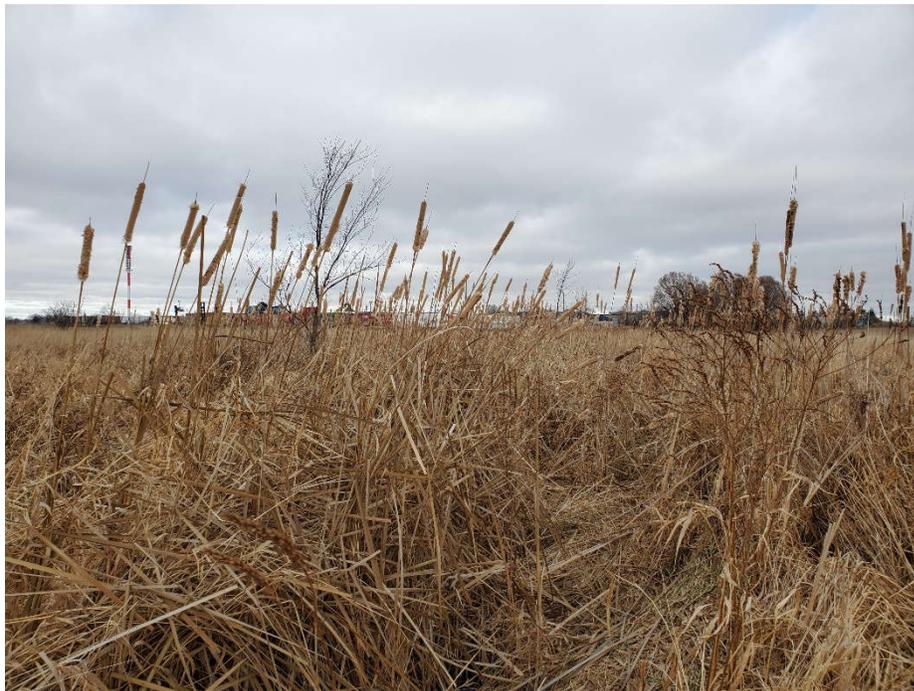
Photo 1
Rainbow Creek Reach RCT-3

Photograph taken facing upstream.
The majority of the reach consisted of a wetland/swale feature.

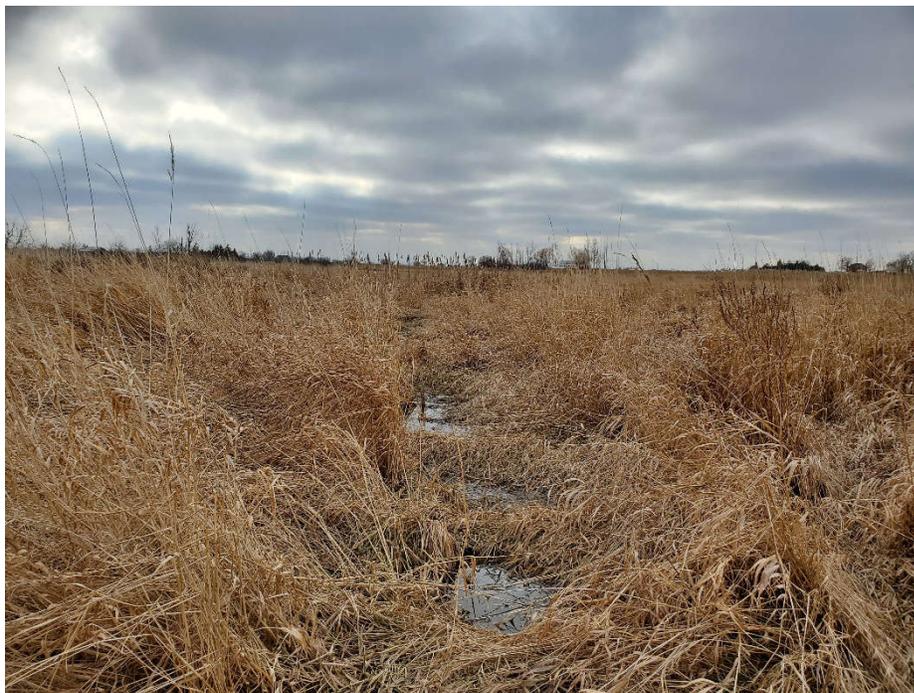
Photo 2
Rainbow Creek Reach RCT-3

Photograph facing downstream at the upstream extent.
A defined channel was observed at the upstream extent.

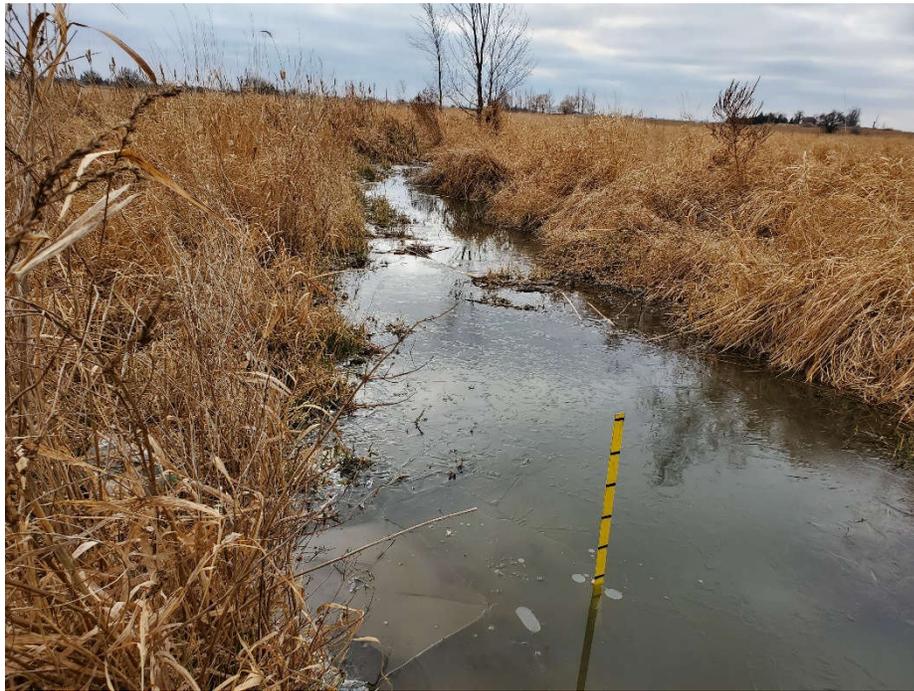
Photo 3
Rainbow Creek Reach RCT-4

Photograph taken facing downstream at the downstream extent.
The reach consisted of a plain bed, with no riffle-pool development

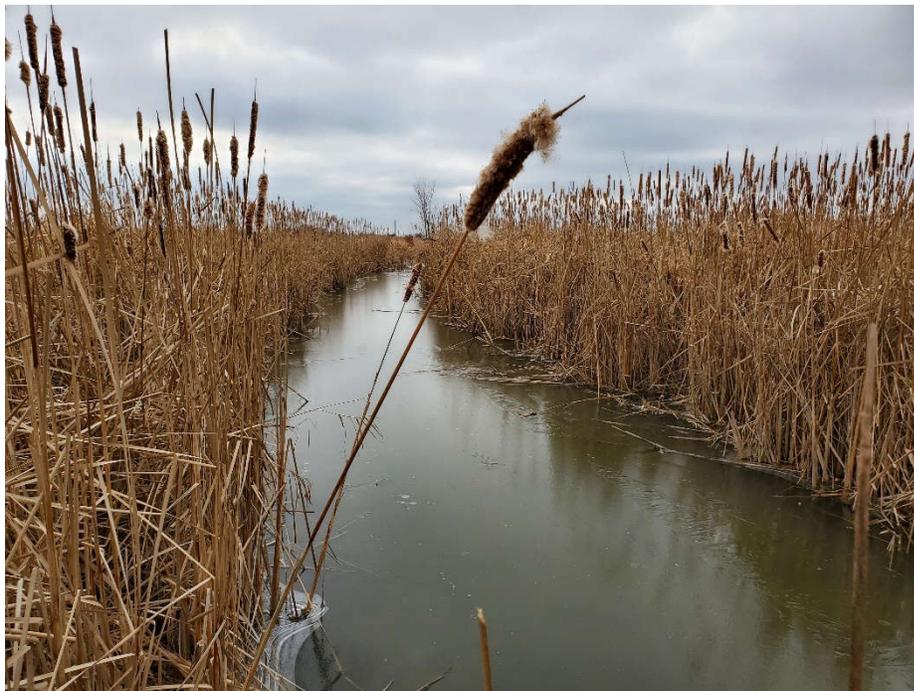
Photo 4
Rainbow Creek Reach RCT-4

Photograph taken facing downstream at the upstream extent.
The banks had low angles with little to no erosion.
