Subject: Recommendation Report
Heritage Theatre Block Redevelopment (Ward 1)

70-86 Main Street North
HERITAGE BACKGROUND ASSESSMENT
MAY 2009

HERITAGE THEATRE BLOCK

5.0 ASSESSMENT OF EXISTING CONDITION

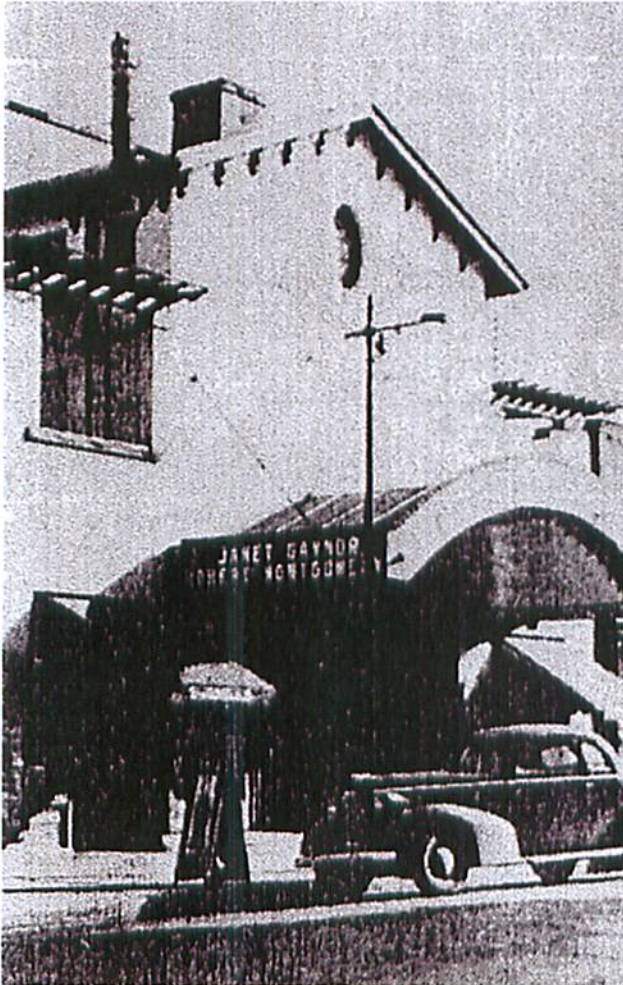
Exterior c.1940

The Capitol Theatre was built in 1922 and opened on February 28th, 1923. The theatre was used for the presentation of vaudeville acts and silent films. The opening of a commercial theatre in the heart of downtown Brampton was a major event that marked Brampton's growth as a residential community. In the 1920s, this two-storey building was considered to be a large theatre of a size that was typically not found outside the major cities. The vaudeville and silent film era came to an end in Brampton when the Odeon Corporation purchased the theatre in 1946. The original orchestra pit was removed and new technical upgrades were made for the projection of "talking films". The theatre was purchased by the City of Brampton in 1981 from the Odeon Corporation.

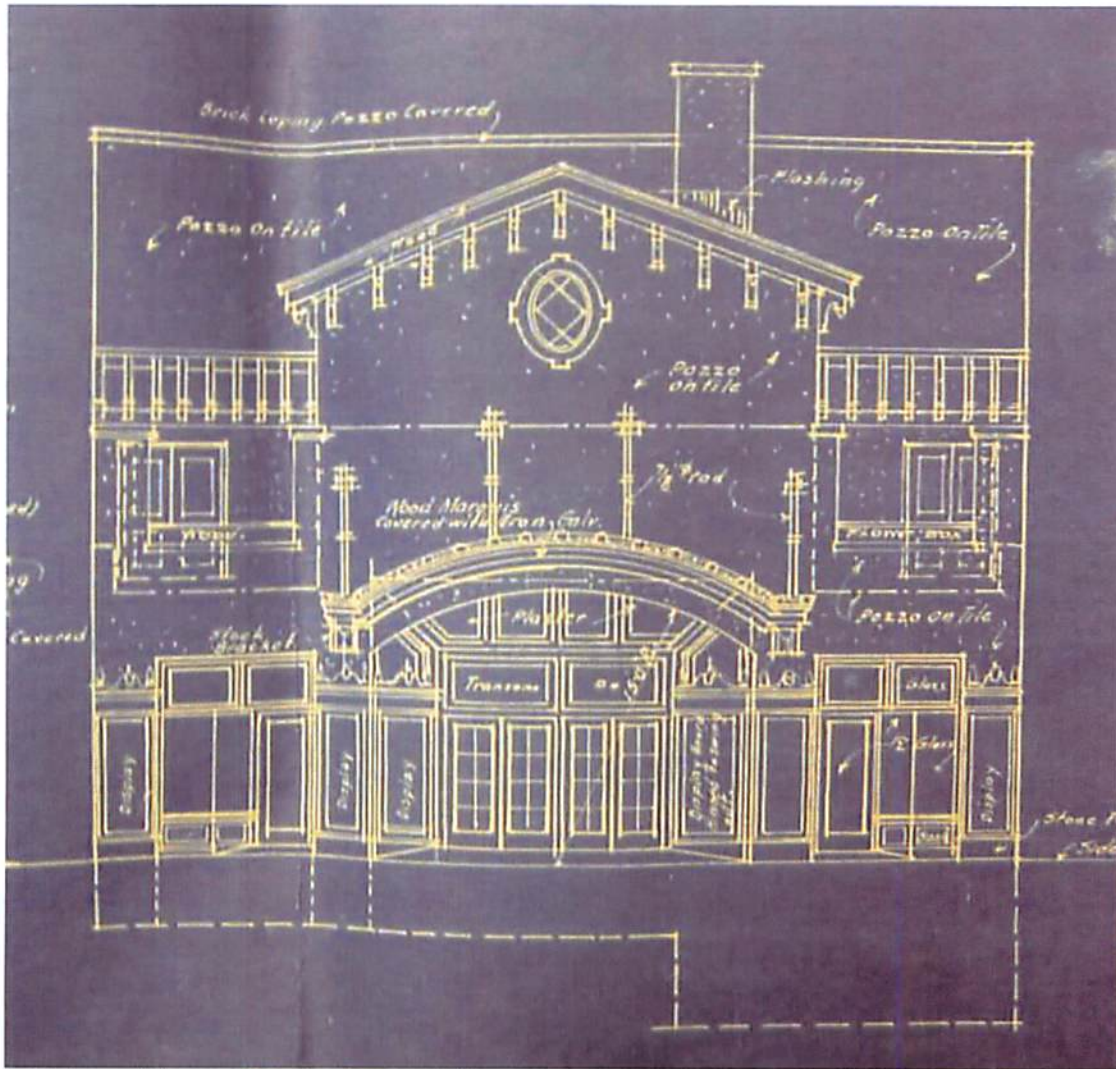
Original 1922 Main Street Elevation (Source: Archives of Ontario, RG 56-10, Container 59)

The original design of the Capitol Theatre was sympathetic to the Main Street context in which it was built. The ground level along the street edge consisted of the theatre's main entrance flanked by two retail spaces, effectively breaking up the wider building frontage into three distinct spaces that related well to the fine-grained character of the adjacent commercial buildings. This feature survived the 1947 renovation, but was not restored by the city during the 1980s restoration work.

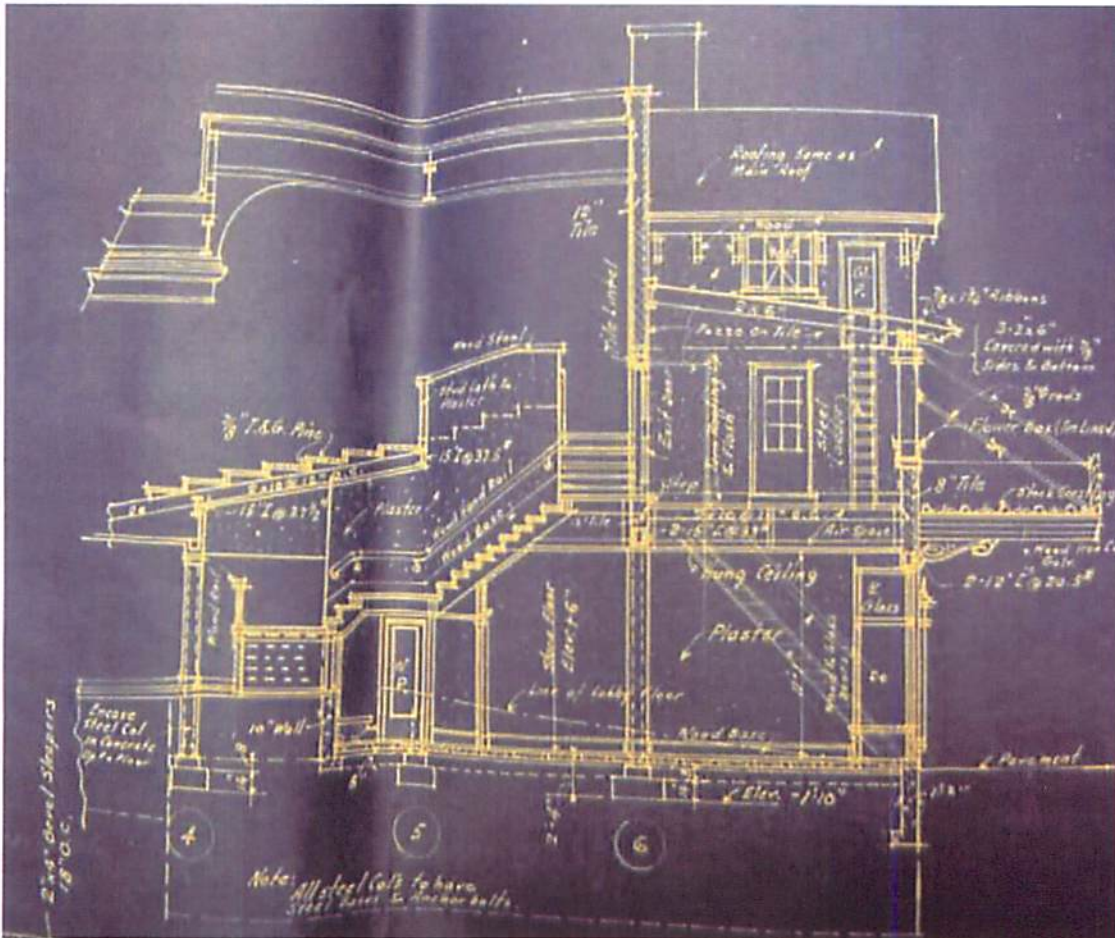
Another notable aspect of the original design is the quality of public access and the public presence that it fostered. Originally, the lobby space of the Capitol Theatre sloped down from foyer to street level. This provided a larger pre-theatre social space than the distinct foyer and entrance landings created in 1947. Additionally, there were previously two outdoor terraces located on the second level, where the expanded washroom and changing facilities were located in 1947. These terraces were accessed from the interior balcony level and contributed a semi-public social presence above the Main Street.

Section showing original 1922 lobby, balcony seating and exterior terrace
 (Source: Archives of Ontario, RG 56-10, Container 59)

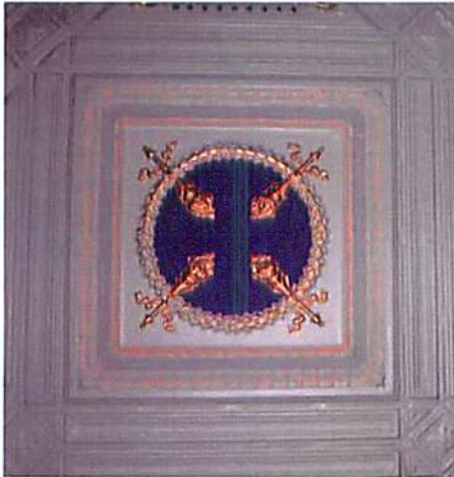
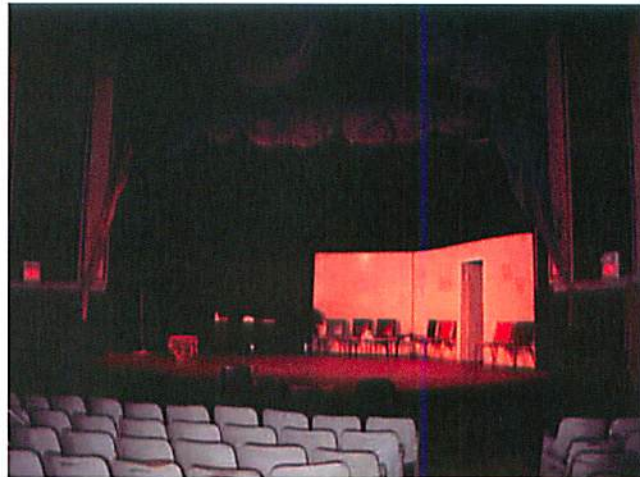
Inside the theatre, there is a decorative pressed tin frieze and ceiling in the Liberty Torch pattern.

- 1.1.3.1. An appropriate colour scheme to be determined
- 1.1.3.2. Provide for ceiling repair and maintenance
- 1.1.3.3. Provide for repainting of ceiling
- 1.1.3.4. Allow budget for new lighting

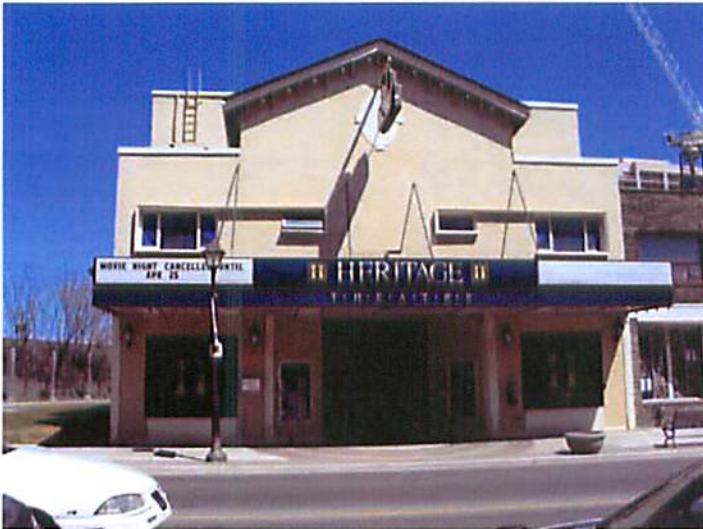
The exterior envelope and masonry is generally in good condition and shows evidence of continued maintenance. The three-storey solid brick building tinted stucco applied to the west elevation is in keeping with the building's historic appearance.

- Limited areas of open mortar joints;
- Minimal signs of masonry deterioration (spalling and cracking of bricks); and
- Minor efflorescence caused by de-icing salts at the south east corner of the building.

- Minor cracks and paint flaking.

- Some broken panes of glass on north elevation of gable;
- Flaking and missing paint; and
- Failure of putty, sealants and weather stripping.

- The bitument flat roof shows signs of fatigue and will require replacement within the next two years; and
- Asphalt shingles on gable in poor condition.

- Parapet flashing in fair condition; and
- Gable flashing and eaves in fair condition.

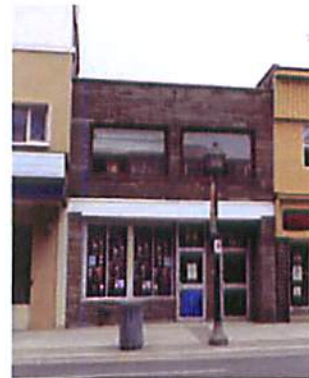
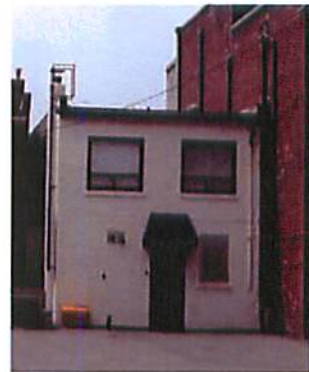
The exterior envelope and masonry is generally in good condition, however; we did not have access to the narrow space between the two buildings and could not determine the condition of this area.

The building at 80 Main Street North is constructed from concrete block and has been faced with a cast stone veneer on the west elevation. The large second floor windows may have replaced a series of smaller sash windows that would have been typical for buildings of this age. There is no basement space below this property.

- Minor spalling and cracking of bricks.

- No signs of cracks or deterioration.

- Missing window pane on east elevation.

- The bitumen flat roof in fair condition.

- Parapet flashing and eavestrough in fair condition.

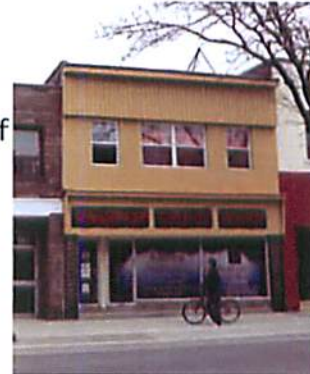
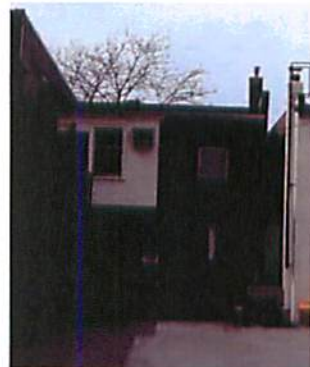
The exterior envelope and masonry is generally in good condition, however; we did not have access to the narrow space between the two buildings and could not determine the condition of this area.

76 Main Street North is of brick construction and has been faced with wood, stucco and brick veneer on the west elevation. The foundation and floor joists remain in good condition in the basement.

- Limited areas of open mortar joints on north elevation of 76 Main St around chimney just below the parapet; and
- Minor spalling and cracking of bricks.

- No signs of cracks or deterioration.

- Missing window pane on east elevation.

- Single ply membrane flat roof in fair condition.

- Parapet flashing and eavestrough in fair condition.

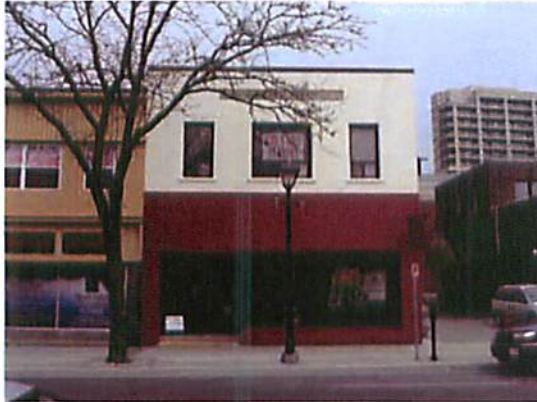
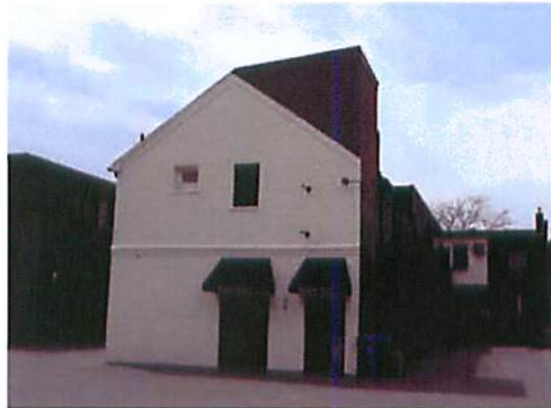
The exterior envelope and foundation is generally in good condition.

The two-storey brick building is faced with stucco on the west, south and east faces. A commercial unit at grade and a separate residential/office unit above. The entrances to both units are located on the building west elevation.

Formerly known as the Robson Block, 70 Main Street North was constructed in sections in the 1920s. The pitched roof section at the rear was built first, followed by the flat roofed portion in front along Main Street. A stone unit with "Robson Block" still remains. Also, sections of faceted precast concrete units to mimic the appearance of stone still remain in the basement. These units would have been available through mail-order catalogue companies, such as the Sears Roebuck Co. and were common throughout the late 1800s and early 1920s.

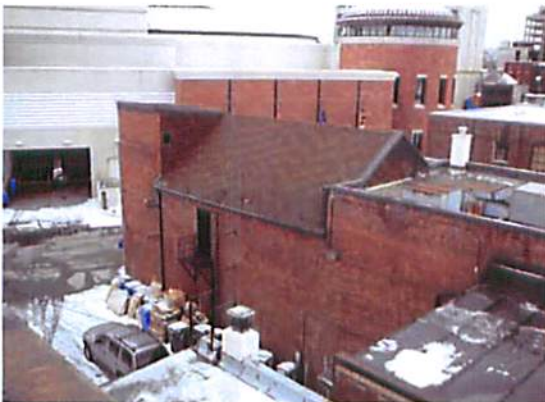
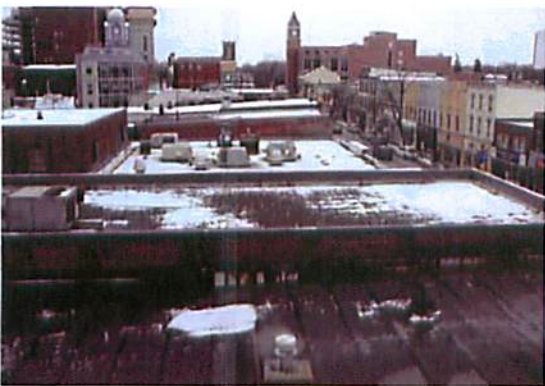
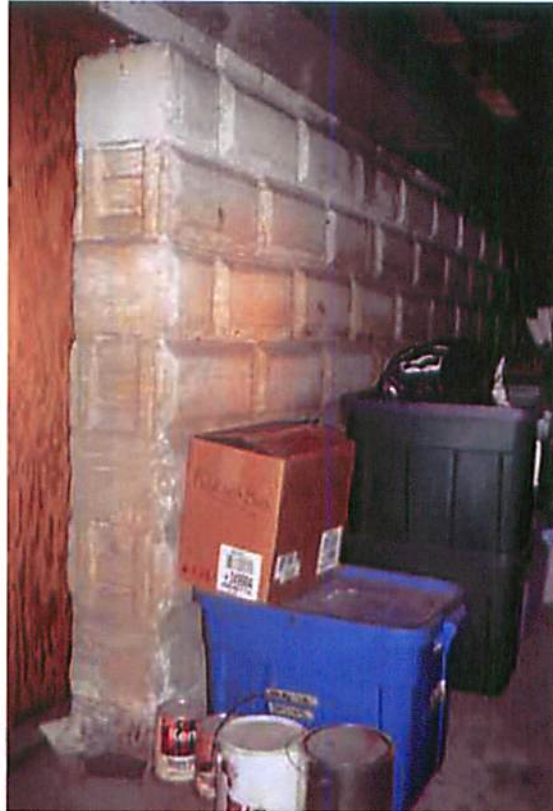
- Replaced sash windows on second floor window (though stone sills appear original);
- Ground level windows along Vivian Lane have been enlarged and are missing the sills; and
- Partially finished to provide storage space for artwork and supplies.

- Limited areas of open mortar joints on north elevation at grade;
- Minor spalling and cracking of bricks; and
- Some moisture penetration in the basement with isolated wetting.

- No signs of cracks or deterioration.

- Windows and doors in fair condition.

- The bitumen flat roof in fair condition.

- Parapet flashing and eavestrough in fair condition.

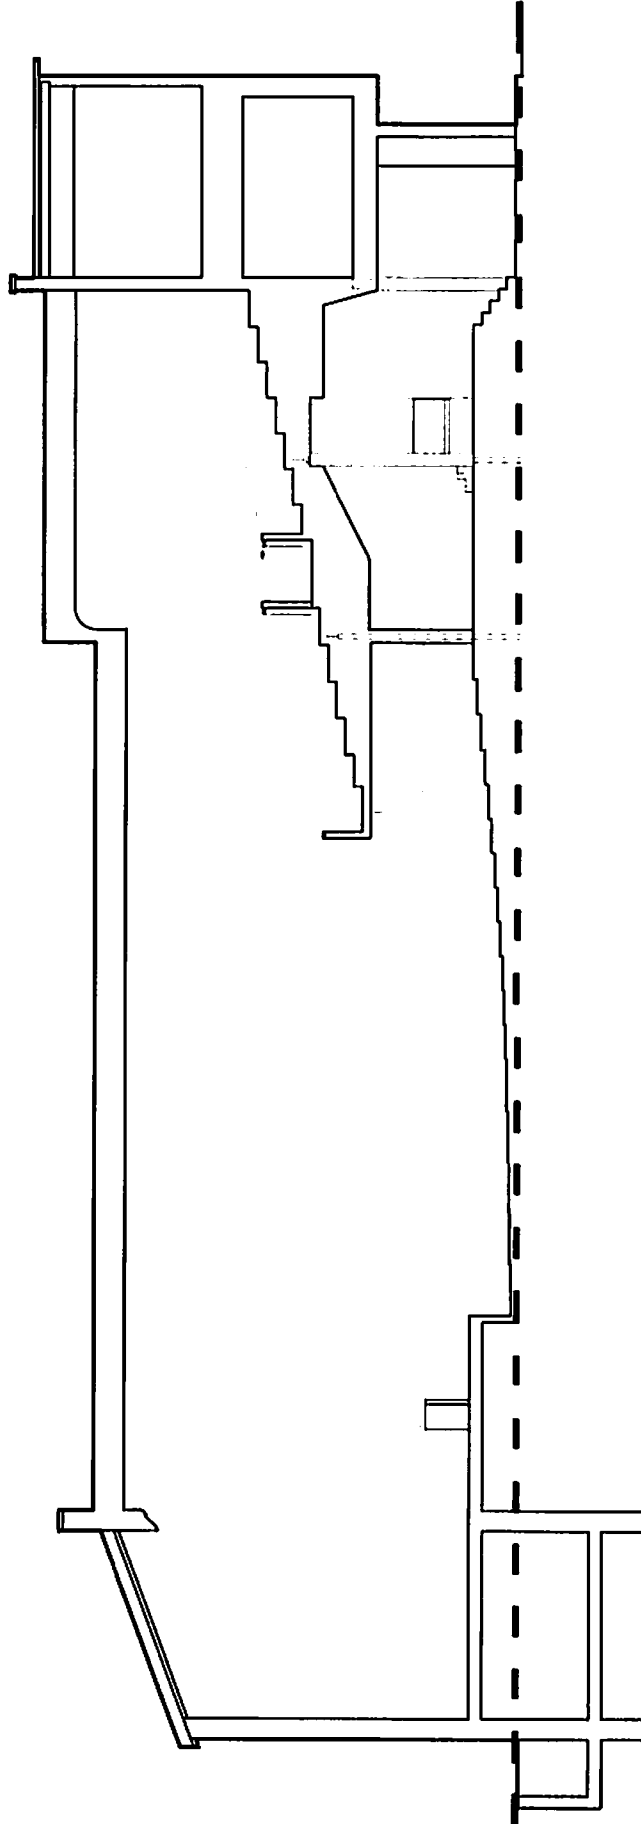
(1.1) Dotted blue line represents the leveling of the floor

- 1.1.1. Level Ground Floor, Auditorium and Lobby
 - 1.1.1.1. Remove existing concrete stairs at entrance
 - 1.1.1.2. Remove seating from theatre
 - 1.1.1.3. Remove raking from theatre and lobby and excavate to consistent floor level
 - 1.1.1.4. Provide new 4" concrete floor throughout
 - 1.1.1.5. Allow for structural repairs of existing columns
- 1.1.2. Existing Stairs to Accommodate Grade Change
 - 1.1.2.1. Make good the stairs to accommodate new floor level
 - 1.1.2.2. Maintain and make good the stairs to the basement beneath lobby
