Natural Environment Assessment Report Municipal Class Environmental Assessment Schedule 'C'

ARTERIAL ROAD NETWORK WITHIN THE HIGHWAY 427
INDUSTRIAL SECONDARY PLAN AREA (AREA 47) PART 'B'
STUDY CORRIDOR
City of Brampton
Project # TP115086

November 2021

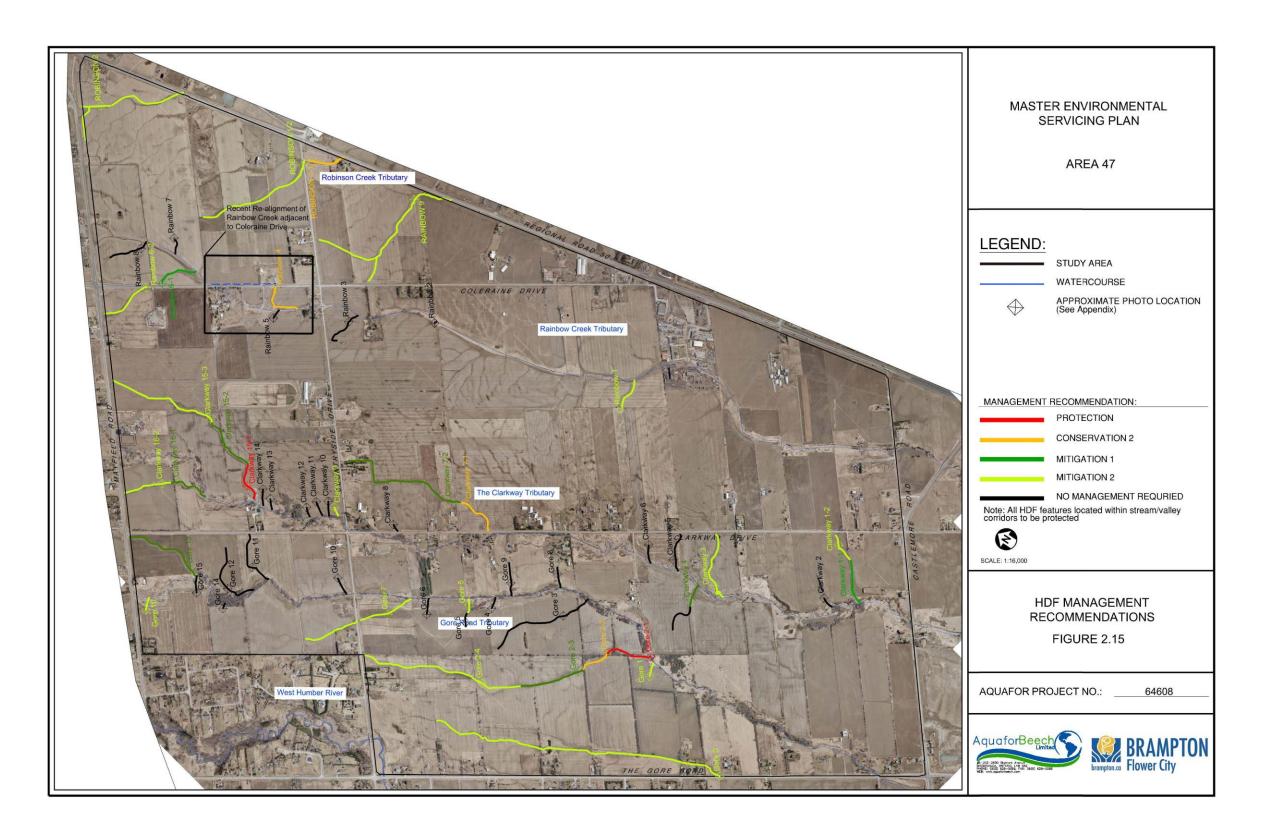
Figure 5-1: HDF Management Recommendations from the MESP Figure 2.15

The remaining HDF's in the Study Area are classified as "Mitigation 1", "Mitigation 2", or "No Mitigation" (Figure 2.15 "HDF Management Recommendations" in the MESP by Aquafor Beech Limited 2016). HDFs classified as "Mitigation 1" or "Mitigation 2" could either remain as open watercourses provided that flows can be maintained (via stormwater pond outlets, LID swales or other techniques), or be replicated using well-vegetated urban swales or wetlands (Mitigation 1), or lot-level and conveyance stormwater techniques such as LID measures. Those HDFs with "No Management" classification could be eliminated and replaced with a traditional urban major-minor drainage system.

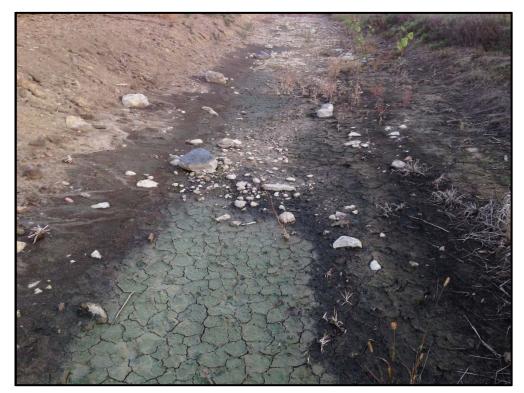
Photo 1: Crossing RB1 downstream. Channel dry with sediment deposition apparent and vegetation within the channel.

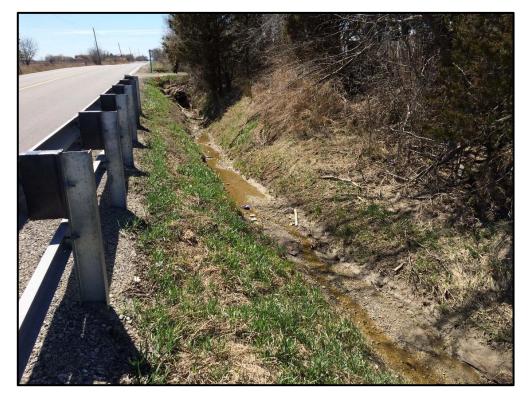
Photo 9: Upstream end of Crossing RB2. Note ditch drainage outletting from the west of the watercourse.

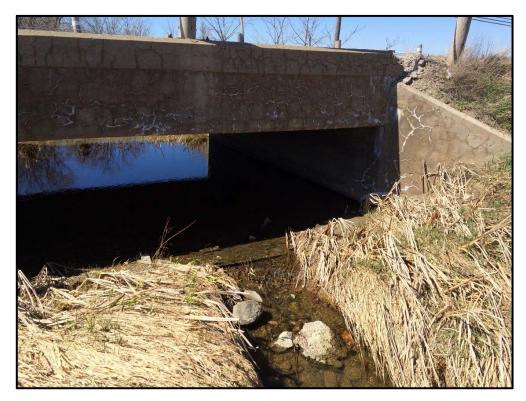
Photo 1: GT4 looking downstream of crossing.

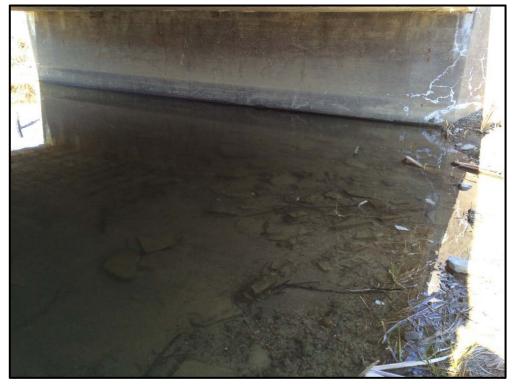
Photo 2: GT4 facing downstream end of bridge.

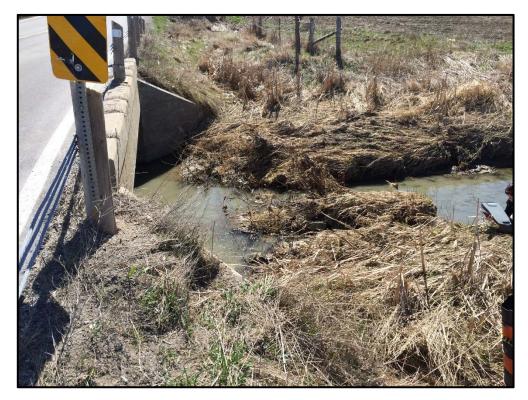
Photo 3: GT4 within the ROW. Nests observed under bridge.

A pool habitat extended from upstream of the ROW to under the bridge structure. The pooled area under the bridge was measured as having a maximum depth of 0.67 m and a substrate composition of 100% fines (silts, sand and clay). Evidence of nesting activity was found under the bridge, with residual material present from approximately 12 fallen Cliff Swallow (Petrochelidon pyrrhonota) nests. A dry wildlife bench

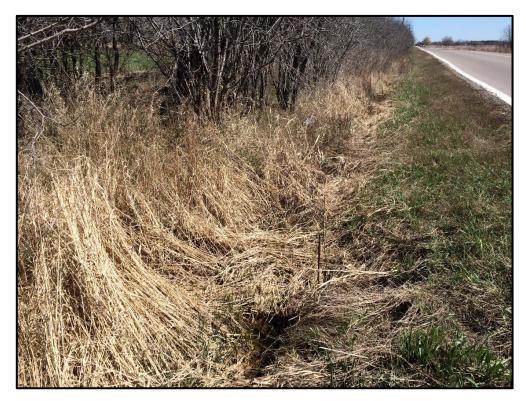
Photo 7: GT5 upstream of crossing mud visible in photo but no water present.

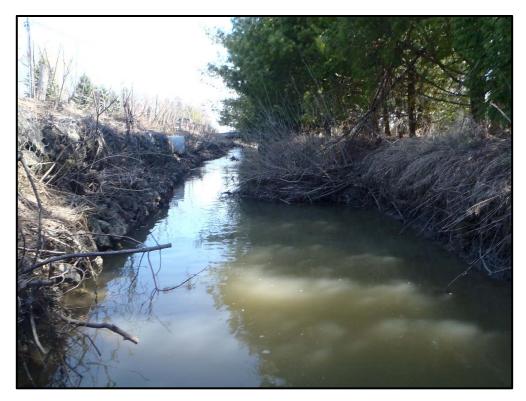
Photo 13: CTA, facing upstream (north). Note gabion baskets and channelization.

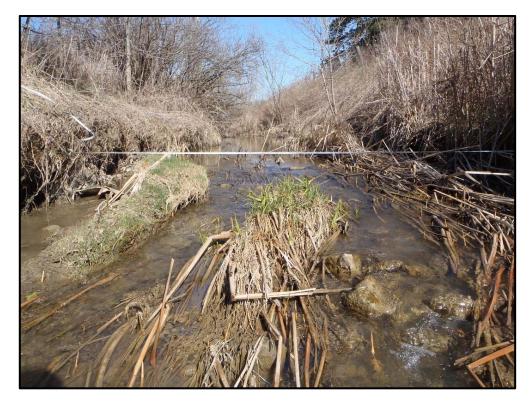
Photo 19: CTA Reach 4. Active erosion evident on western bank.

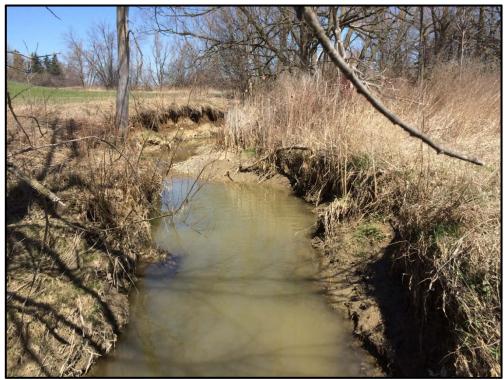
Photo 38: Crossing CT5, ROW to 20 m upstream area. Note failing bank on south bank of stream adjacent to roadway.

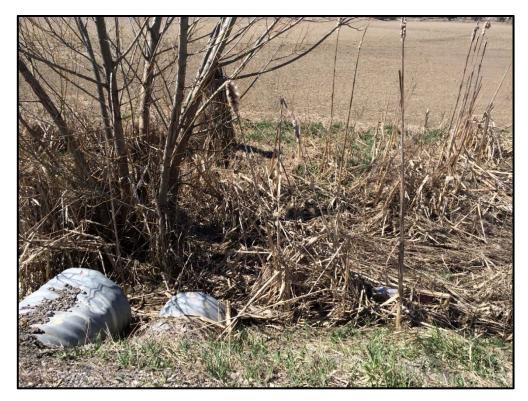
Photo 41: Crossing RS1, downstream ROW, twin CSP culverts.
