# F VEGETATION AND AESTHETICS ASSESSMENT

Highway 427 Industrial Secondary Plan Area Environmental Assessment  
Existing Vegetation/Aesthetic Assessment  
**Section B**

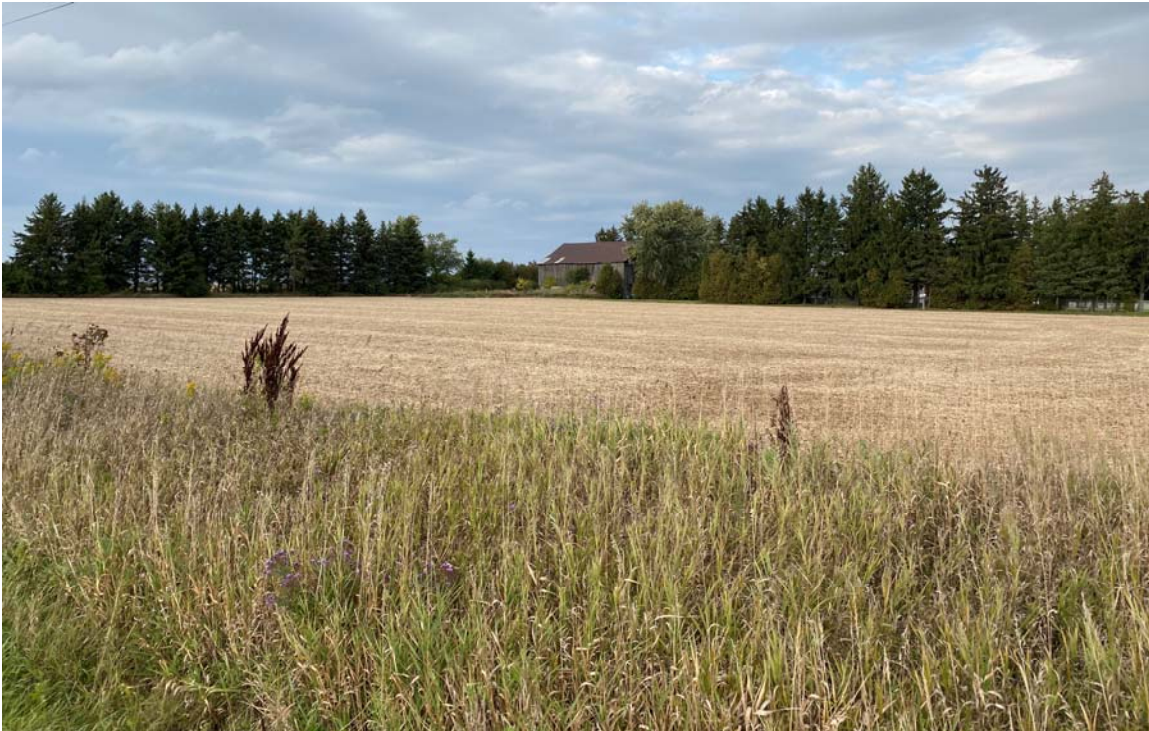
*Image 1: Site/Rural Character – Looking east from Coleraine Drive*

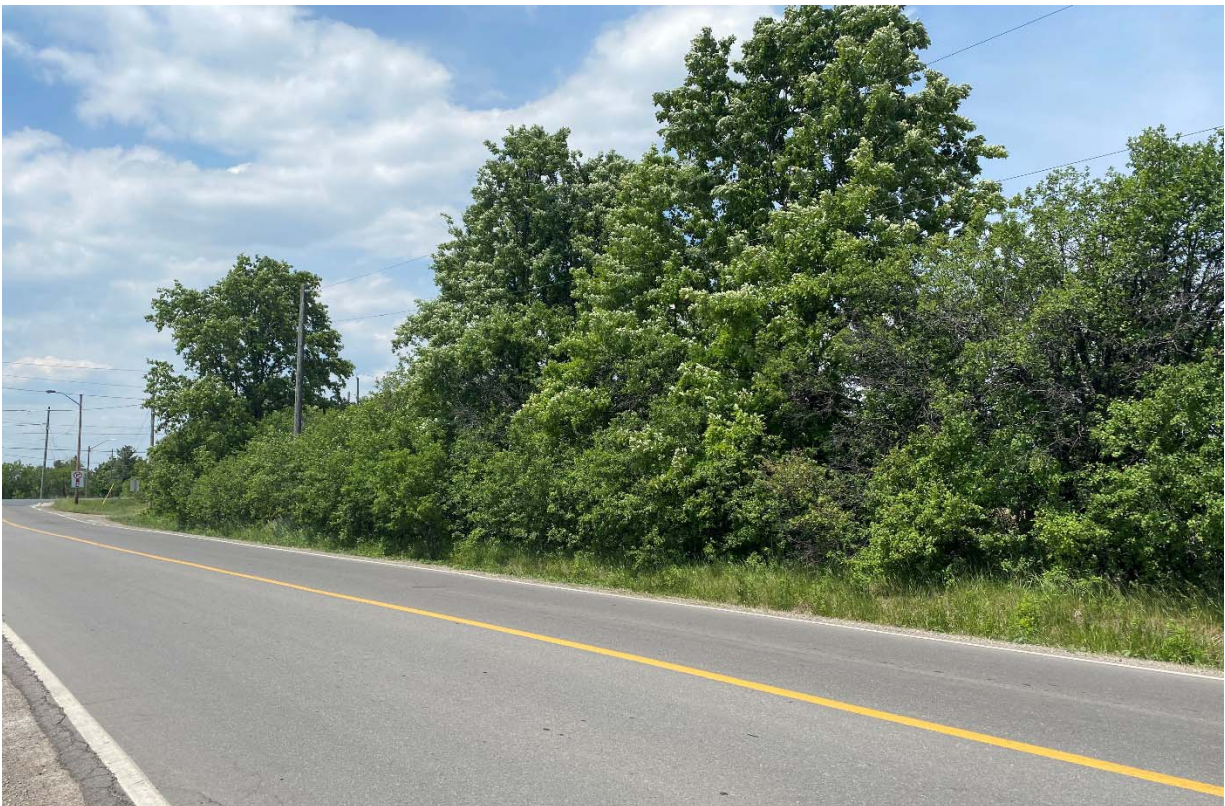
**Image 1:** Clarkway Drive – Looking north to the intersection with Mayfield Road. Buckthorn hedgerow begins. Three *Quercus* spp. can be seen in the background, established well outside the proposed ROW.

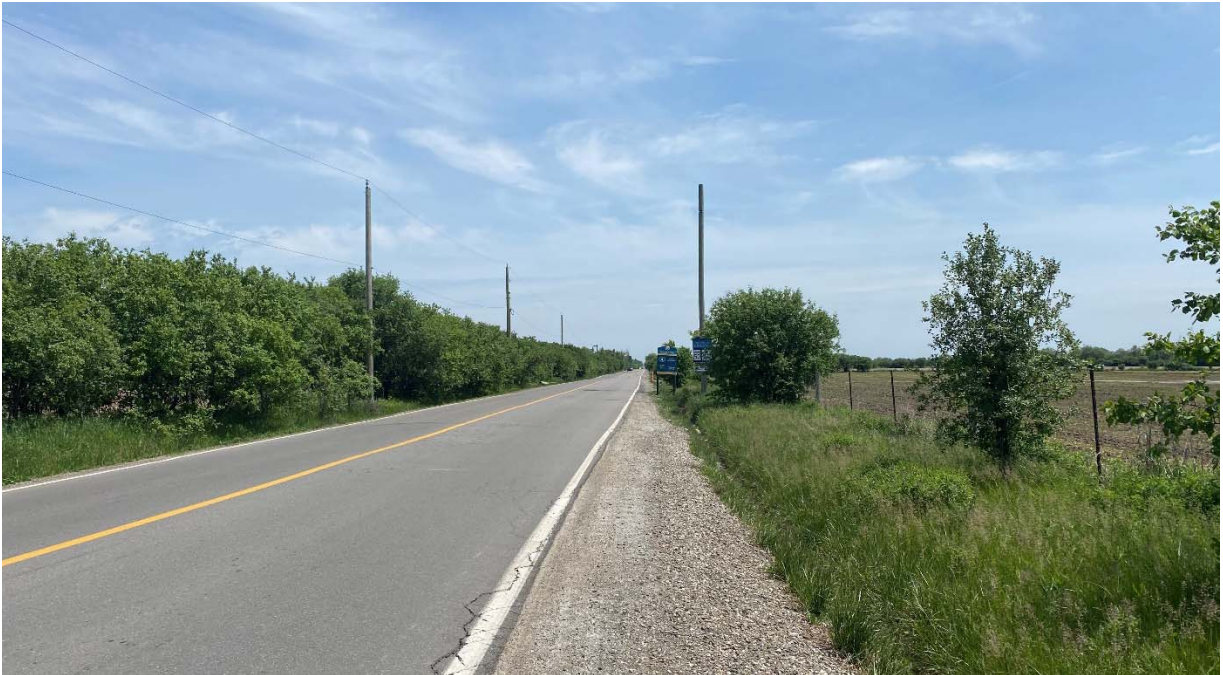
**Image 2:** Clarkway Drive – Looking south from just beyond the intersection with Mayfield Road. Buckthorn hedgerow on the eastern roadside extending into the distance. Level agricultural land exists on both sides of the road.

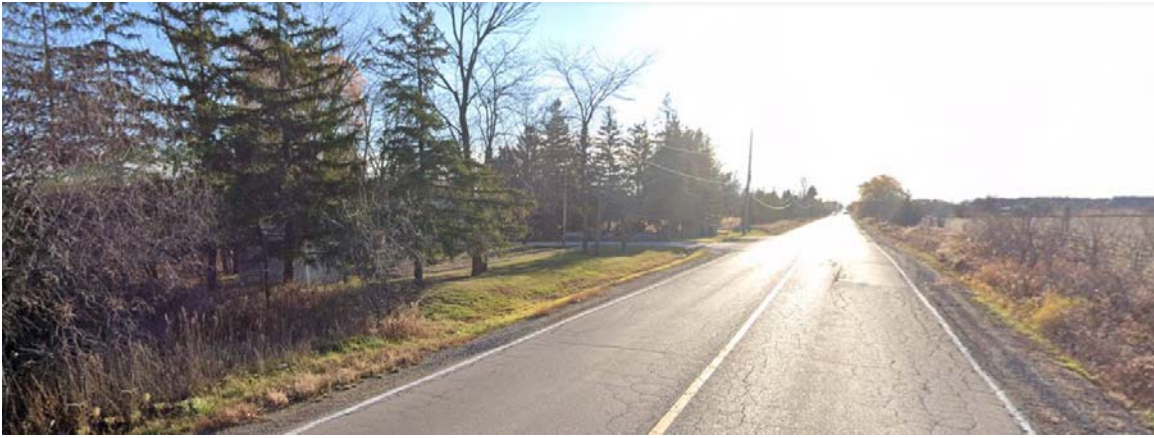
**Image 3:** Clarkway Drive – Looking south at the first encountered residential site. Deciduous trees exist in a manicured lawn but appear to be well beyond the site work needed for the proposed ROW.

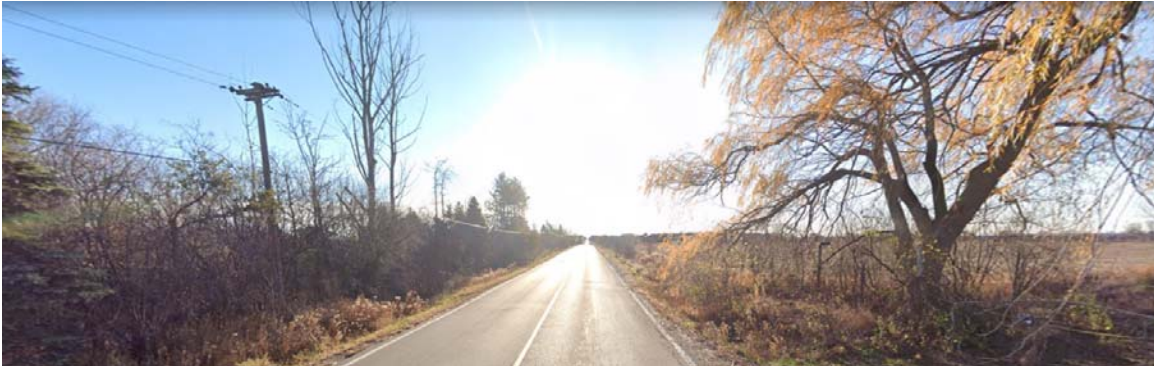
**Image 4:** Clarkway Drive – Looking south beyond the first encountered residential site. Naturalistic landscape exists to the east containing invasive Buckthorn Hedgerow remnants. Large existing trees appear dead as observed throughout several points of the year. A large Willow can be seen at the western side of Clarkway Drive.

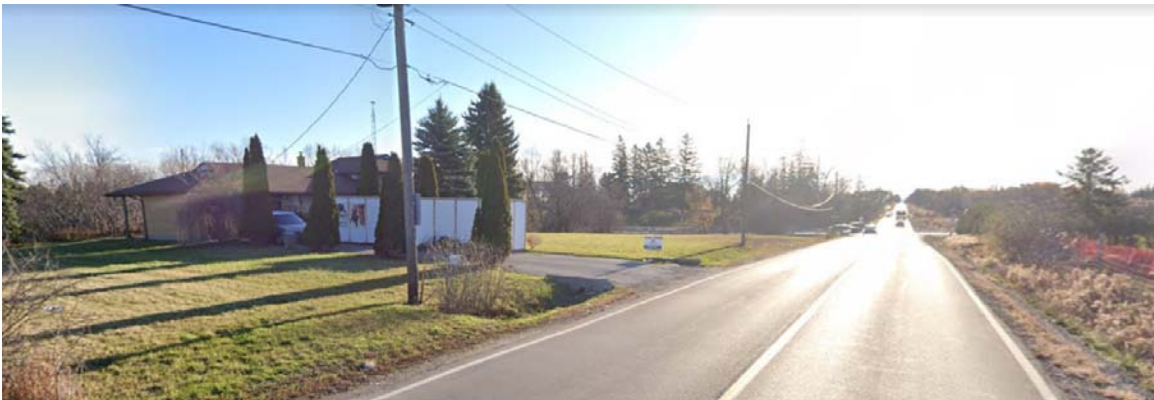
**Image 4:** Clarkway Drive – Looking south to the intersection of Clarkway and Countryside Drive. Residential sites lie on both sides of the road but pose no conflict with the proposed ROW.

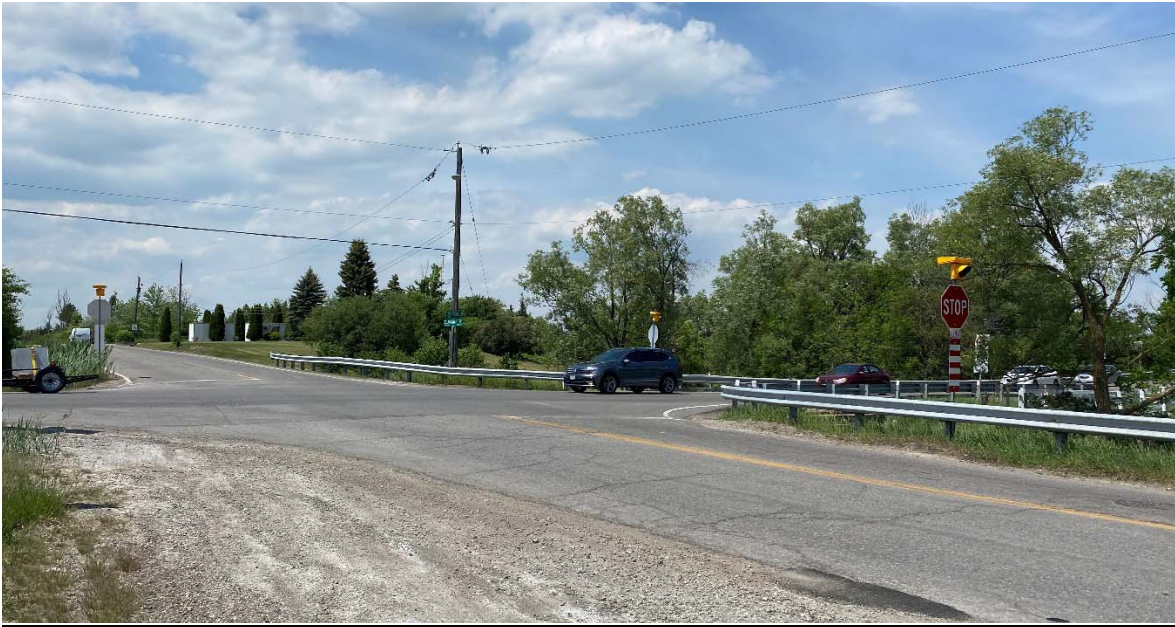
**Image 5:** Intersection of Clarkway Drive and Countryside Drive – Looking north.

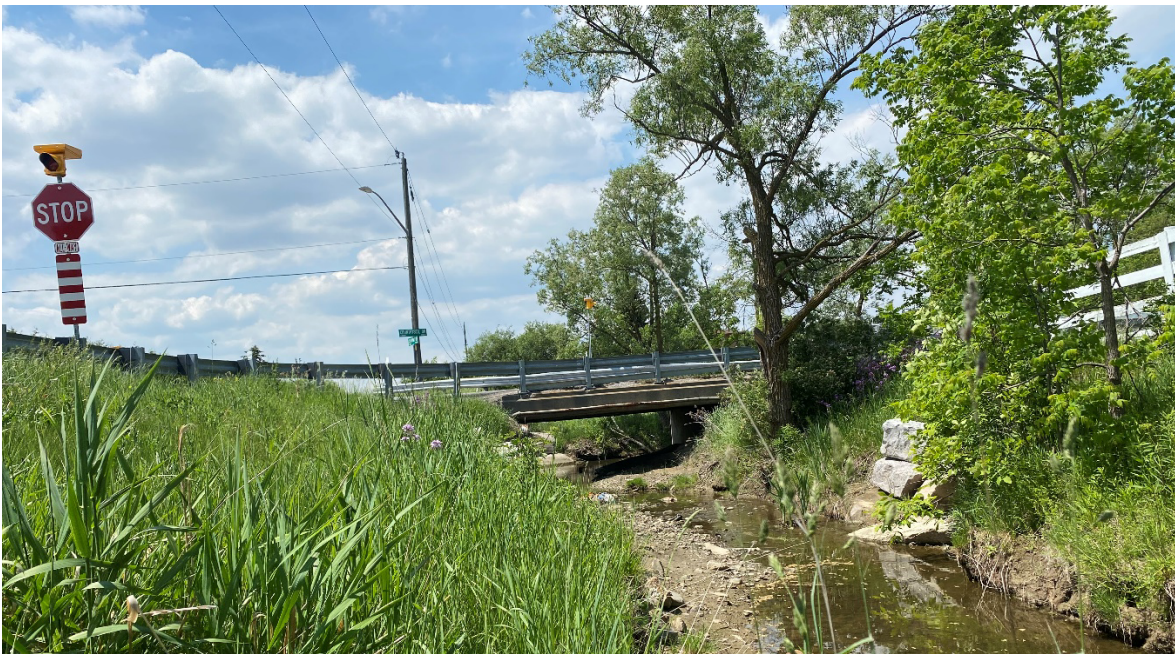
**Image 6:** Looking north on east side of Clarkway Drive – Clarkway Tributary passes beneath Countryside Drive. Riparian zone is dominated with seasonally maintained roadside grasses and forbs.

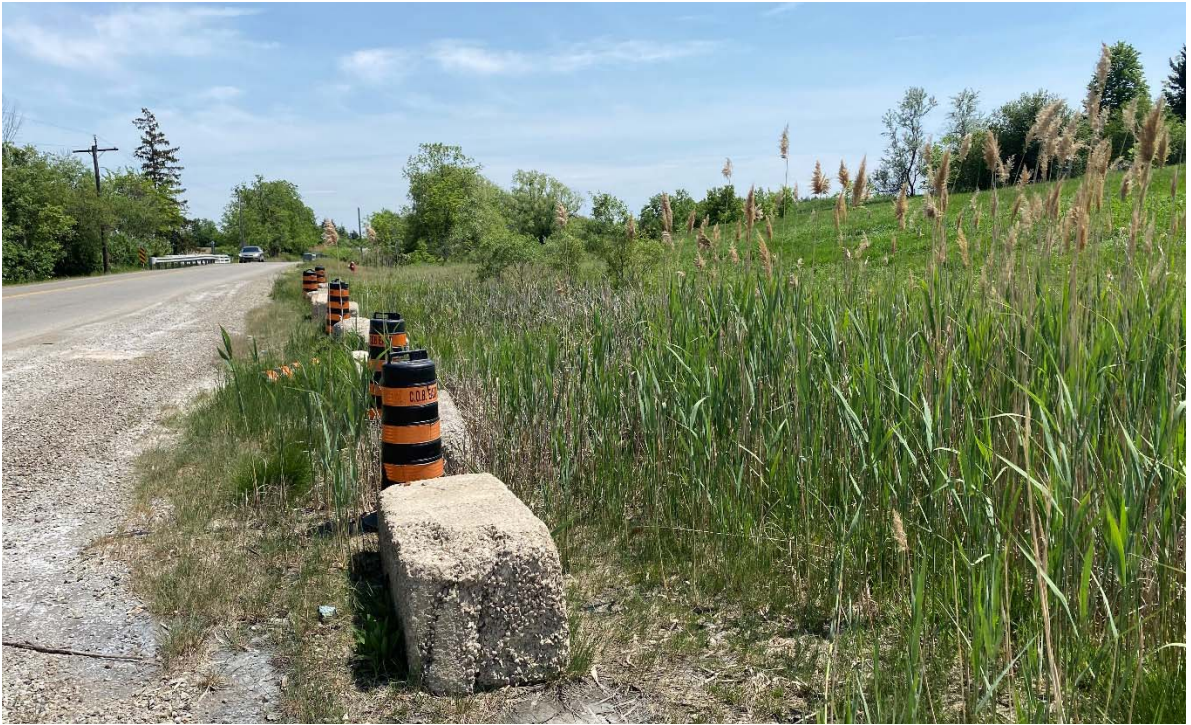
**Image 7:** Intersection of Clarkway Drive and Countryside Drive – Looking south. Road work and adjacent manipulation of the landscape mixed with the naturally occurring topography/drainage patterns has led to the beginnings of confined and limited wetland establishment. In the distance the guardrails indicate the crossing of Clarkway Tributary to the West Side of Clarkway Drive.

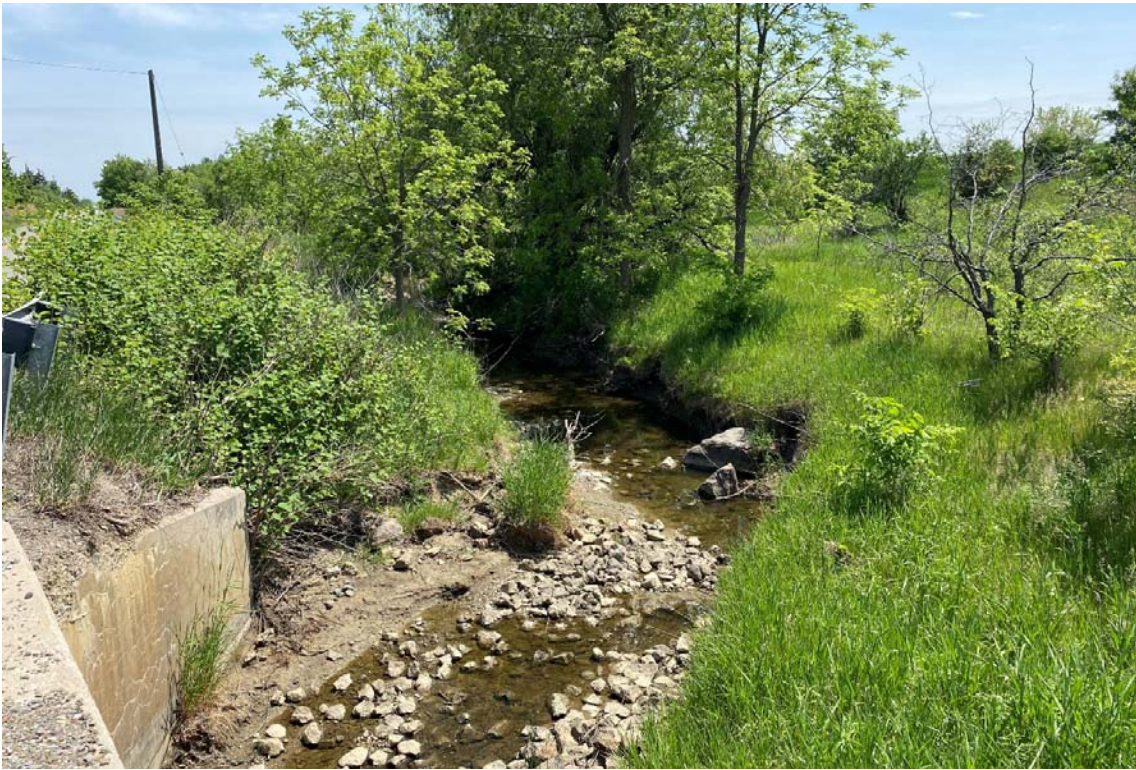
**Image 8:** Looking south. – Clarkway Tributary as it enters to the west side of Clarkway Drive. Riparian vegetation and cross section of creek are in much better condition with an increased localized capacity for both aquatic and terrestrial ecological function.

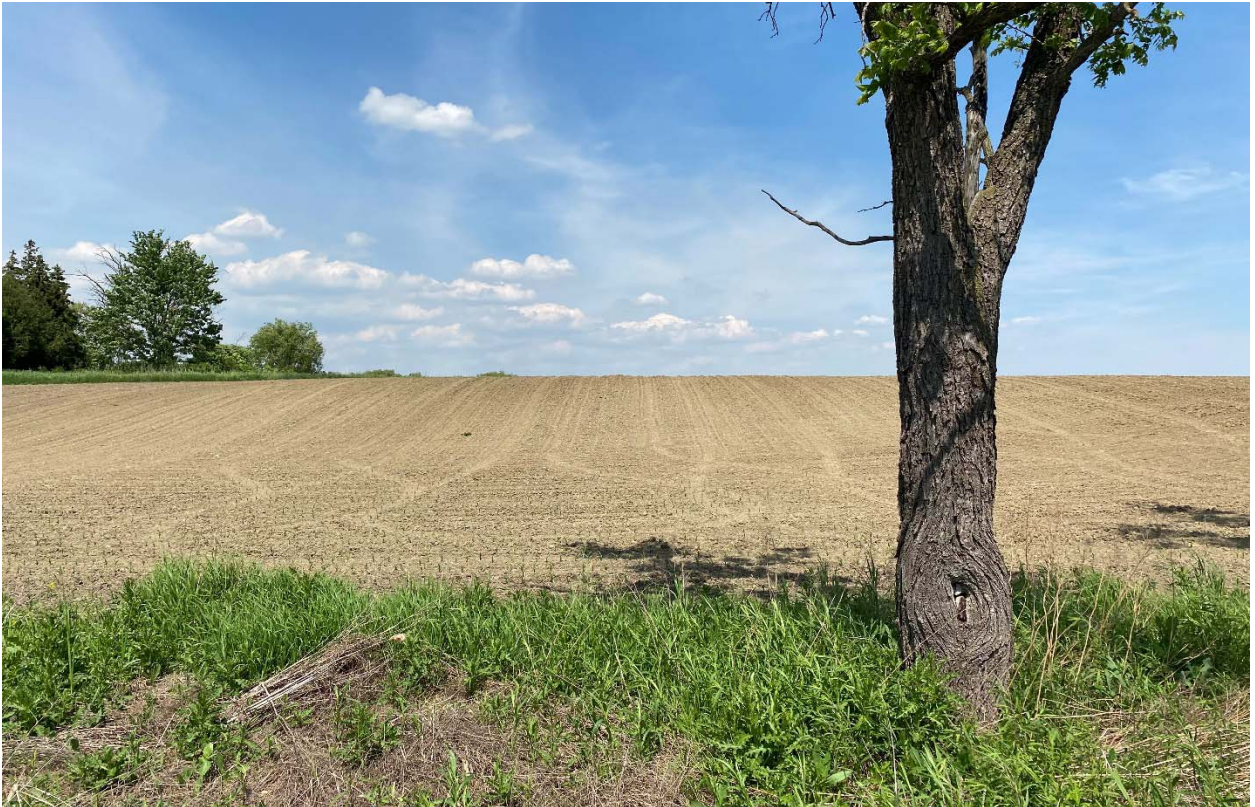
**Image 9:** Looking east - View from Clarkway Drive south of intersection with Countryside Drive. Open agricultural lands.

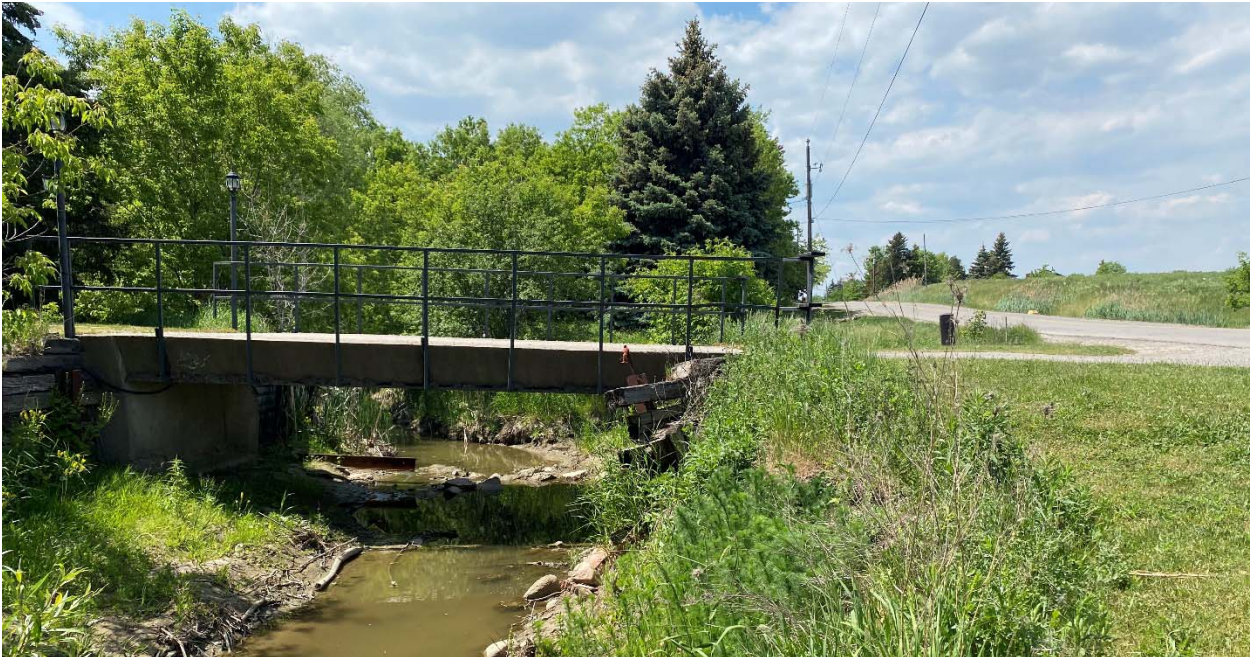
**Image 10:** Looking north on the east side of Clarkway Drive. – Clarkway Tributary swings easterly towards Clarkway Drive. The roughly 700 metre stretch between this point and the tributaries crossing of Clarkway Drive to the North represent the most intake riparian conditions thus far.

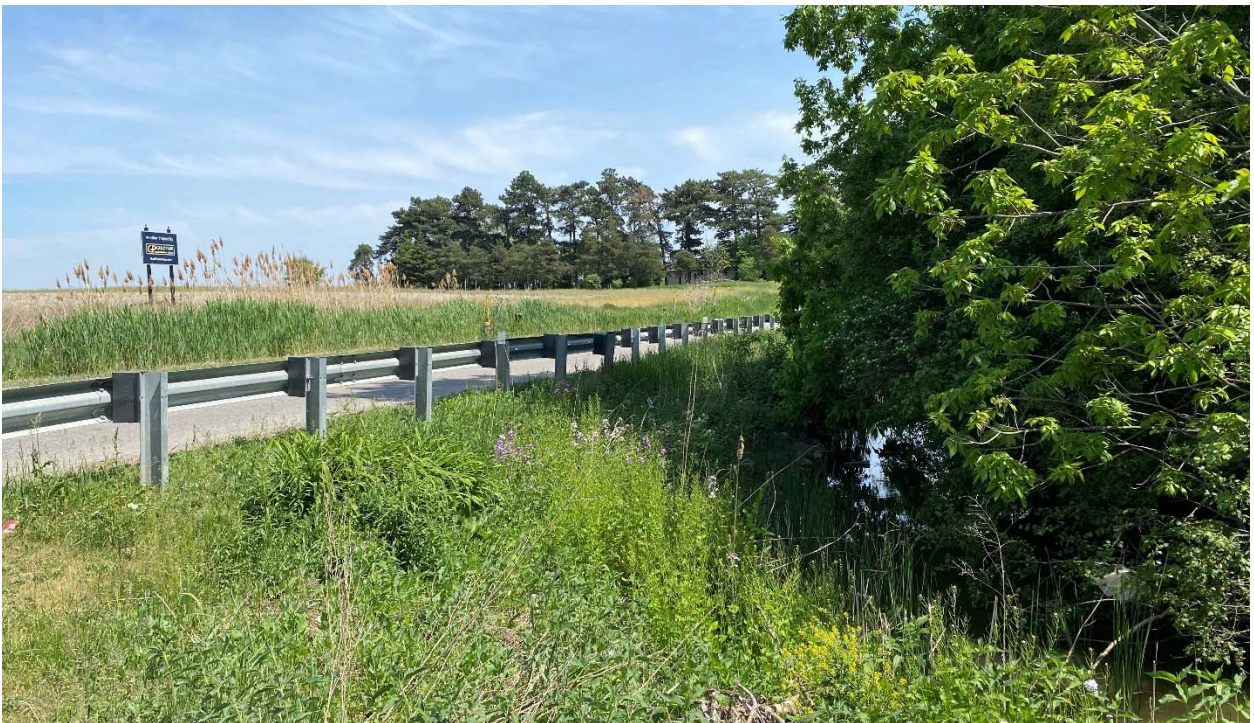
**Image 11:** Looking south on the east side of Clarkway Drive. – The reflection of Clarkway Tributary can be seen beneath the shadows of overhanging trees. From this point south 400 metres the tributary clings to the roadside necessitating steel guardrails. It is assumed significant channel protection, alignment, and restoration will be needed for the proposed corridor improvements to take place.

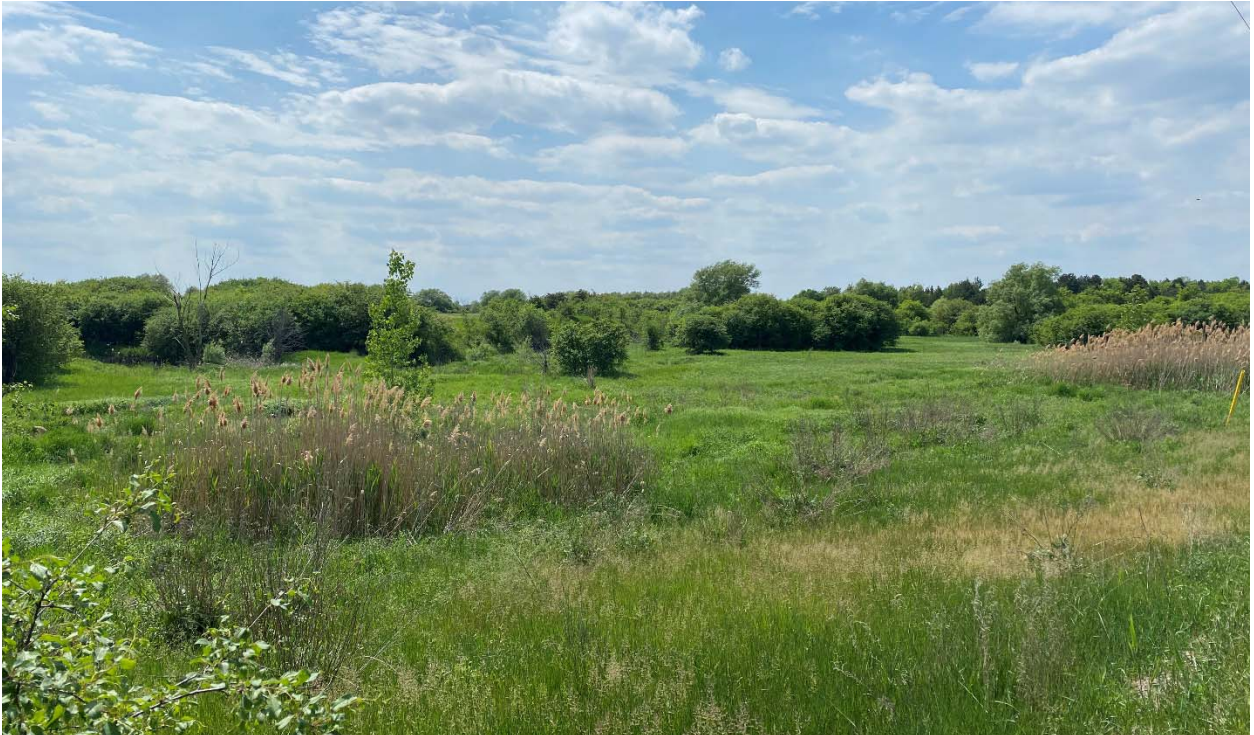
**Image 12:** Looking east of Clarkway Drive – A stretch of rolling lowlands of the Clarkway Tributary corridor. Diverse shrubs and a mix of wet meadows are most prominent, representing one of the largest perceivable patches of non-anthropocentric landscape in the Clarkway Drive corridor.

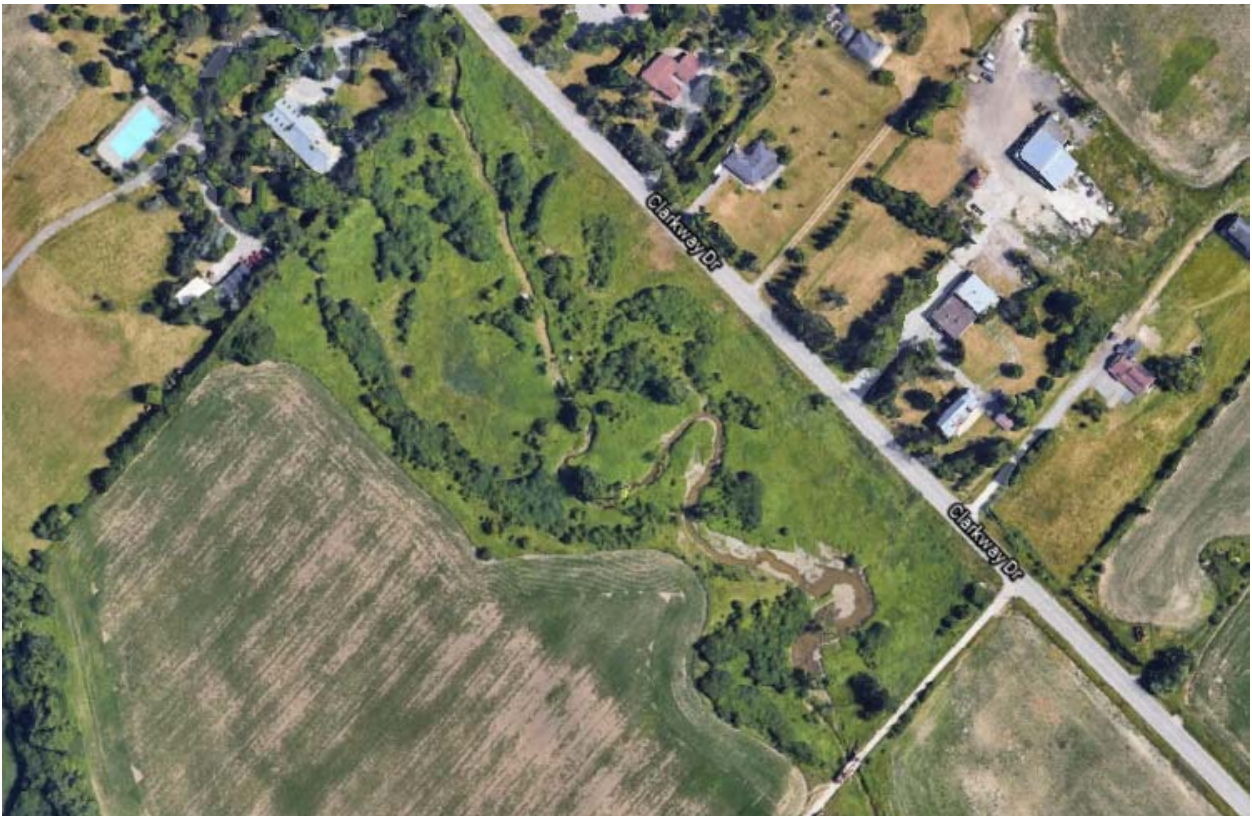
*Image 13: Aerial view of Image 12 area.*

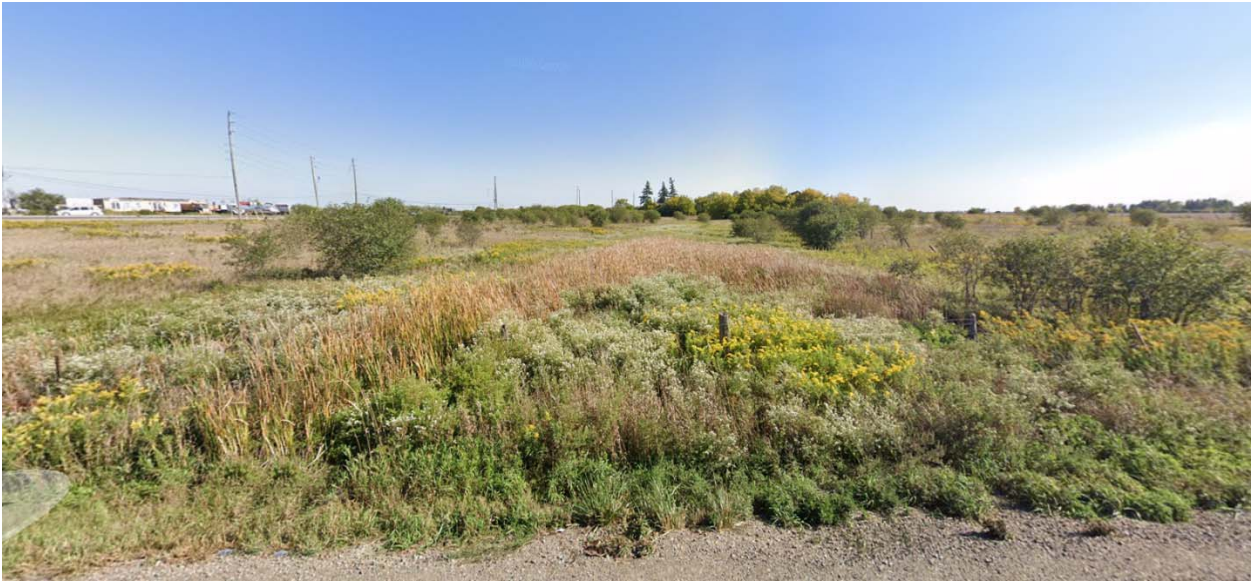
**Image 14:** East end of Countryside Drive – Looking south to naturalizing abandoned agriculture land. Highway 50 can be seen to the east.

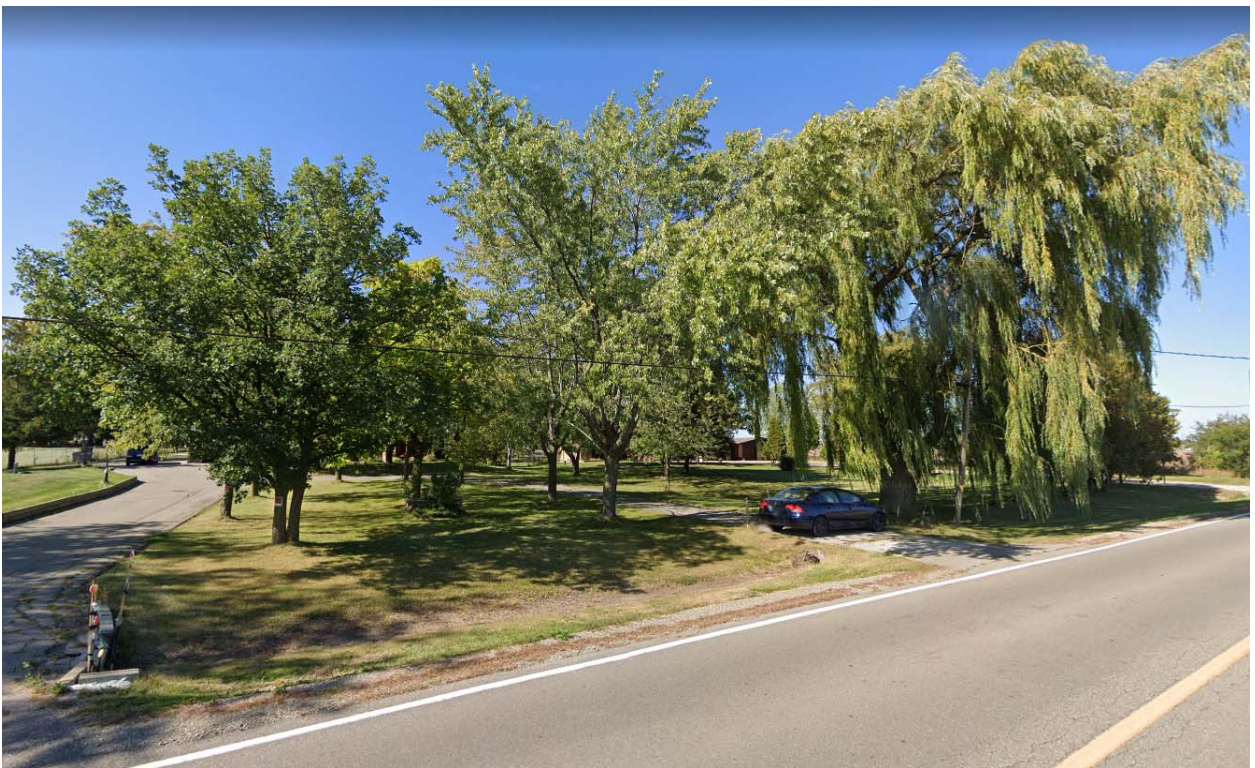
**Image 15:** East of intersection of Countryside Drive and Coleraine Drive – Looking north. Clustering of three residential sites with landscapes recessed from the proposed ROW. The exception, due to its size, is this large Weeping Willow (*Salix babylonica*).

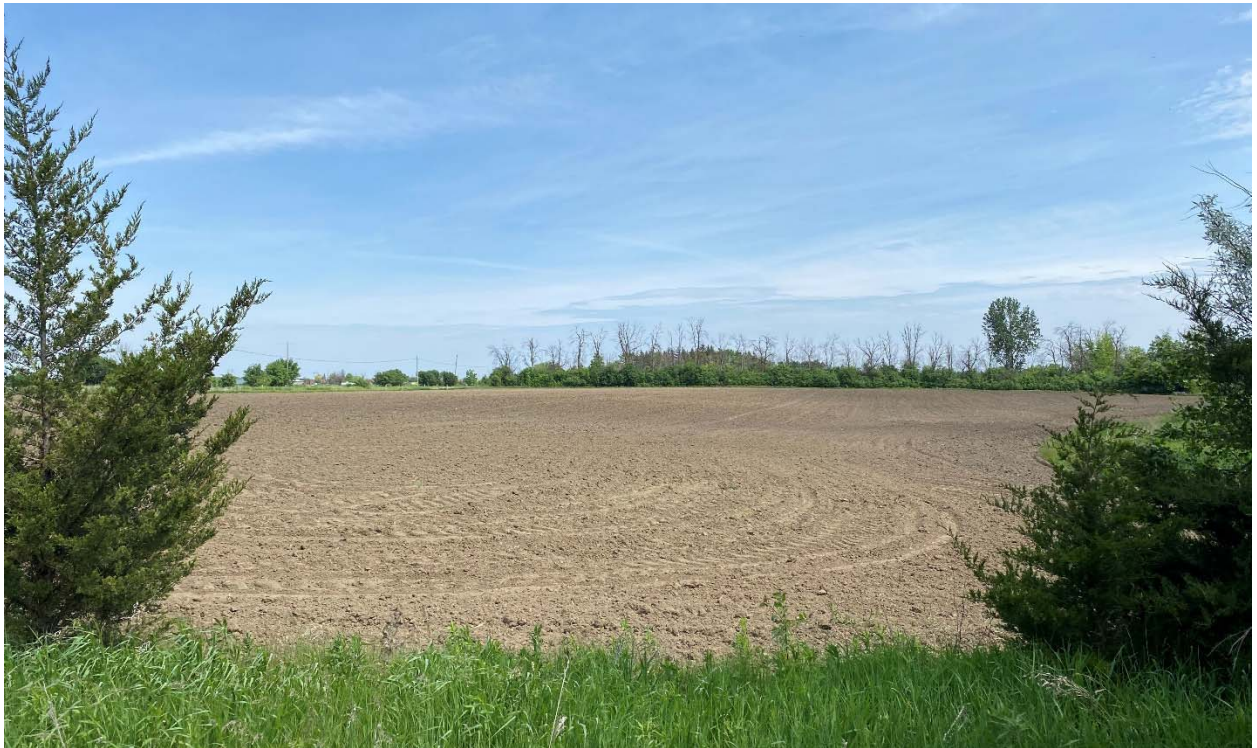
**Image 16:** Just west of intersection of Countryside Drive and Coleraine Drive – Looking south. Open Farmland with abandoned treed farmstead in the distance. Most large trees in this portion are dead, as observed throughout several points in the growing season.

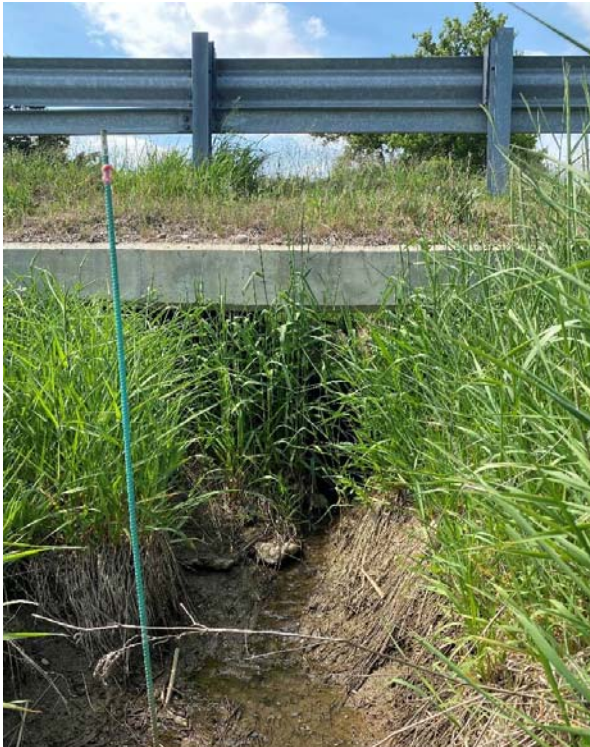
**Image 17:** Rainbow Creek Crossing – Looking north to Countryside drive.

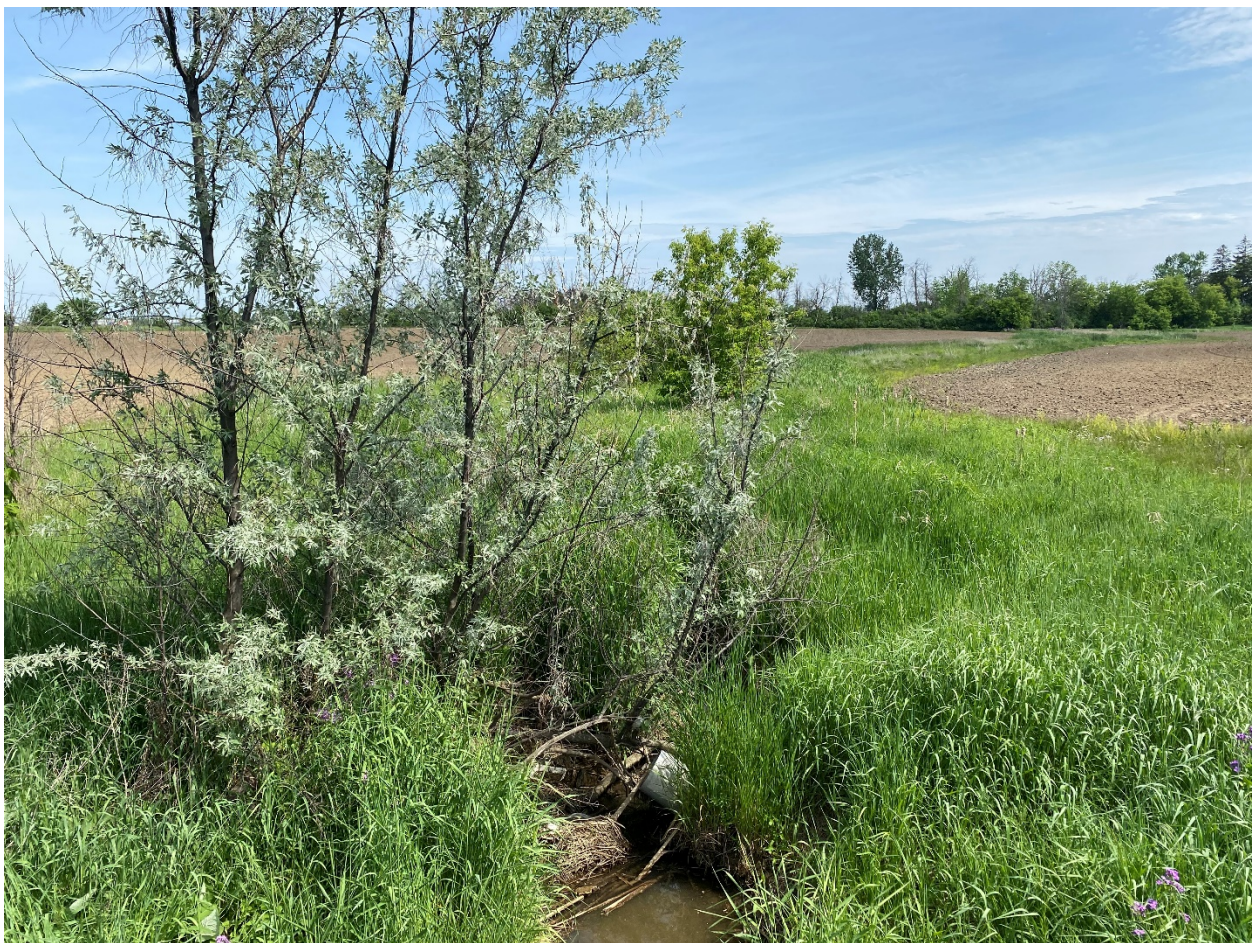
**Image 18:** Rainbow Creek Crossing – Looking south. Rainbow Creek meanders through the agricultural landscape. Wolf Willow (*Elaeagnus commutate*) can be seen growing on the bank, with a young maple in the distance. The abandoned farmstead in the background appears as a residual forest patch.

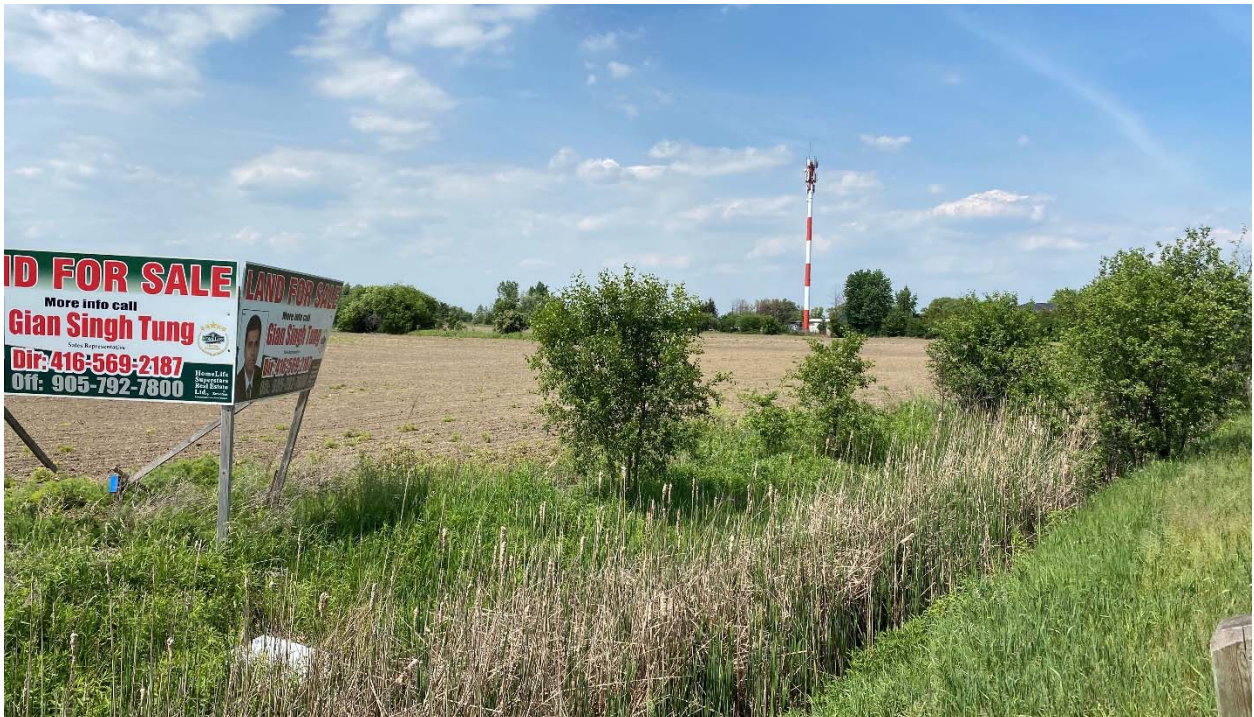
**Image 19:** Countryside Drive – Looking north. After passing a cluster of residential sites the land once again opens to large agricultural fields. On the north side the land drops sharply from the shoulder to a stormwater ditch containing wetland vegetation.

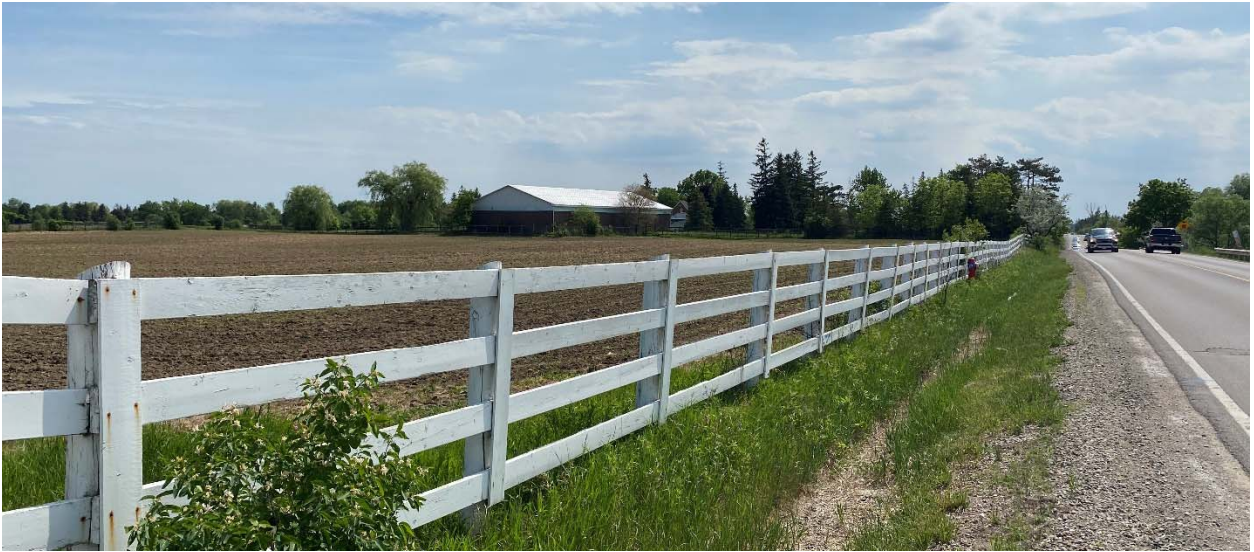
**Image 20:** *Countryside Drive – Looking south. After passing a cluster of residential sites the land once again opens to large agricultural fields. On the south side a 270 metre long white wooden fence runs parallel to the road. This fence continues to the intersection of Countryside Drive and Clarkway Drive.*

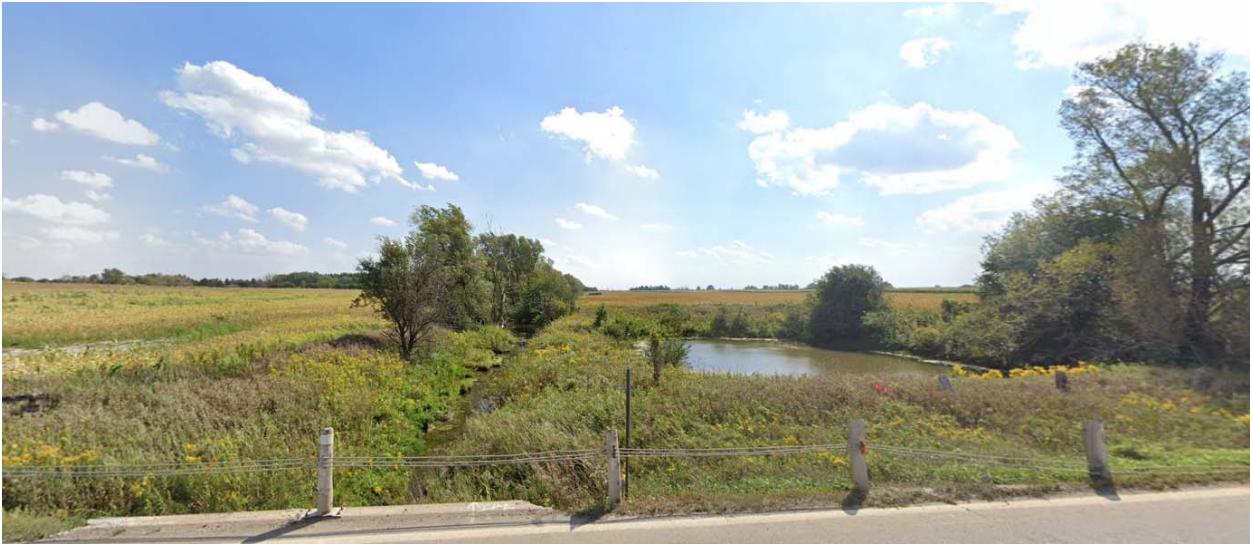
**Image 21:** *The Gore Road Tributary – Carving a defined path through the landscape, The Gore Road tributary maintains a somewhat functioning riparian corridor throughout this stretch. To the west is the old stock pond, connected, and providing diverse habitat to the system.*

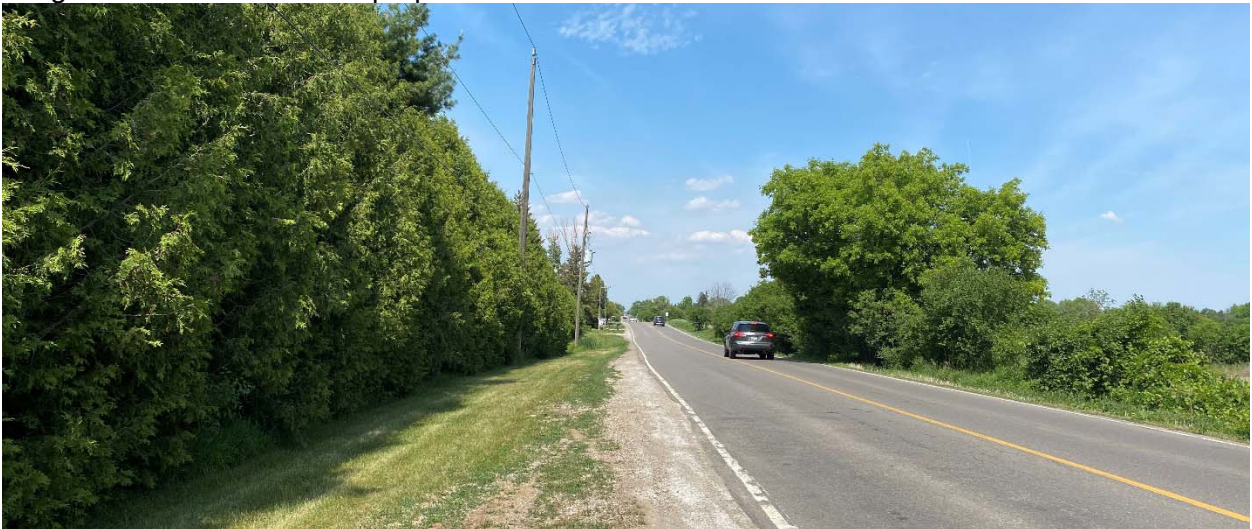
**Image 22:** *Countryside Drive – Looking east. Tall evergreen privacy hedge can be seen on the north side. To the south; remnant buckthorn shrubs and a multi-stemmed small tree, Clearing of the south side will likely be necessary.*

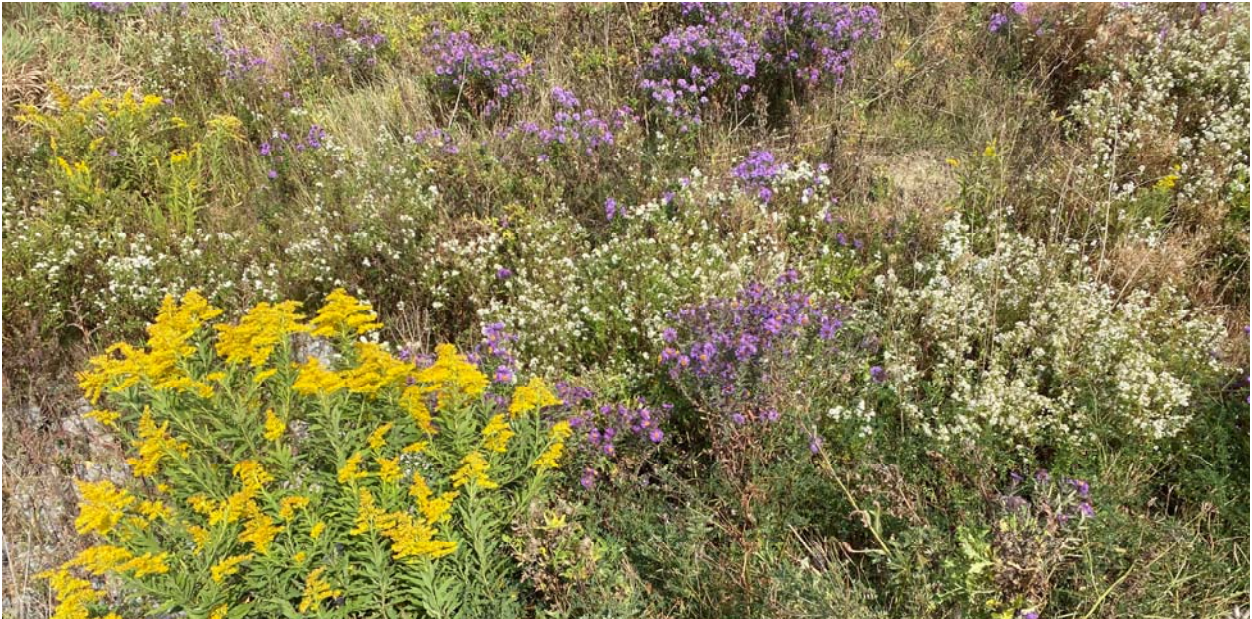
**Image 23:** Typical roadside vegetation observed consistently throughout the project zone. Asters, Goldenrod, native and European grasses, and the occasional cluster of Ragweed.

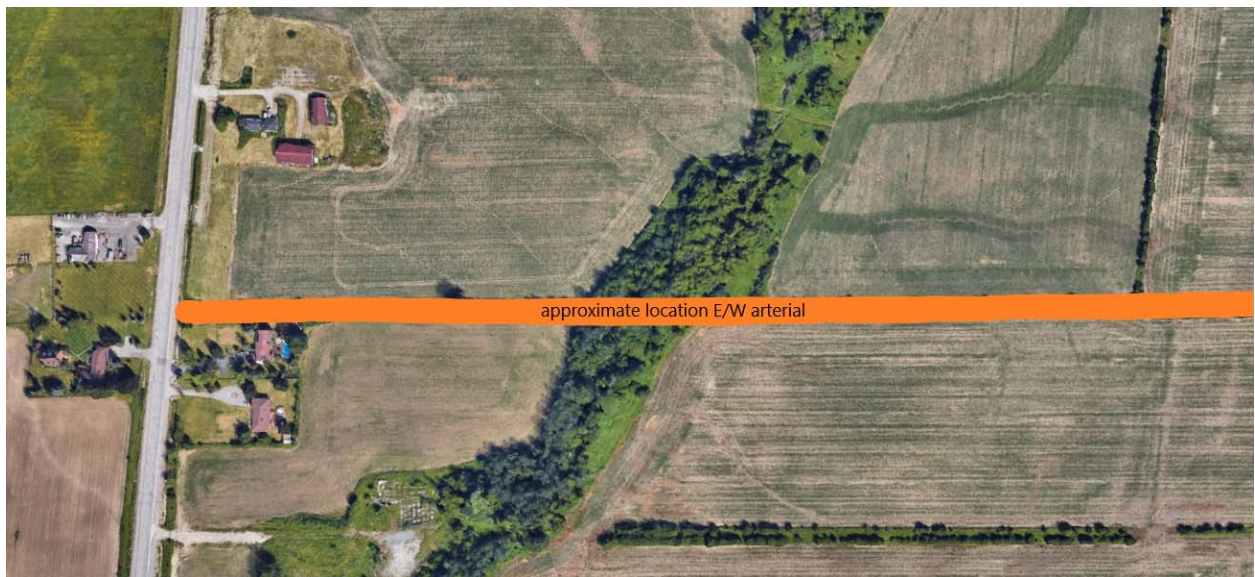
**Image 24:** Approximate location of proposed East – West Arterial as it departs from The Gore Road, seen here crossing The Gore Road Tributary.

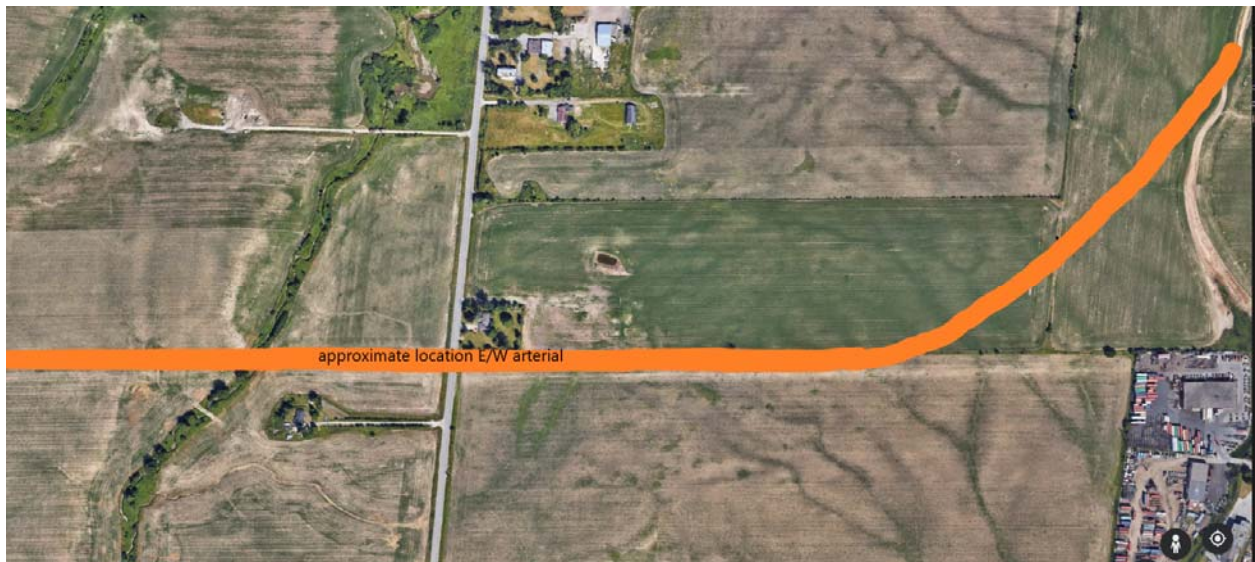
*Image 25: Approximate location of proposed East – West Arterial as it continues east to the intersection with proposed Arterial A2, seen here first crossing the Clarkway Tributary, Clarkway Drive, and intersecting with Rainbow Creek.*
