# Clark Boulevard Extension and Eastern Avenue Improvements Environmental Assessment Study

Rutherford Road to Kennedy Road

Safety Analysis Report City of Brampton

May 3, 2021

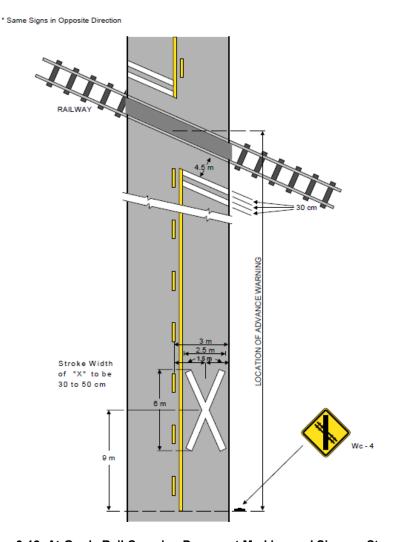
Figure 3-12: At-Grade Rail Crossing Pavement Marking and Signage Standard

Thus, the existing at-grade rail crossing pavement marking and signage does not meet standard shown in OTM Book 11 Figure 46, Page 100 in and shown in Figure 3-12.

The frequency for rail vehicles at this crossing is unclear, however, the need for potential upgrade to traffic control devices should be considered for future alternatives where increased traffic and active road users are expected.
