William Parkway Improvements Municipal Class EA

Bridge Over Spring Creek Structural Assessment Report

Submitted to: City of Brampton, Ontario

January 2024

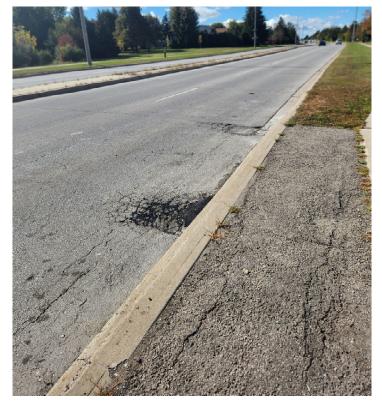
PHOTOGRAPH 4 DECK TOP LOOKING WEST

- The abutments are generally in good condition. Medium longitudinal cracks are found at west abutment close to stream elevation.
- The bridge deck is generally in good condition. Alligator cracks and pothole are noted on top of road close to the edge of north and south sidewalks. Wide transverse asphalt cracks are found on the top of road at both lanes.

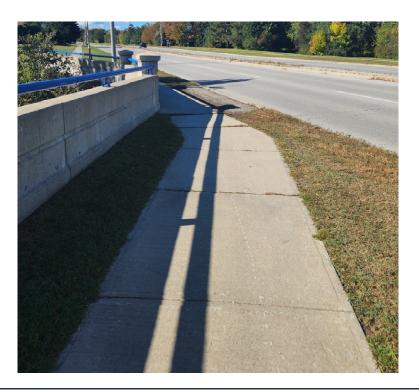
PHOTOGRAPH 17 SOUTH SIDEWALK LOOKING WEST

- North and south sidewalks are in good condition.
- Barrier walls at both sides of bridge are generally in fair condition. Wide vertical cracks are noted near joint
 locations at SE and NW barrier walls. Small vertical cracks are found at some of the railing supports at NW
 barrier wall. Delamination of rebars is noted at SW barrier wall. Some of the plugs for form ties are lost in north
 and south barrier walls.
