THURBER ENGINEERING LTD.

DRAFT
OVERVIEW PHASE ONE ENVIRONMENTAL SITE ASSESSMENT
CLARK BOULEVARD EXTENSION AND EASTERN AVENUE IMPROVEMENTS
FROM KENNEDY ROAD SOUTH TO RUTHERFORD ROAD SOUTH
CITY OF BRAMPTON, ONTARIO

HDR Inc.

Date: September 27, 2021
File: 30427

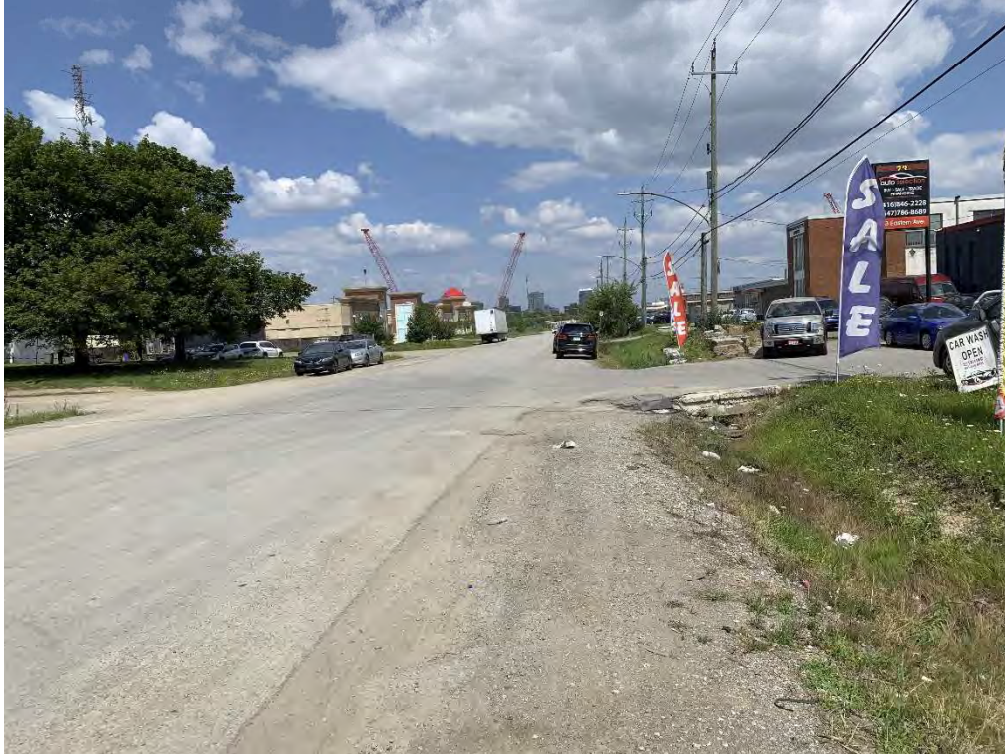
Photo 1: A general view of Eastern Avenue (Project Alignment) – View to the east near 73 Eastern Avenue.

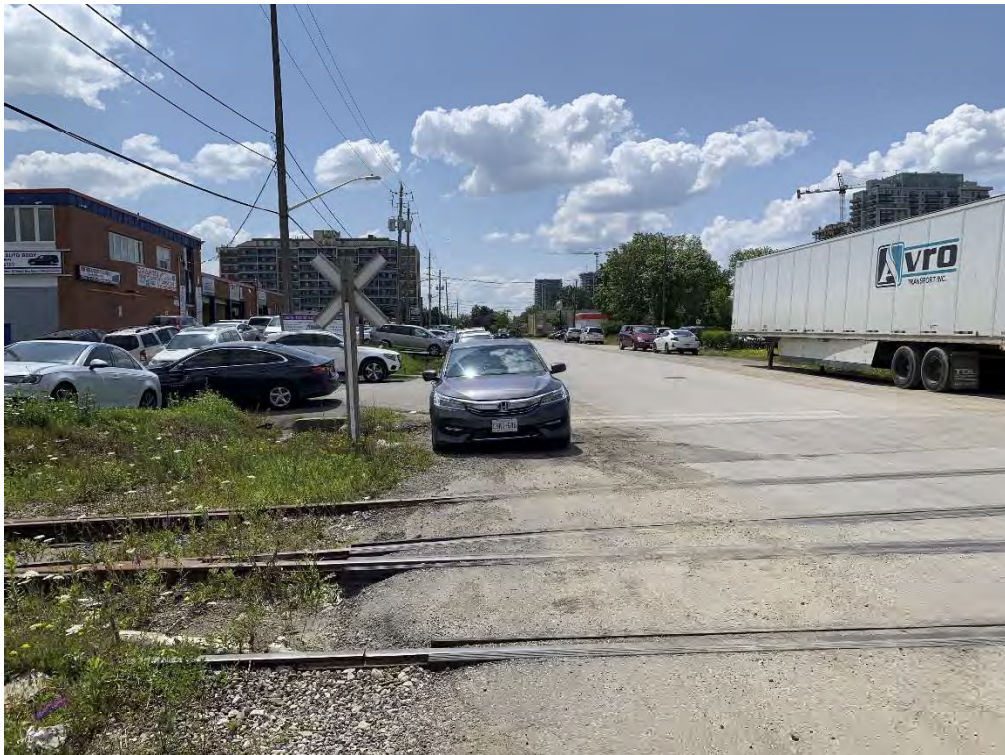
- xiii. Ground surface: The ground surface along Eastern Avenue within the Project Alignment appeared to be recently paved. Minor cracking was observed in the asphalt near Kennedy Road South. Minor stains typical of road markings were observed near the entrances of 69 Eastern Avenue, 75 Eastern Avenue and 79 Eastern Avenue, however, significant staining was observed near the abandoned railway sidings between 69 Eastern Avenue and 73 Eastern Avenue (Photo 2).

- xiv. Current or former railway lines: An abandoned railway siding (Photo 2) was observed between 69 Eastern Avenue and 73 Eastern Avenue.
- xv. Areas not covered by building or other structures: No stressed vegetation was observed along the road-side ditches. No fill materials or debris were observed on the ground surface within the Project Alignment.

Photo 2: A view of the stains near the abandoned railway siding between 69 and 73 Eastern Avenue – View to the west on Eastern Avenue.

- **PCA# 46: Rail Yards, Tracks and Spurs**
 - Railway Sidings between 69 and 73 Eastern Avenue including the adjacent stained areas
- **PCA# 30: Importation of Fill Material of Unknown Quality**
 - Fill materials are expected to exist beneath Eastern Avenue and may be present on the properties at 25 and 35 Rutherford Road as part of site development for industrial purposes, particularly at 25 Rutherford Road South where a former building (depicted in FIPs) was demolished, and fill may have been imported for grading or backfill purposes. The property at 25 Rutherford Road South was observed to be vacant during the Site Reconnaissance, although shallow excavations and multiple monitoring wells exist on the property that may be related to impact subsurface conditions, remediation and/or monitoring of the groundwater conditions.

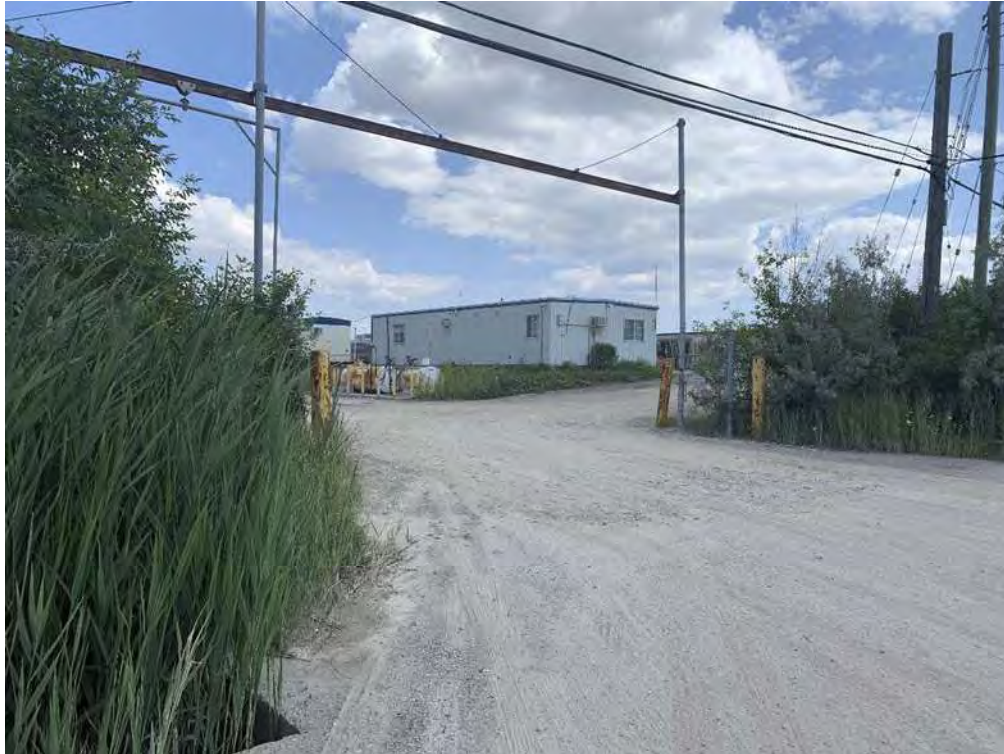
Two above ground fuel storage tanks (Photo 3) were observed on this property near the property entrance at Hansen Road South and Eastern Avenue. The tanks were placed on a concrete pad. Multiple building structures and numerous pre-cast concrete blocks were stored in the area of the proposed project alignment. The ground surfaces near the property entrances at Hansen Road South and Rutherford Road South generally consisted of sand and gravel. A number of reinforcing steel bars were visible near the entrance at Rutherford Road South.

Photo 3: A view of the above ground storage tanks at 35 Rutherford Road South.

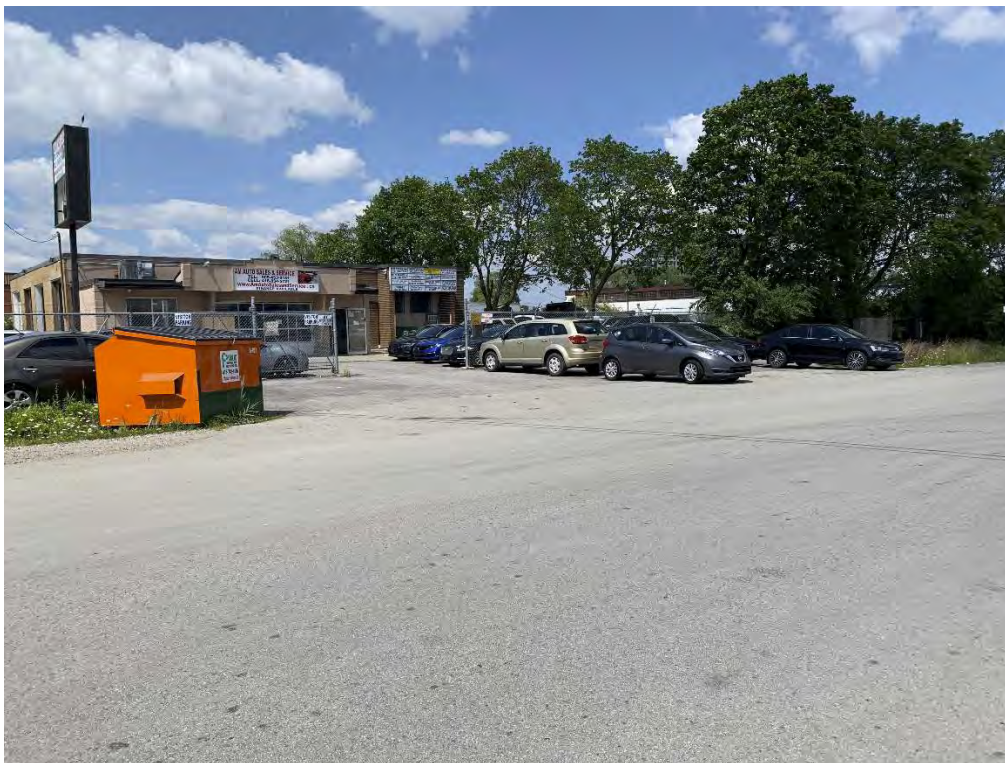
Photo 4: A view of the autobody shop at 60 Eastern Avenue.

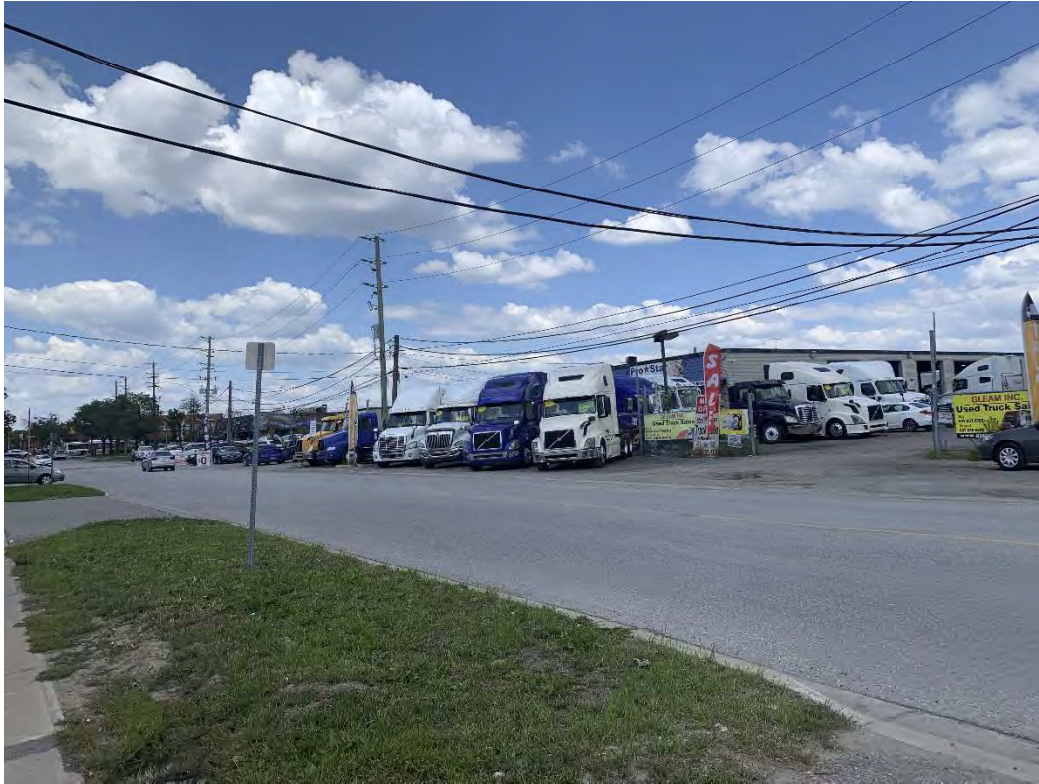
- Queen Street East: 243
 - Rutherford Road South: 19, 26, 28, 32
- **PCA# 11: Commercial Trucking and Container Terminals**
 - Commercial trucking terminals were observed at 14 Hansen Road South (Photo 5) and 27 Hansen Road South.

Photo 5: A view of the commercial trucking terminal (used truck sale) at 14 Hansen Road South.

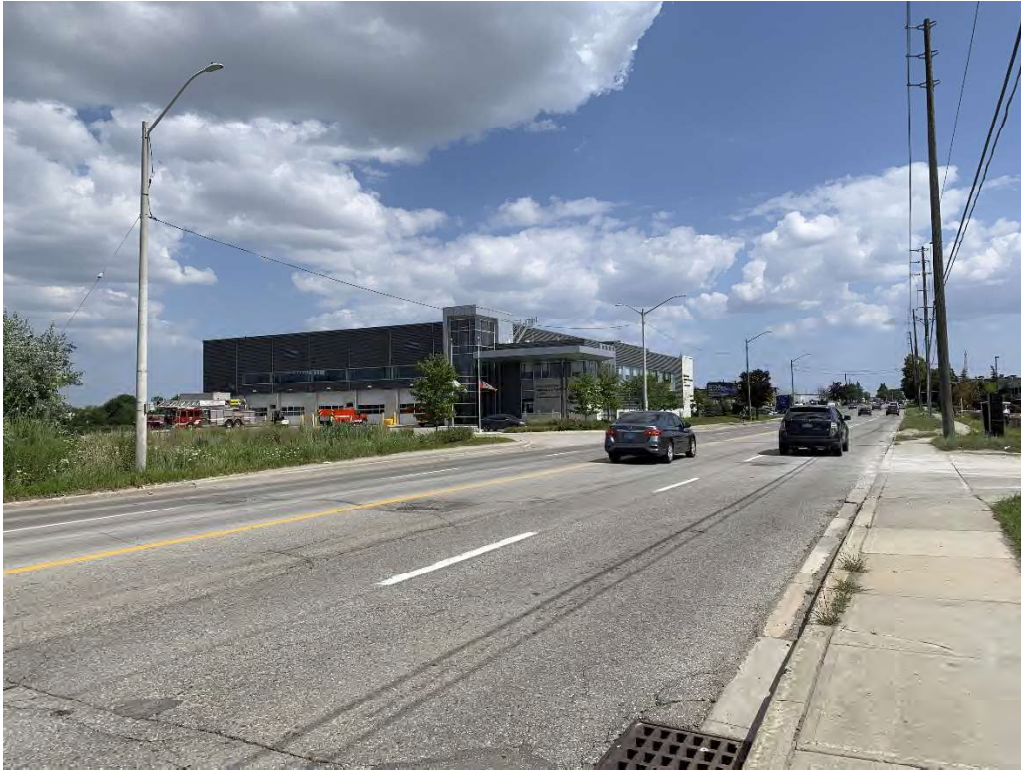
Photo 7: A view of the City of Brampton Apparatus and Maintenance Facility at 52 Rutherford Road South.

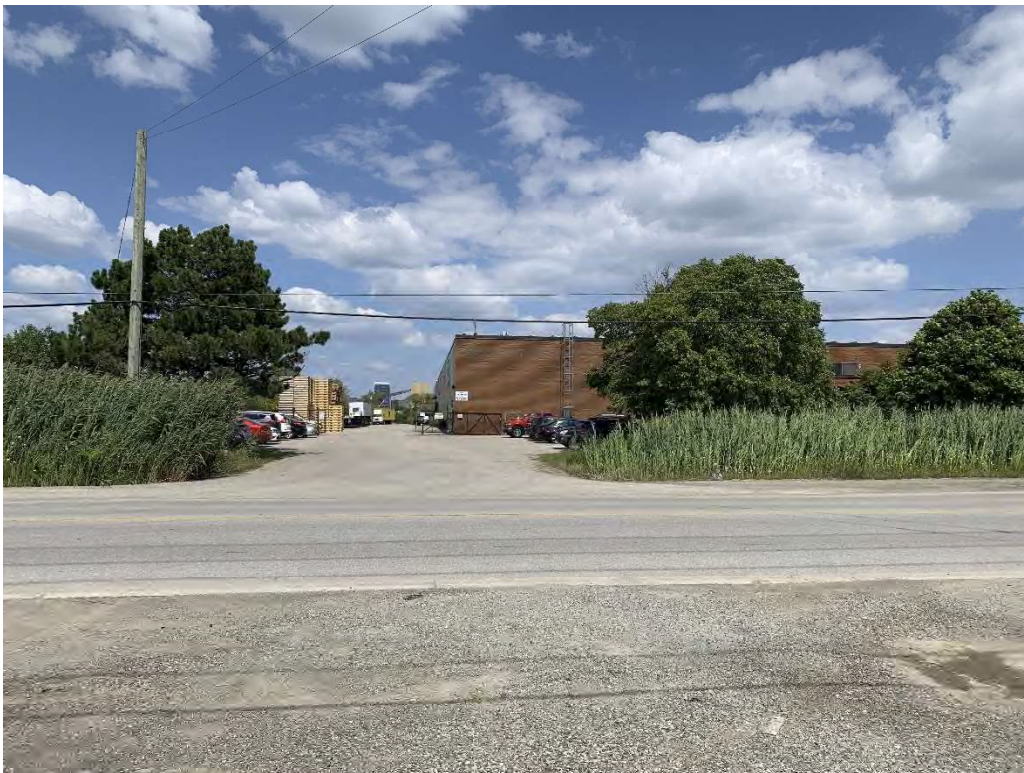
Photo 8: A view of the furniture manufacturer at 34 Hansen Road South.

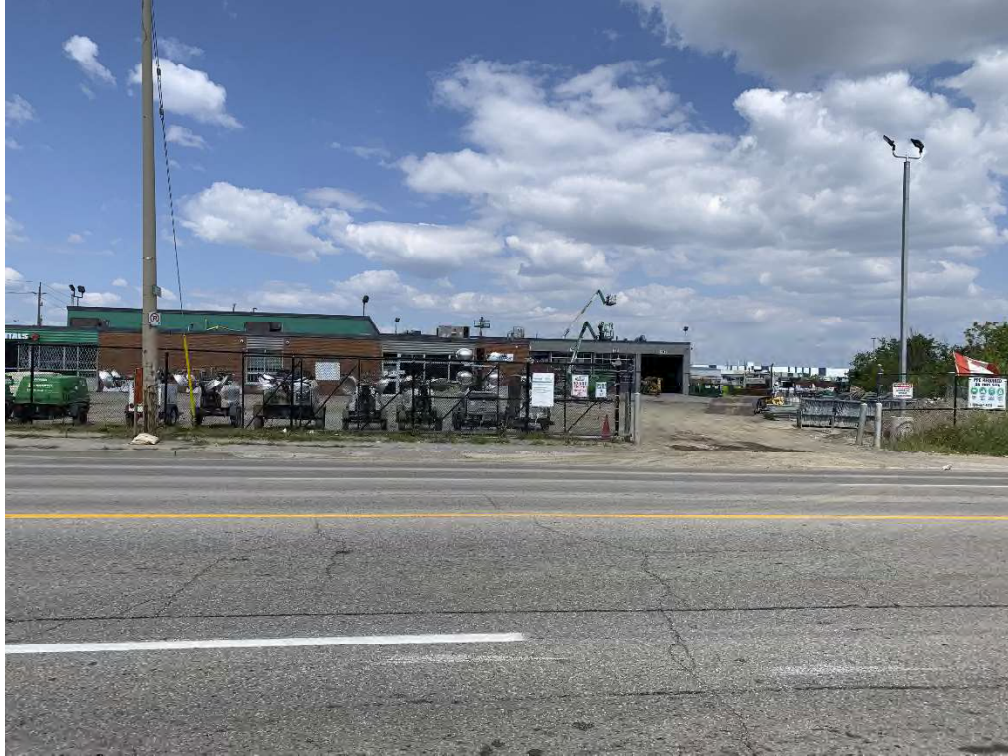
Photo 9: A view of the rental company at 36 Rutherford Road South – maintenance garages for machinery equipment were observed.

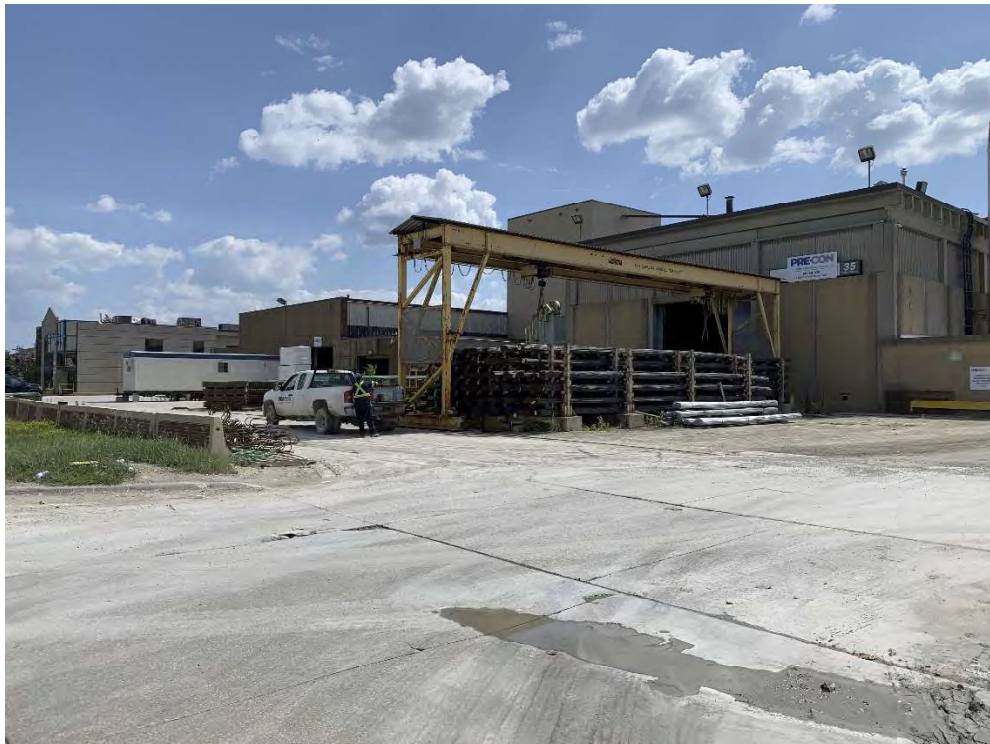
Existing buildings and structures include the facilities on the concrete plant property at 35 Rutherford Road. Considering buildings were present on the site in the late 1960s/early 1970s, designated and hazardous materials may be present in the building materials and infrastructure.

Photo 10: A view of 35 Rutherford Road South – a private property that contains the proposed Clark Boulevard Extension.

In this regard, a Designated and Hazardous Substance Survey is recommended as part of Phase One and Two ESAs if the buildings are going to be acquired as part of the property acquisition to accommodate the proposed road improvements/extension. Surveys are also recommended for the properties along Eastern Avenue where the Right of Way (ROW) required to widen the road includes a portion(s) of existing buildings(s), if any.

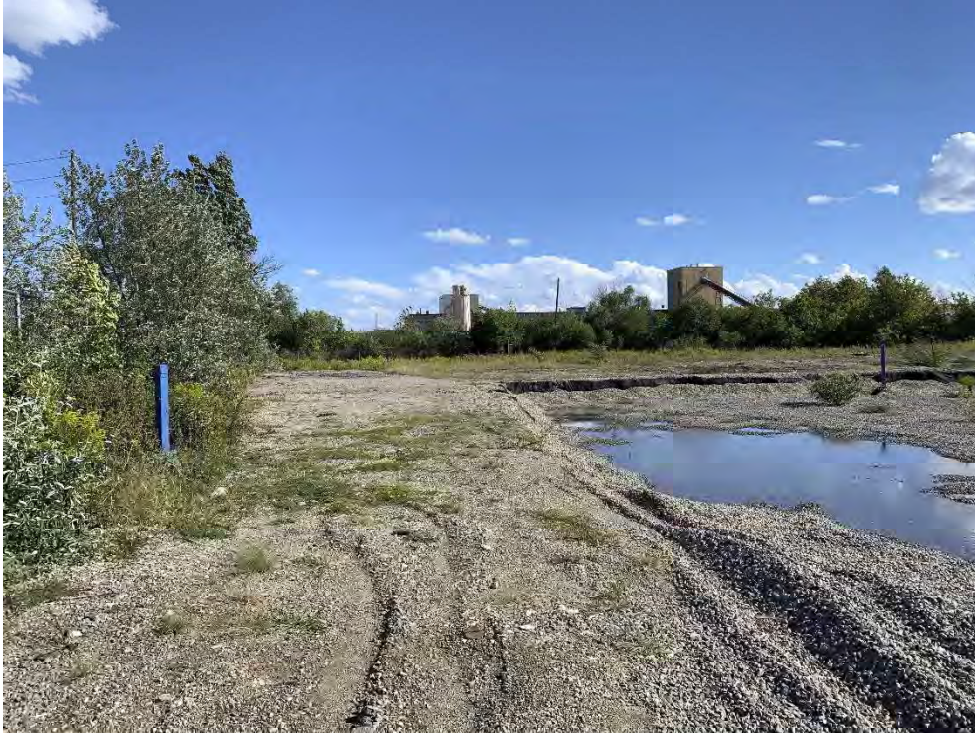
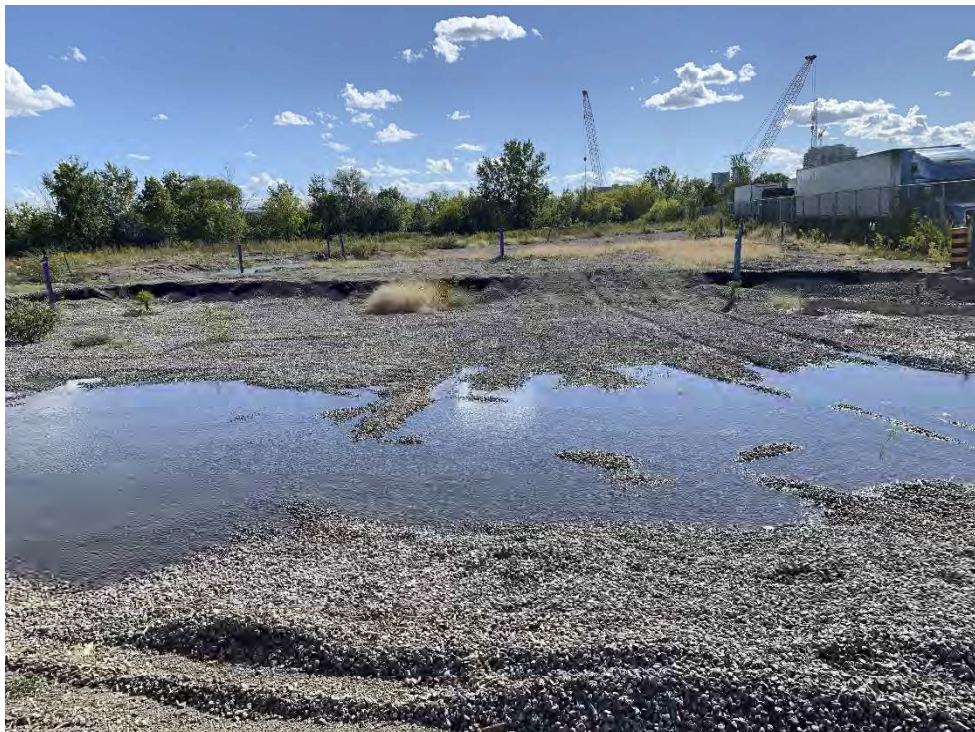
The property was vacant at the time of the Site Reconnaissance. No buildings or other structures were visible, although a large shallow excavation (i.e., less than 1 m deep) existed across a major portion of the property, with a smaller excavation to the west. A geomembrane liner with gravel existed across the bases of the excavations. Multiple groundwater monitoring wells existed around the perimeter of the excavations and on the property: the purpose of the excavations and monitoring wells are unknown but may be related to remediation and/or monitoring of the groundwater conditions.

Photo 11: 25 Rutherford Road South – View to the south from the northeast corner of the property.

Photo 12: 25 Rutherford Road South – View to the west from the northeast corner of the property.
