Contamination Overview Study

Arterial Roads Within Highway 427 Industrial Secondary Plan Area (Area 47) – Environmental Assessment Study Brampton, Ontario Project No. TP115086

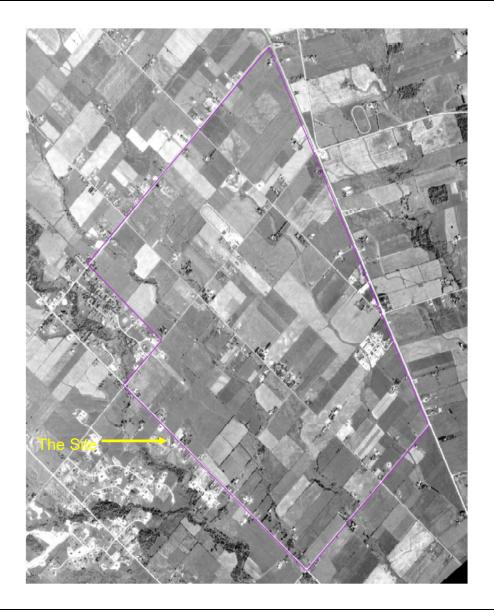
1988 1: 40,290	Seven (7) rectangular buildings, likely of commercial or industrial use, are visible in the eastern portion of the Site, from Highway 50. Additional residential properties are present on Clarkway Drive.	A residential subdivision is visible west of the Site, and north of Countryside Drive. No other major changes were noted in the Study Area.
2004 Scale Unknown	The area of commercial and/or industrial use from Highway 50 has expanded. Equipment and tractor trailers are visible around the buildings.	Additional residential subdivisions are visible west of the Gore Road. Commercial warehouses are visible east of
	An additional commercial and/or industrial property is present in between Coleraine Drive and Highway 50.	the Site, on the east side of Highway 50.
	The rest of the Site is still generally comprised of residential and agricultural properties.

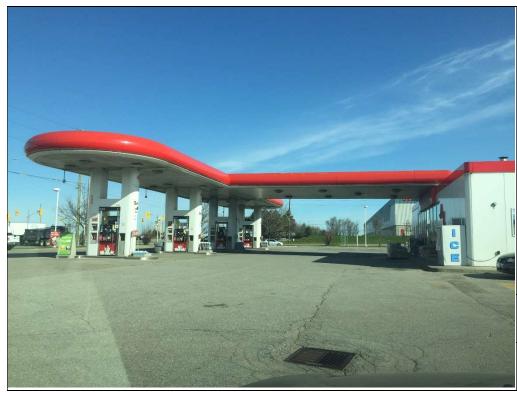
Photo 1:

Gas station located at the southeast corner of Regional Road 50 and Rutherford Road.

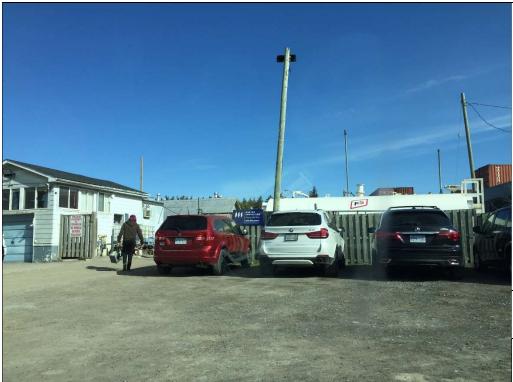
Photo 2:

View of the aboveground storage tank (AST) at the northeast corner of Regional Road 50 and Major Mackenzie Drive.

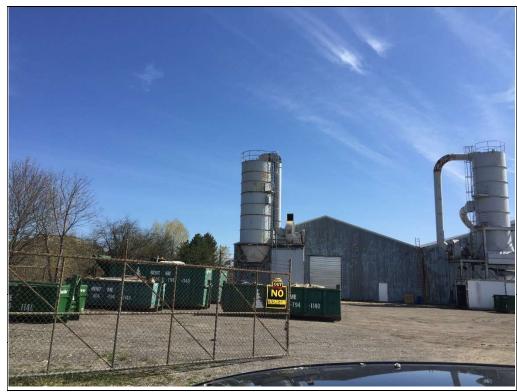
Photo 7:

View of the industrial property at 10562 Regional Road 50.

13	10562 Highway 50	Industrial building, with soil fill piles noted on the property.	Industrial property use 30. Importation of fill material of unknown quantity	All COCs listed at the end of this table
14	North end of Old Castlemore Road	Fill pile with concrete and brick material dumped at the end of Old Castlemore Road	30. Importation of fill material of unknown quantity	All COCs listed at the end of this table
15	20 Cadetta Road	Quality Fabricating – Listed as a iron and steel mill and ferro-alloy manufacturer, and miscellaneous fabricated metals products manufacturing.	34. Metal Fabrication	Metals VOCs PHCs

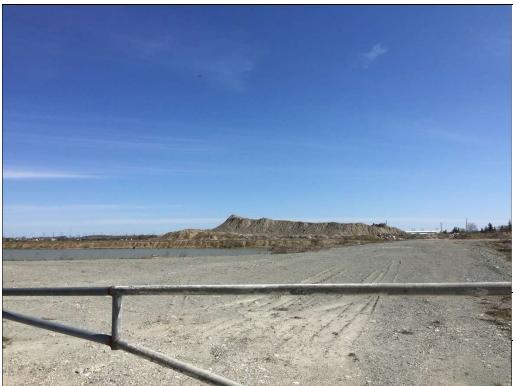
Photo 8:

View of soil piles on Coleraine Drive.

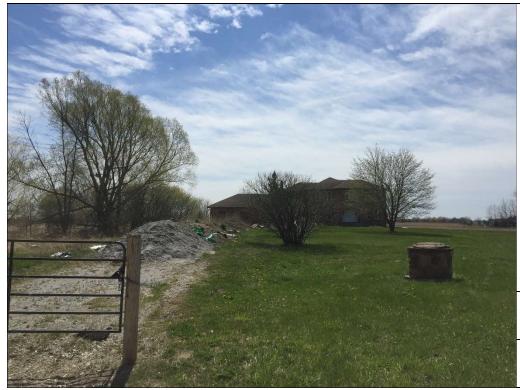
Photo 11: View of soil fill piles in front of 5253 Countryside Drive.

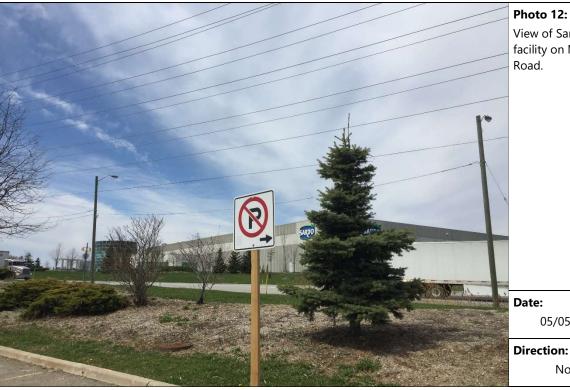
View of Sardo Foods facility on Mayfield

Number	Address	Occupant and Description	Ranking Rationale
37	11411 Clarkway Drive	Clarkway Construction Limited – Eris report lists an ECA for waste management systems.	Vehicle and equipment storage noted on the property.
38	10462 Highway 50	Greenside Garden Gallery Limited	Limited pesticide vendor.
39	10775 The Gore Road	The Corporation of the City of Brampton – Registered standby power system. Fire Station noted on property during site visit.	Potential presence of diesel equipment associated with the power system. Community Property Use
40	7875 Mayfield Road	Adinatha Swamy Jain Temple	Community Property Use
41			
42	23 Marysfield Drive	Arbor Mill Landscaping Contracting Inc.	Pesticide operator.
43	8602 Mayfield Road	Albion Nursery and Garden Centre	Pesticide vendor.
44	100 Pillsworth Road	The Home Depot Canada	Waste generator, commercial property.
45	99 Pillsworth Road	Sardo Foods Inc.	Food manufacturing facility
